SERVICE BULLETIN

MODEL: IC-R7000 SN AFFECTED: ALL BULLETIN # 35187-001

SUBJECT: **SUPERSEDES SB# 32787-001 (11/25/87)** PROBLEM: AUDIO OUTPUT BECOMES

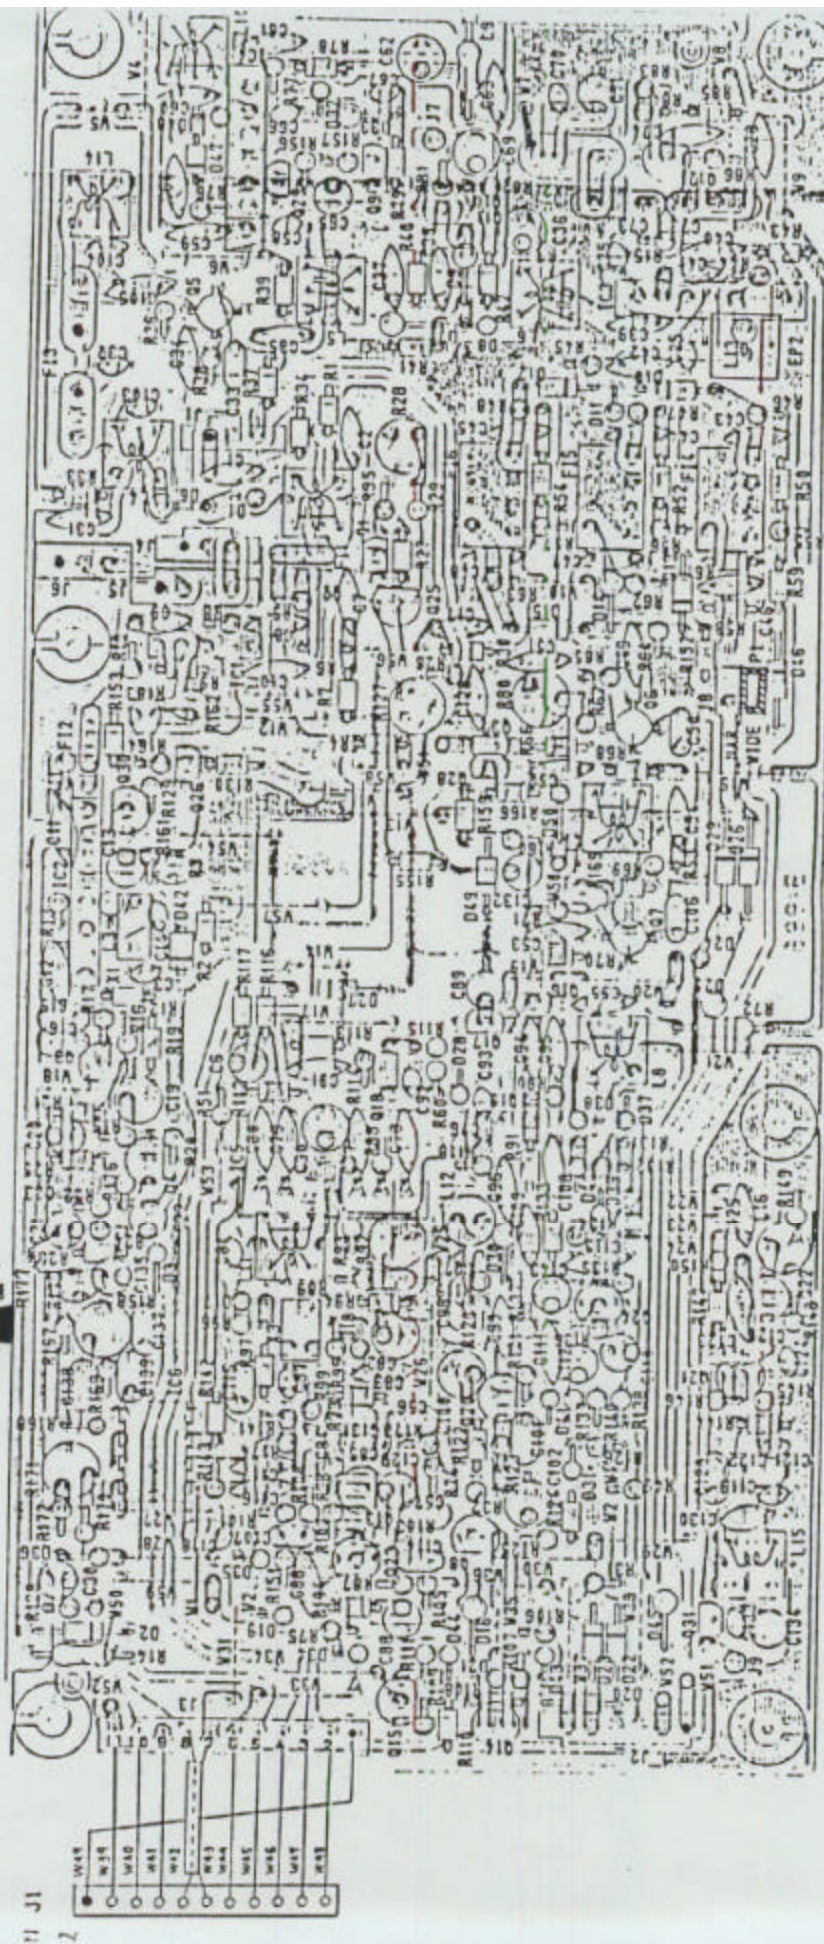
R-7000 IF Board

DISTORTED (CLIPPED) WHEN UNITS WARM UP. THIS PERIOD MAY BE A FEW MINUTES TO A FEW HOURS
DEPENDING ON THE AMBIENT STARTING TEMPERATURE. THIS MAY NOT BE EVIDENT AT LOW LEVELS.

1. REMOVE THE TOP COVER AND DISCONNECT AND REMOVE MAIN I.F. BOARD.
2. ADD R-177 (P/N 915-01187 100 K) TO THE POINT SHOWN ON DIAGRAM 1 (FOIL SIDE)
3. RE-INSTALL BOARD AND TEST IT. REPLACE COVERS AND WARM UP FOR A MINIMUM OF TWO HOURS IN ORDER TO CHECK FOR DISTORTED AUDIO.
4. RETURN TO SERVICE

Add R-177
at this
point on the
foil side
