## Trio / Kenwood TS-430S information.

### Common faults:

#### Intermittent Drop in Power Output, Erratic ALC behaviour, SSB distortion:

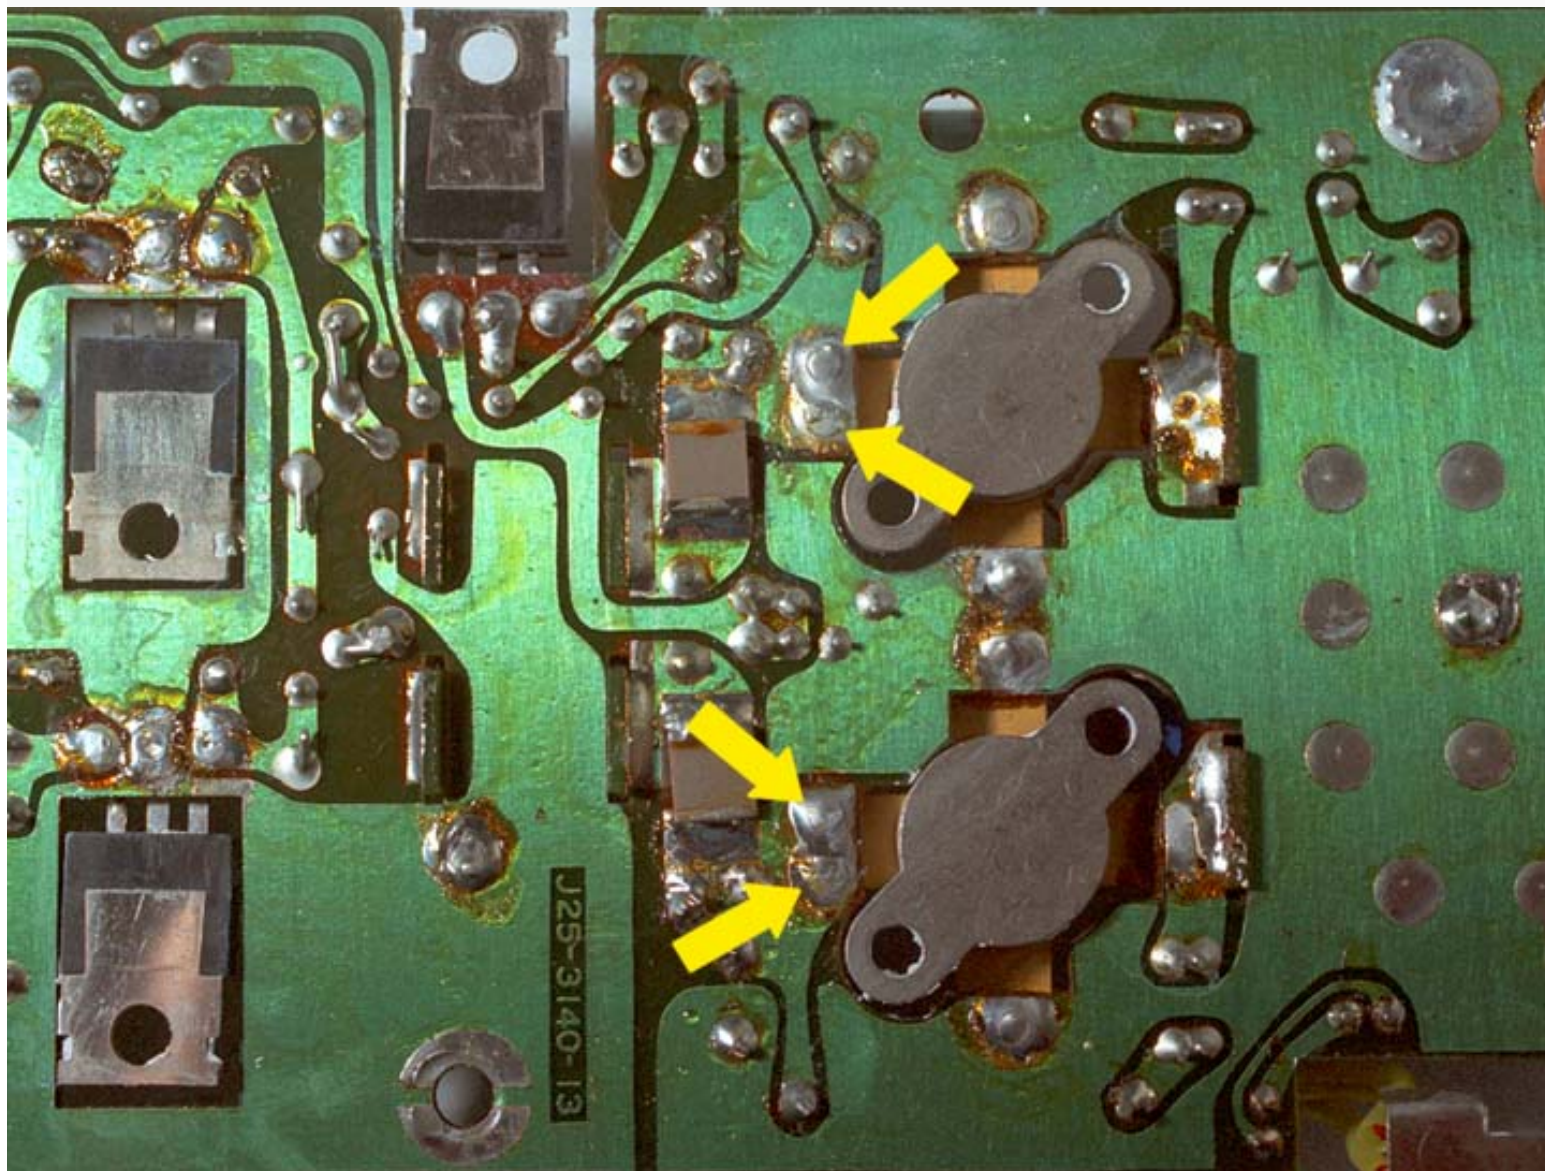
Unless your TS430 has been in a store room since it was manufactured, you have an appointment with the vias (PCB through-hole connections) and soldered joints around the PA final transistors. All units will eventually fail through solder-fatigue; brought on by constant temperature cycling, and exacerbated by embrittlement due to migration of gold atoms from the transistor tabs. This is not a problem exclusive to the TS430, but the cheap construction, particularly the SRBP circuit board with riveted vias, is something of a liability in this case. This is one area in which periodic maintenance can help to prevent disaster; the disaster in question being the open-circuiting of the PA transistor base connections, and consequent failure of the driver and driver-bias transistors. Warning signs are (as in the heading) one or more of the following: Intermittent variation in output power, erratic ALC level indication, and reports of audio distortion on SSB signals.

- 2) Remove the final amp PCB retaining screws, transistor retaining screws, and the thermistor retaining screw, and separate the board from the heat-sink. Note which transistors require mica washers, then clean off all of the old heat-sink compound with isopropanol and cotton buds. Inspect the PA transistor base via rivet heads (2 per transistor) on the underside of the PCB. A dark circle in the solder indicates that the connection has failed (even though it may exhibit a low DC resistance at the time of examination). The problem is clearly evident in the photograph below (yellow arrows), and the module shown was indeed producing distorted SSB. A cursory examination of the board also reveals failure of the emitter vias, but since the emitters are connected to the ground plane on both sides of the board, these additional failures do not prevent the unit from working.

Bridge the PA base vias with wire. This can be done without removing the transistors, by passing a wire through the gap to the side of the transistor tab. Also inspect all of the other vias on the board, particularly those at the driver transistors, and resolder as necessary.

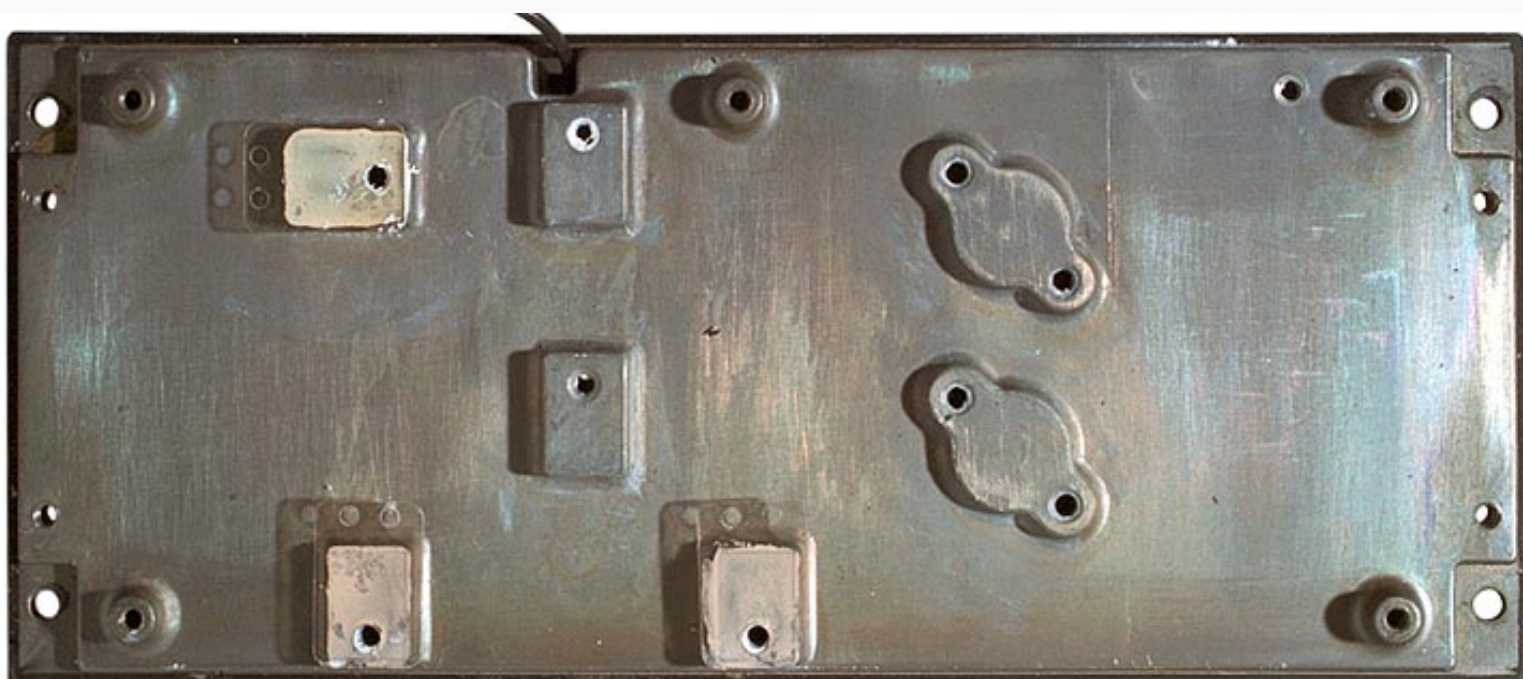
Heatsink in preparation for reassembly, showing which transistors require mica washers.

- Avoid using excess heat-sink compound.
- Do not over tighten transistor retaining screws. Leave time for the grease to extrude and then retighten.
- Re-solder SOE transistors after reassembly to relieve stresses.
- Remove old solder as far as possible and replace it, to reduce gold contamination.
- Check for shorts - bases measure  $7.5\Omega$  to ground. Collectors o/c fwd, 0.53V rev.
- Re-commission using a **current-limiting PSU**.
- Test initially at low power levels in case of loose or shorted output connectors. The operation of the SWR protection circuit depends on a proper connection between it and the amplifier.
- **Reset Bias** according to the procedure in the service manual.
- Check that the antenna connector is not loose. A faulty ground connection at this point can cause a bad SWR and activate the protection circuitry.
