Modifications for the Kenwood TS-820

Trio-Kenwood Communication, inc.

Service bulletin no. 11 13-1-1977

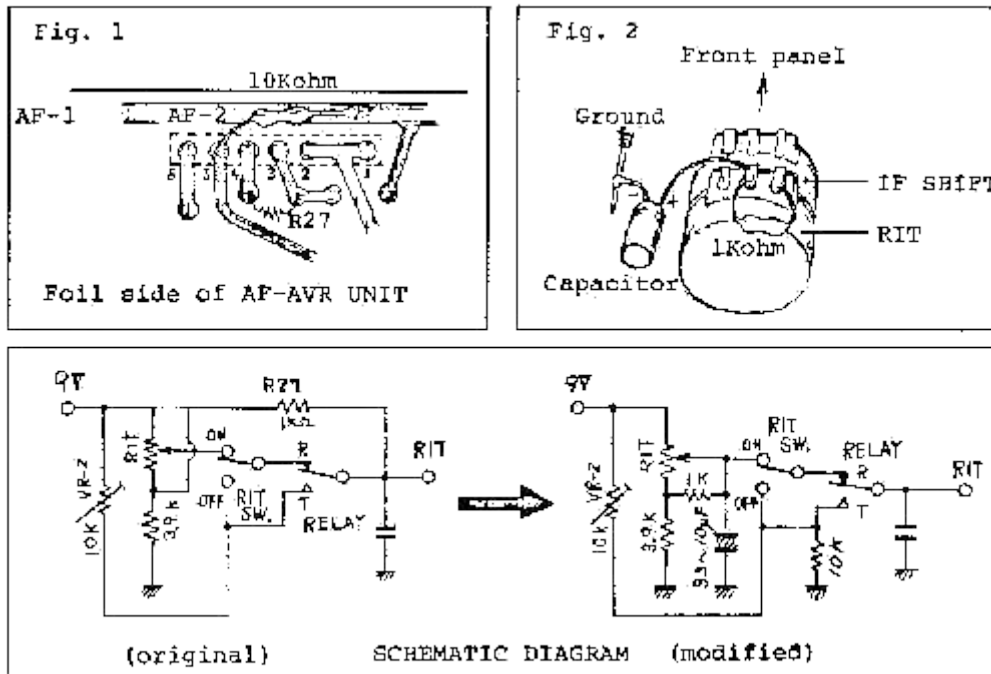
TS-820 RIT modification

We have had a few reports of the TS-820 RIT tuning being "rubbery". The following information will solve this.

1. Remove resistor R27 (1Kohm) on AF-AVR unit (X49-1080-00).
2. Install a 10Kohm resistor on foil side of AF-AVR unit. See figure 1.
3. Install a 1 Kohm resistor on RIT control. See figure 2.
4. Install a capacitor (3.3uF - 10uF) between RIT control and ground. See figure 2.
5. Adjust VR-2 on AF-AVR unit (X49-1080-00) for the same frequency as the center position of the RIT control.

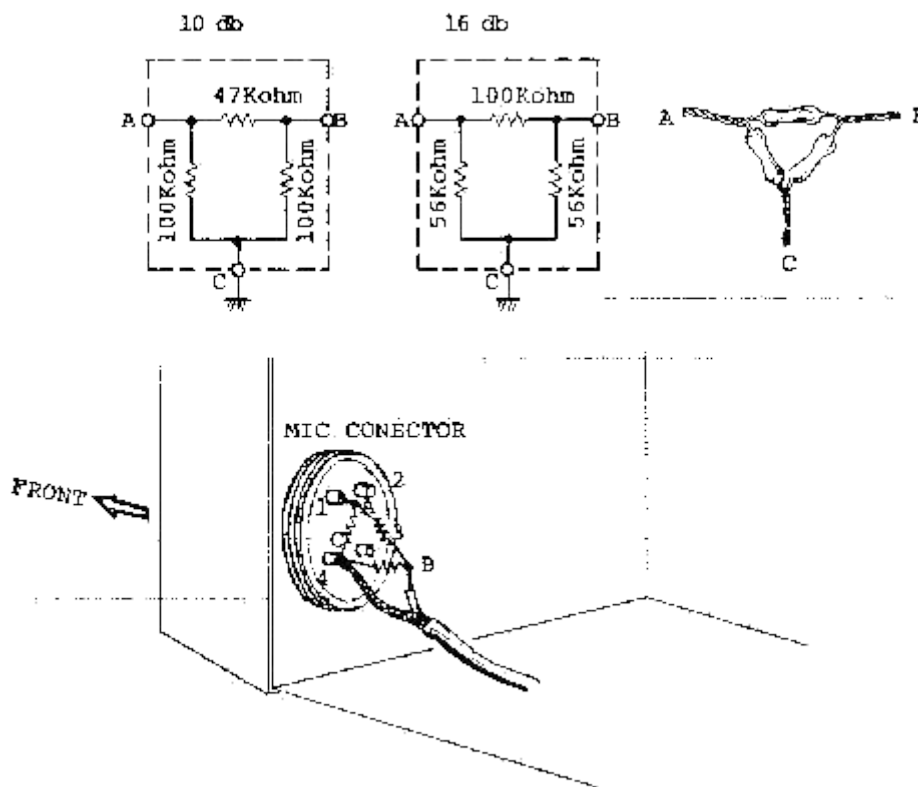
Microphone input attenuator for TS-820

When using a high output microphone (i.e. Shure 444), it is very likely that there will be distortion of the transmitted audio if the processor is used. The reason the distortion occurs is because the processor is between the first microphone amplifier and the microphone gain control. The installation of one of the attenuators shown below will reduce the microphone input to a level that will not cause RF speech processor distortion. The attenuator figures are approximate.
