SERVICE BULLETIN

COLLINS RADIO COMPANY

30S-1 RF LINEAR AMPLIFIER

PREVENT INTERMITTENT DROPOUT OF PLATE OVERLOAD RELAY

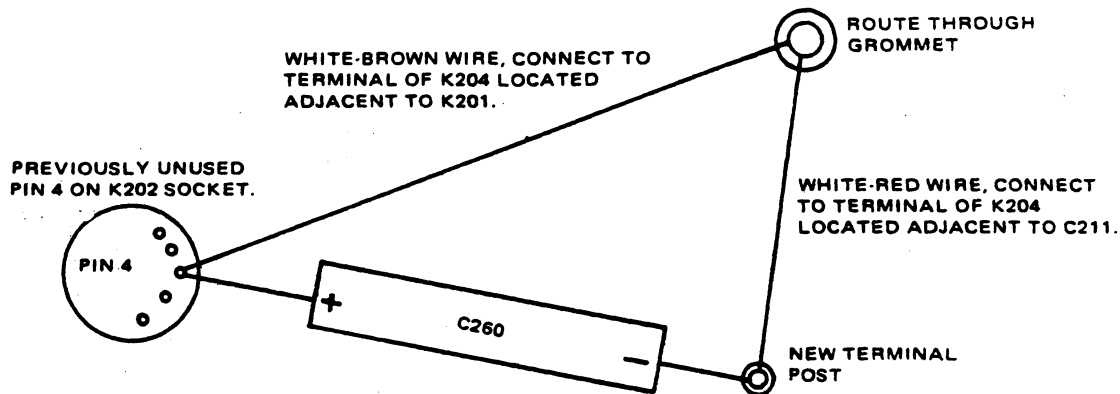
30S-1 Relay Shelf, Underside, Modification Instructions

Some 30S-1 operators experience occasional dropout of plate overload relay K204, caused by short duration high plate currents. These currents sometimes occur after application of signal but before the exciter output is reduced by the alc circuits. A 2000- μ F, 6-volt dc capacitor installed across the energizing coil of the relay presents a low-impedance path to the audio envelope currents, but continues to provide dc overload protection. The instantaneous currents are not harmful to the 4CX1000A tube because of conservative tube operation.

3. Install 2000- μ F capacitor C260 (183-1311-000) and approximate 10-inch lengths of white-brown (439-7302-000) and white-red (439-7303-000) wires as shown in the illustration.
