Ten Tec Titan 425 Amplifier with Ameritron AL800H P. S. Transformer

John, W1AN 8/7/2014

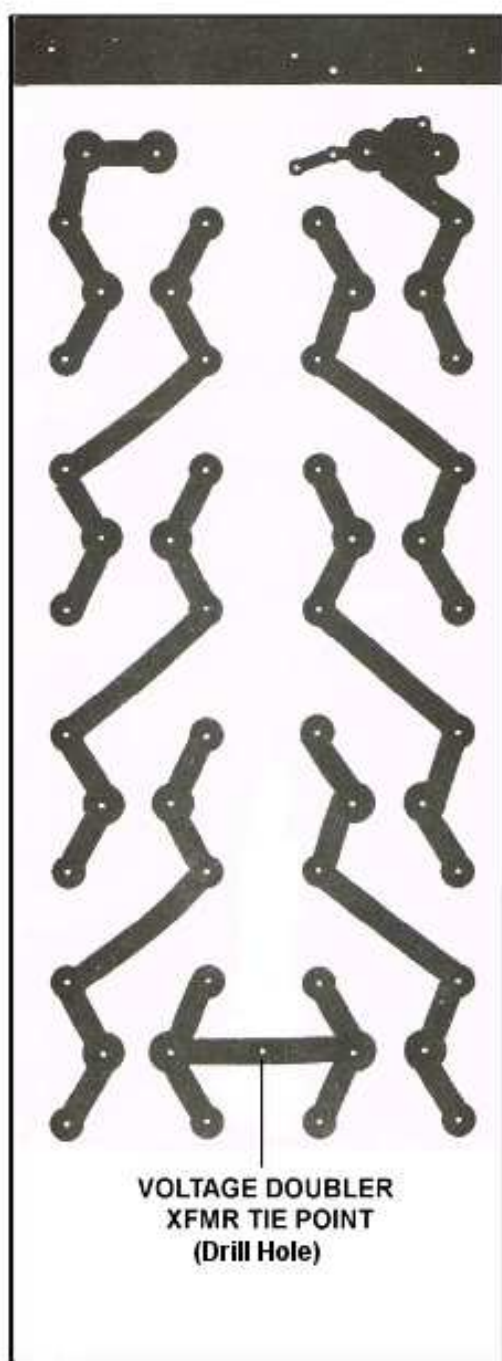
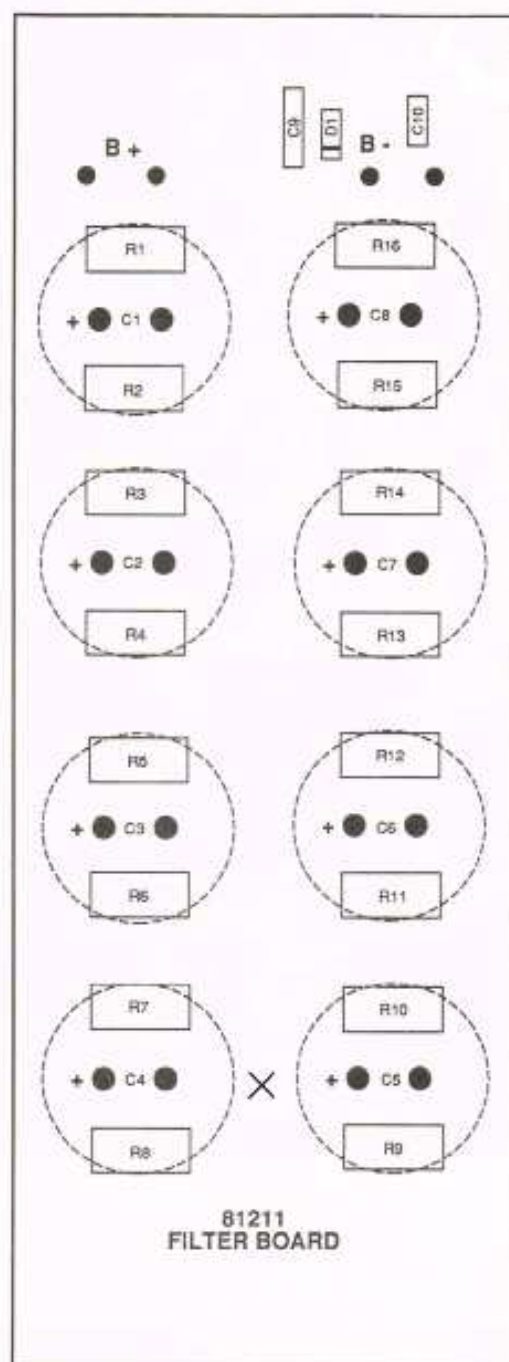
VOLTAGE DOUBLER MODIFICATIONS

On the Rectifier board Relay K2, D5 and resistor R8 were removed. They were no longer needed. Removing D5 added clearance to the ground trace for B+ level voltages.

On the Rectifier board D6-D12 diodes were removed, reversed and replaced. (Seven diodes) Several of the original diodes were bad so it was easy just to reverse several with the new ones. (Suggest 1N5408).

The Rectifier and Filter boards show the connection point and diode changes required to change from a full wave bridge to a voltage doubler. The schematic shows the wiring, and other interconnections within the power supply.

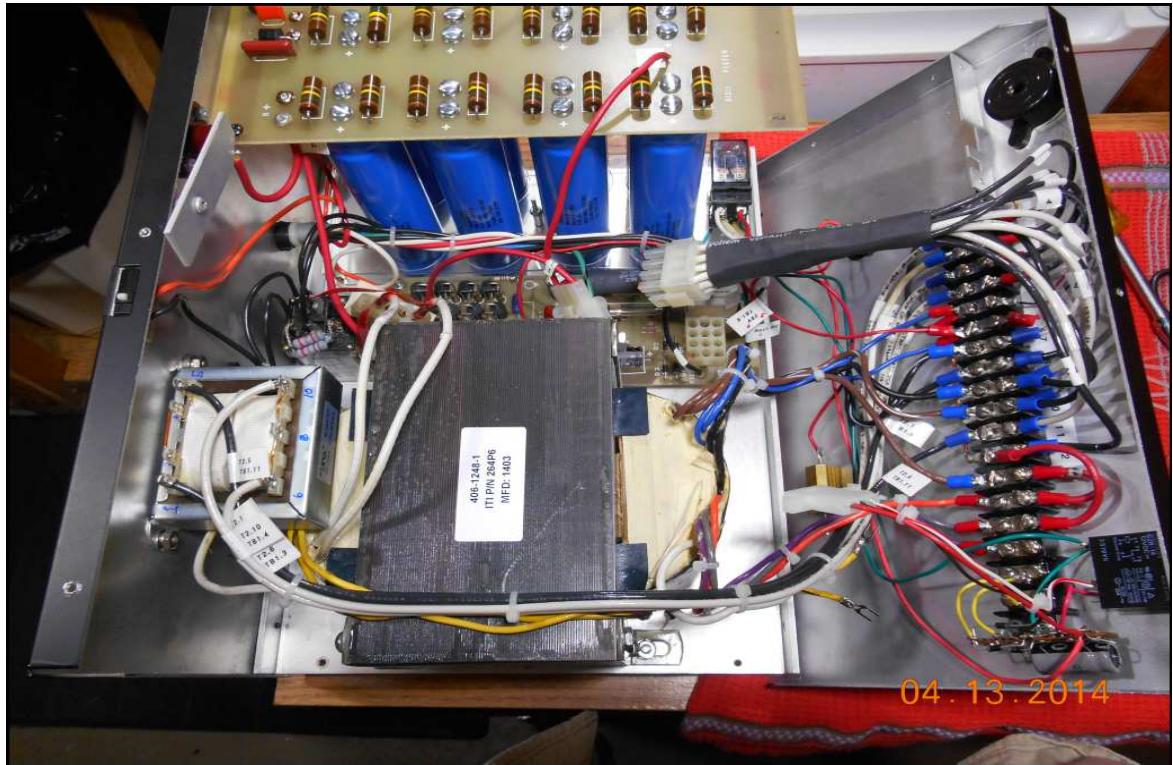
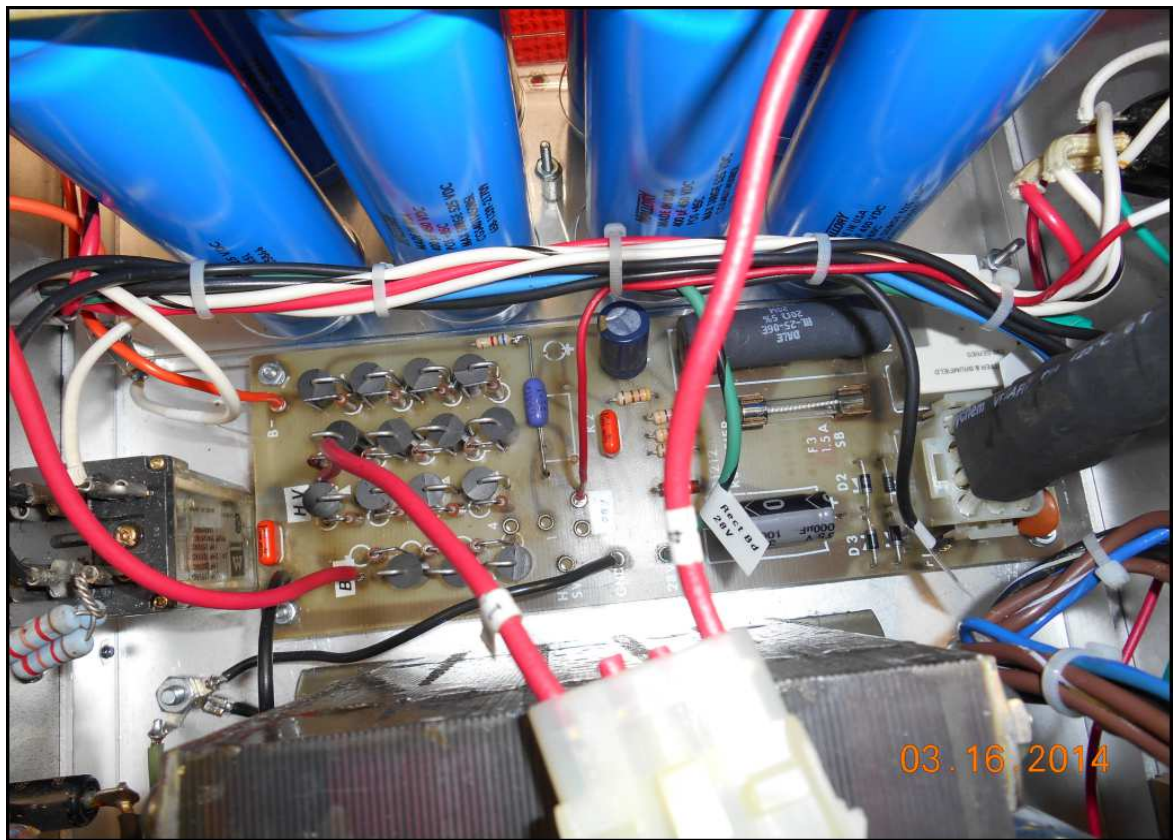
VOLTAGE DOUBLER CHANGES

Red HV leads from the transformer connector were relocated. One was to the rectifier board. One small hole was drilled on the Filter board as a tie point for the other. Two red wires were cut off from the connector.
