# TECHNICAL INFORMATION

No: 76/04/04/NAS  
Ref:  
Issue: 1  
Date: 30 April 2004

## Water Ingress to Headliner

Discovery Series II (TL)

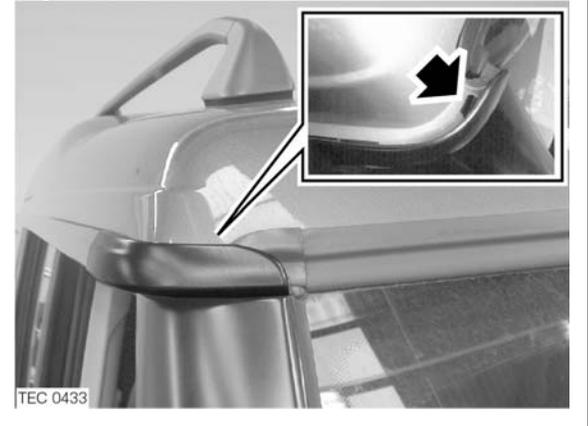
Figure 1

1. Carefully lift the clip securing the drip rail corner trim to the drip rail. (Arrowed in Figure 1)
2. Inspect the drip rail seam joint for a gap or void.

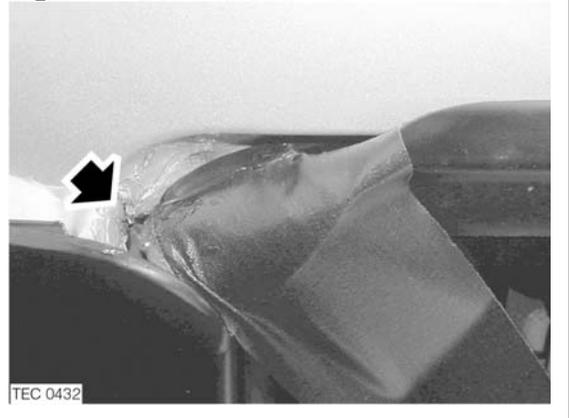
Figure 4

1. Carefully pull back the corner of the windscreen upper seal and use tape to secure the trim moulding to the windshield glass. (Figure 3).
2. Inspect for pin-holes or cracks around the 'A' post-to-roof joint, and the drip rail sealed joints (Arrowed in Figure 4).
3. Refer to RAVE/GTR section 76.64.15.21 and carefully remove interior A-post trim and sun visor assembly.
4. Spray soap water into the affected area outside and test the corner of the windscreen upper seal with low-pressure air nozzle directing the air stream through the sun visor and/or the A-post mounting hole.
5. If no pin-holes, cracks, or air bubbles are found, remove tape securing the windshield upper moulding to the windshield and push the trim moulding back into position.
