# TECHNICAL INFORMATION

No: 76/10/99/NAS  
Ref:  
Issue: 2  
Date: 05/19/99

## Rattle in Right A-pillar

**DISCOVERY Series II (LT) Up to XA224285**

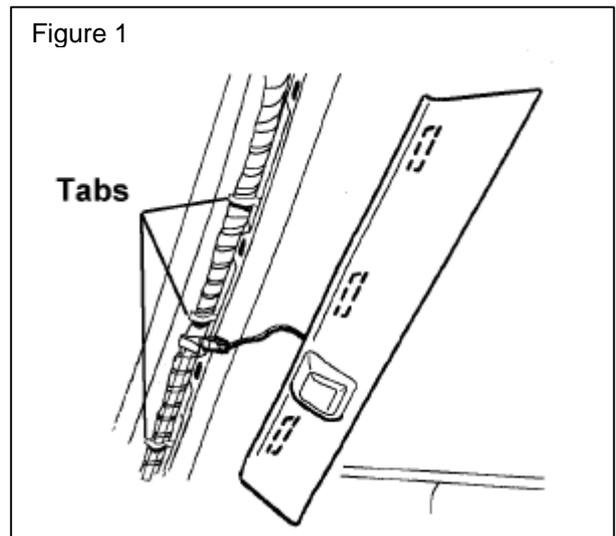
Figure 1

Customers may complain of a tapping or rattle in the right "A-post" area. The rattle may be the result of wiring harness contact with the pillar trim.

1. Carefully release the clips securing the right hand "A-post" trim. (Figure 1)
2. Disconnect the multi-plug from the speaker.
3. Remove right hand "A-post" trim.
4. Release the body tags securing the coaxial cable.

1. Twist foam tape around the cable from top to bottom.
2. Reposition cable and secure with body locating tabs.
3. Connect the multi-plug to the speaker.
4. Locate "A-post" trim and snap into position.
