Rear Wiper Arm Breaking at Arm Pivot Pin

No: 84/02/04/NAS
Ref:
Issue: 1
Date: 17 September 2004

Discovery Series II (LT)

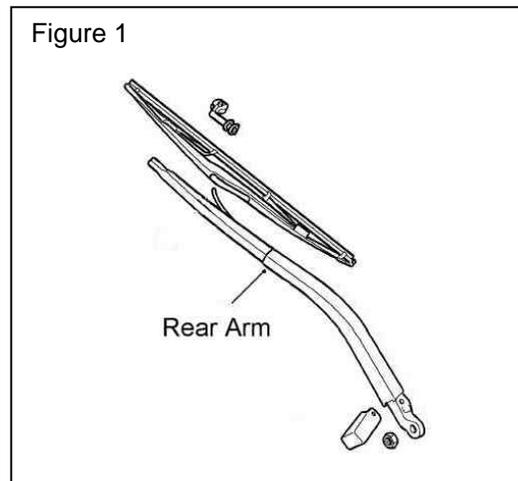
A tolerance inconsistency exists between the arm pivot pin and the wiper arm head. This results in a weak point at the pivot pin which can result in a crack in the arm under heavy loads – such as snow.

1. Remove the spare wheel from the tail door.
2. Release the grommet from the tail door, withdraw and disconnect the washer tube.
3. Raise the nut cover on the wiper arm and remove nut.
4. Remove wiper arm from spindle.
5. Remove the wiper blade from the old arm.
6. Install blade on the new wiper arm.
7. Position the arm assembly on the spindle.
8. Start threads and finger-tighten nut.
9. Tighten the wiper arm nut to **13 Nm (10 lbf.ft)** and install the nut cover.
10. Connect the washer tube.
11. Pass the washer tube through door and secure grommet.
12. Mount the spare wheel to the tail door.
