## Errata Sheet of Rev. B PIC16C62 Silicon

The PIC16C62 (Rev. B) parts you have received conform functionally to the upcoming PIC16C6X preliminary data sheet (DS30234B), except for the anomalies described below.

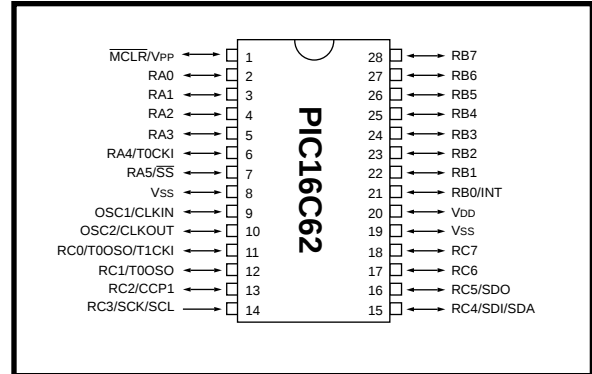
**FIGURE 0-1: NEW SSOP PIN-OUT**

3. In the PIC16C62 Product Brief (DS30414A), the pin-out of the SSOP package is wrong. The correct pin-out is shown in Figure 0-1.
