## PIC16C62A Rev. A Silicon Errata Sheet

The PIC16C62A (Rev. A) parts you have received conform functionally to the Device Data Sheet (DS30234D), except for the anomalies described below.

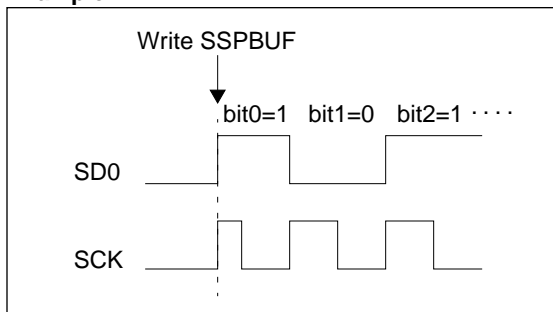
### Example:

## 4. Module: SSP (SPI Mode)

When the SPI is using Timer2/2 as the clock source, a shorter-than-expected SCK pulse may occur on the first bit of the transmitted/received data.

To avoid producing the short pulse, turn off Timer2 and clear the TMR2 register, load the SSPBUF with the data to transmit, and then turn Timer2 back on.

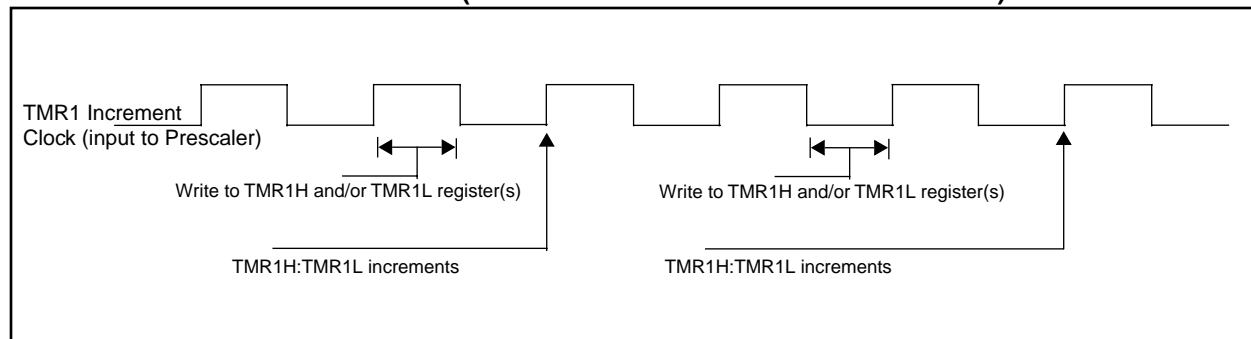
**FIGURE 1: WRITES TO TIMER1 (EXTERNAL CLOCK / OSCILLATOR MODE)**

When the TMR1H and/or TMR1L registers are written while this clock is high, TMR1 will increment on the next rising edge of this clock.

When the TMR1H and/or TMR1L registers are written while this clock is low, TMR1 will not increment on the next rising edge of this clock, but must first have a falling clock and the the rising clock for TMR1 to increment.

Figure 1 shows the two cases of writes to the TMR1H and/or TMR1L registers. Due to the  $V_{IH}$  and  $V_{IL}$  thresholds on the oscillator/clock pins, external Timer1 oscillator components, and external clock frequency, the Timer1 increment clock may not be of a 50% duty cycle.

The TMR1 increment clock is out of phase of the T1OSO/T1CKI pin by a small propagation delay.
