## The Chilean Earthquakes of May 1960

Studies of the disaster increase our understanding  
of earth shocks and of ways to withstand them.

C. Martin Duke

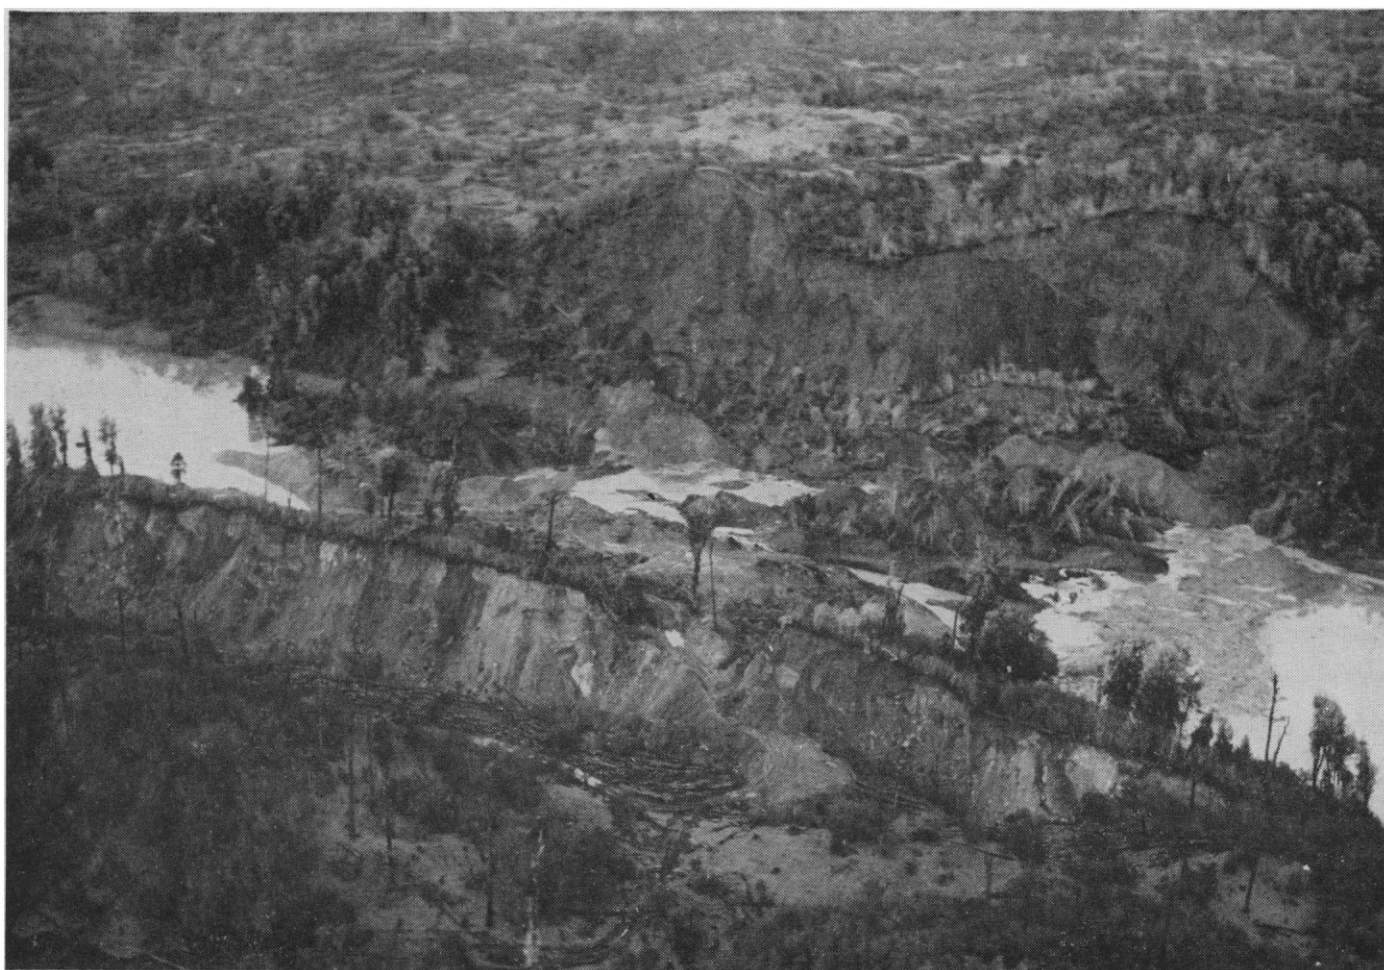
Deformation and failure of the soil in the Chilean earthquakes were dramatically manifested in many ways—in landslides, slumping and fissuring of soft ground, and failures of foundations and earth structures. The afflicted area is a glaciated region, and the soil types in the heavily damaged zones reflect this geologic history. Three examples follow. The landslides below Lake Ríñihue occurred in glaciofluvial deposits that were saturated because of the heavy autumn rains of that region. The soil, of predominantly fine sand, apparently flowed as a liquid under the influence of the vibration. These slides, of which the largest covered

about 1 mile along the San Pedro River, raised the level of Lake Ríñihue by 15 meters, submerging the town of Ríñihue and threatening Valdivia, 50 kilometers downstream, with floods. As a result of earth-moving operations reminiscent of those on the Madison River in Montana after the 1959 earthquake, the danger of sudden erosion of the slides appears at this writing to have been alleviated. Figure 4 shows one of the smaller of the slides. This same situation occurred previously at Ríñihue in an earthquake in the year 1575.

Fig. 4. One of the smaller landslides on the San Pedro River below Lake Ríñihue.

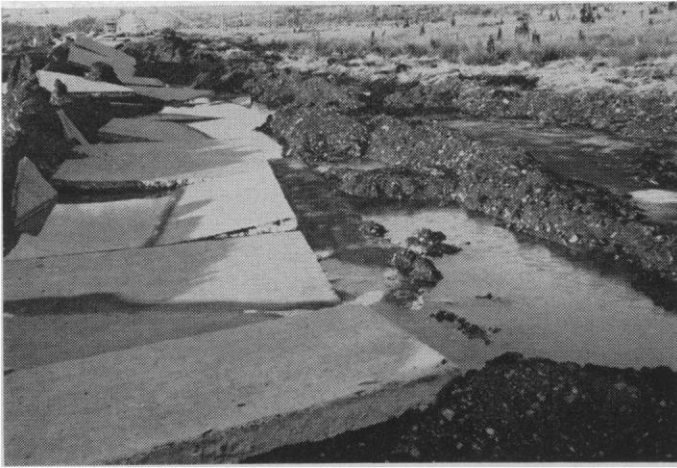
Liquefaction of loose, fine, sandy soil seemed again to be the failure mechanism in the cases of the new highway (Fig. 5) between Puerto Varas and Puerto Montt and of the quay wall (Fig. 6) at Puerto Montt harbor. The strength of sandy soil is derived principally from shear resistance due to internal friction, which is proportional to the compressive forces between adjacent soil particles. The compressive forces are due to the weight of the soil. Under intense vibration of a water-saturated loose sand, part of this compressive force is transferred to the water, which has essentially no shear strength, and this results in marked weakening of the soil. The complete

collapse of the highway fill appeared to be due to these characteristics in the fill itself, but the underlying swampy ground doubtless contributed to the difficulty. The catastrophe at the harbor, of which Fig. 6 is merely illustrative, is hard to explain except in terms of this mechanism. Differential settlements and horizontal foundation movements of the order of feet, occurring along the downtown water front of Puerto Montt and at the nearby naval base (Figs. 7 and 8), are associated with the same kind of soil.

Fig. 5 (left). Failed highway fill between Puerto Varas and Puerto Montt. Fig. 6 (right). Failed gravity quay wall at Puerto Montt harbor.

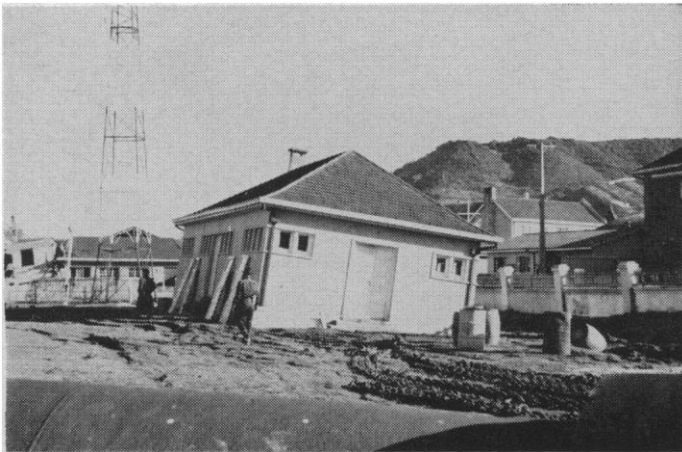
Fig. 7 (left). Settlement at the naval base, Puerto Montt. Fig. 8 (right). Relative horizontal movement of two parts of a building near the naval base, Puerto Montt.

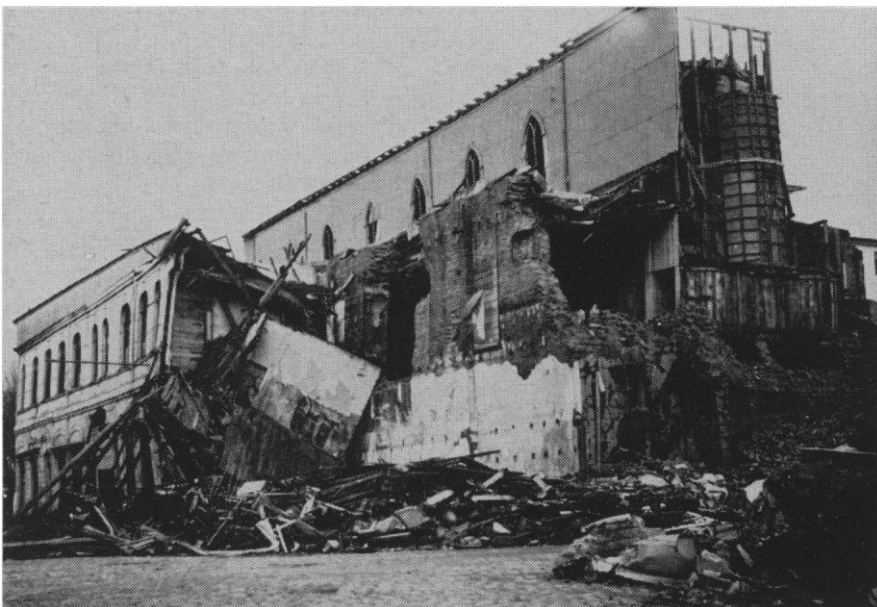
Houses in the northern part of the damage area were predominantly of crude masonry and adobe. The disintegration so familiar to students of earthquakes was the usual failure mechanism. To the south, most houses were built of wood, and the failure of the walls to resist the lateral forces resulted in many collapses and in many instances where the walls tipped from 5 to 20 degrees, leaving floor and roof relatively horizontal. Very common in the case of the frame houses was the tipping over of the foundation walls or piers or the horizontal sliding of the house off its foundation. Fortunately, very few fires broke out in connection with the earthquakes, and those few were confined to single buildings. Figure 9 shows the collapse of a composite

Fig. 9 (left). Collapse of a composite wood-frame and adobe building in Valdivia. Fig. 10 (right). Failure of the supporting members of an elevated water tank in Rio Negro.

adobe and wood-frame building in Valdivia.

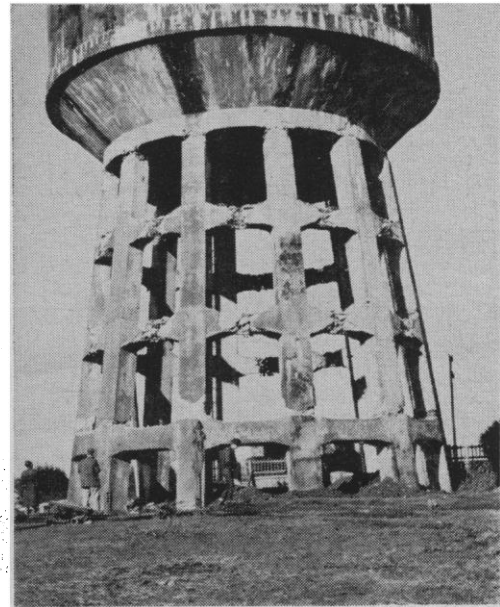
A large number of reinforced-concrete elevated water tanks were damaged. Figure 10, a tank in Rio Negro, shows the characteristic pattern of shear failure of horizontal members and bending failure of columns. These tanks were constructed after a design, originating in Germany, which apparently did not provide for the transmission by the supporting members of the horizontal seismic forces between the heavy tank and the ground.
