## San Fernando Earthquake of 9 February 1971: Pattern of Faulting

**Abstract.** Mapping of the surface breaks that resulted from the San Fernando earthquake of 9 February 1971 reveals that the pattern of faulting was highly complex; it consisted of a number of segments that produced ground displacements and acceleration throughout the entire northern end of the San Fernando Valley. Instead of occurring on the frontal fault zone, as might have been expected, the faulting occurred on the valley side of the frontal fault system, which separates the crystalline rocks of the San Gabriel Mountains from the Tertiary sediments of the San Fernando Valley. However, the new fault system does, in many cases, follow breaks in slope and subtle escarpments that suggest faulting along these zones in the recent geologic past.

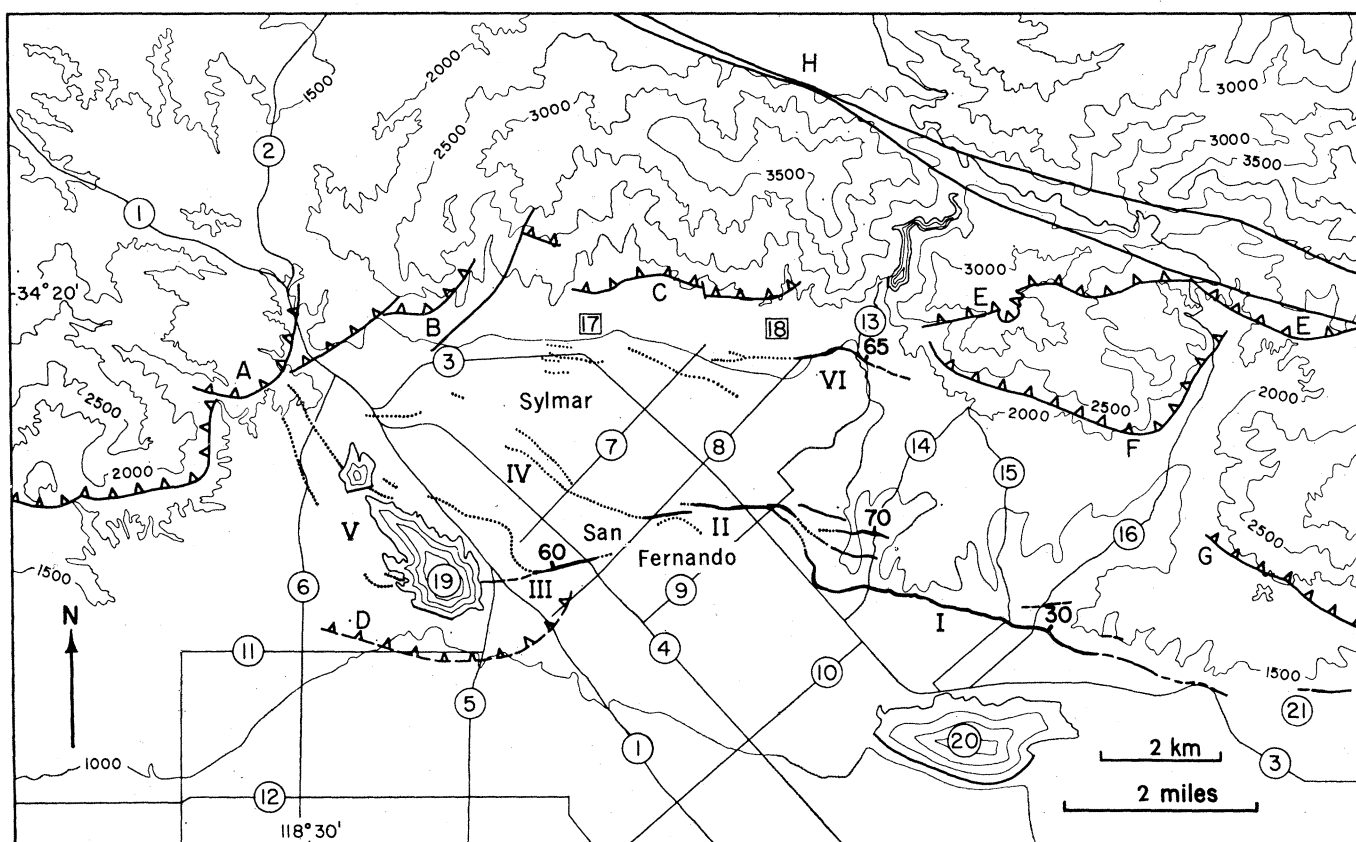
The eastern extent of the San Fernando fault system (segment I, Fig. 2) is first observed in and along the northern bank of Big Tujunga Wash. The maximum displacement in Big Tujunga Wash is about 60 cm on a scarp dipping about 75° to the north. To the west, the main scarp follows the break in slope between the Tertiary sediments on the north and the alluvium on the south. In addition, a series of apparently discontinuous breaks occurs to the north of the frontal scarp. These scarps may be more continuous than shown; they are most clearly seen in canyon bottoms but are difficult to trace over the ridges. At Little Tujunga Canyon the frontal scarp has 50 cm of uplift and 1.5 m of overthrusting, with a small component of left-lateral offset. A second scarp 400 m to the north has about 25 cm of uplift with about the same amount of apparent right-lateral offset, the only right-lateral offset observed along the entire fault. West of Kagel Canyon, the main scarp occurs as three discrete breaks over a zone that is 10 to 50 m wide. At Lopez Canyon, the zone becomes more com-

plex; a series of breaks trend roughly east-west, up to 1 km north of the main break and then converge near Maclay Avenue and Foothill Boulevard. A north-south profile through the mouth of Lopez Canyon shows vertical displacements of about 50, 15, and 75 cm, respectively, for the three breaks crossed. Total left-lateral motion is of the order of 1 m. These displacements were the maximum observed in the field, but they may be en echelon and would therefore not represent the total displacement field at this point. A second major break occurs about 3 km to the north near the mouth of Pacoima Canyon (segment VI, Fig. 2). The maximum displacement on this fault is 20 cm of dip-slip motion immediately to the west of the mouth of Pacoima Canyon, with apparent displacements decreasing westward and eastward from this point. Left-lateral displacement is negligible along this fault.

At Maclay Avenue north of Foothill Boulevard, the faults of Lopez Canyon converge into a single zone (segment II, Fig. 2). Here the ground breakage crosses the Pacoima wash and follows an abrupt change in slope through a residential district. The fault zone then crosses Foothill Boulevard northwest of Maclay Avenue and continues west through residential San Fernando. Discontinuous scarps along this zone exhibit 30 to 50 cm of uplift and up to 50 cm of horizontal compression or overthrusting. Much of the fault zone

Segment II splits into two branches, segments III and IV, one striking S75°W toward Van Norman Reservoir, and the other striking N70°W toward Sylmar. Segment IV is a narrow zone of compression with some overthrusting, which trends northwest toward the intersection of Foothill Boulevard and the Golden State Freeway. Segment III shows a well-developed scarp with the maximum displacement occurring about ½ km west of San Fernando Road. Here uplift was 30 cm, accompanied by 20 cm of overthrusting and an equivalent amount of left-lateral offset. To the west, this segment splits into two branches, one bifurcate trending westward toward the lower Van Norman Reservoir, and the other trending northwest and forming a line of discontinuous compression across the Golden State Freeway toward the upper Van Norman Dam and Balboa Boulevard (segment V). Displacements on this segment west of the Golden State Freeway are difficult to estimate but do not normally exceed 10 cm and appear to decrease to zero toward the northwest. Segment VI, northwest of Hubbard Street, is characterized only by compressional features, with total displacements probably not exceeding 10 cm.
