### RECALL **SLABS ECU Replacement**

No: D263 Ref: Issue: 6 Date: 10/11/02

**Discovery Series II (LT)**

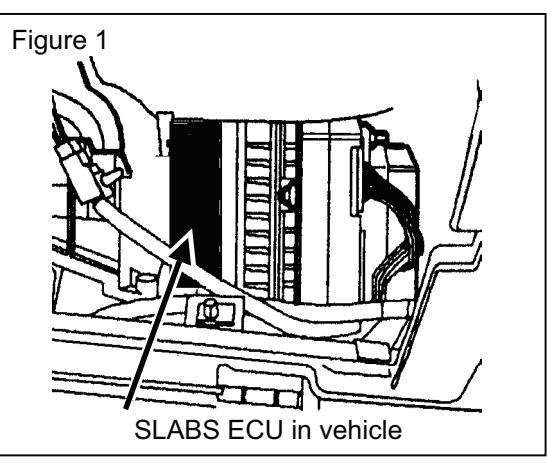
## ✓ NOTE: TestBook/T4 will read the data from the current ECU and prompt for a new ECU to be fitted.

6. Replace the SLABS ECU, following procedure 70.65.01 in the RAVE Discovery Series II Workshop Manual.
