Tektronix 485 repair

Fig. 1 Tektronix 485. 2 channel, 350MHz oscilloscope.

17[™] JUNE

2010

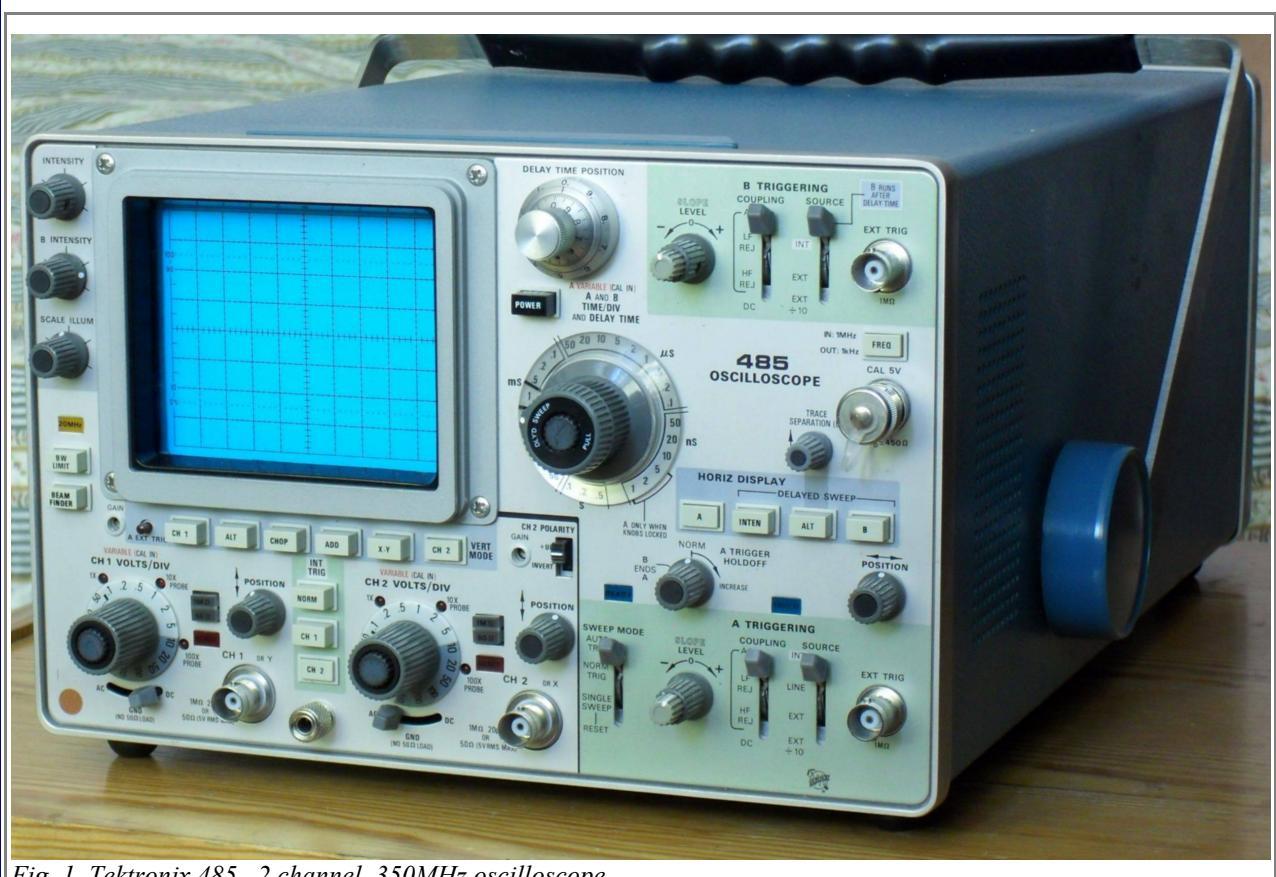
Bright, blue mains fuse explosion after pressing the POWER button.

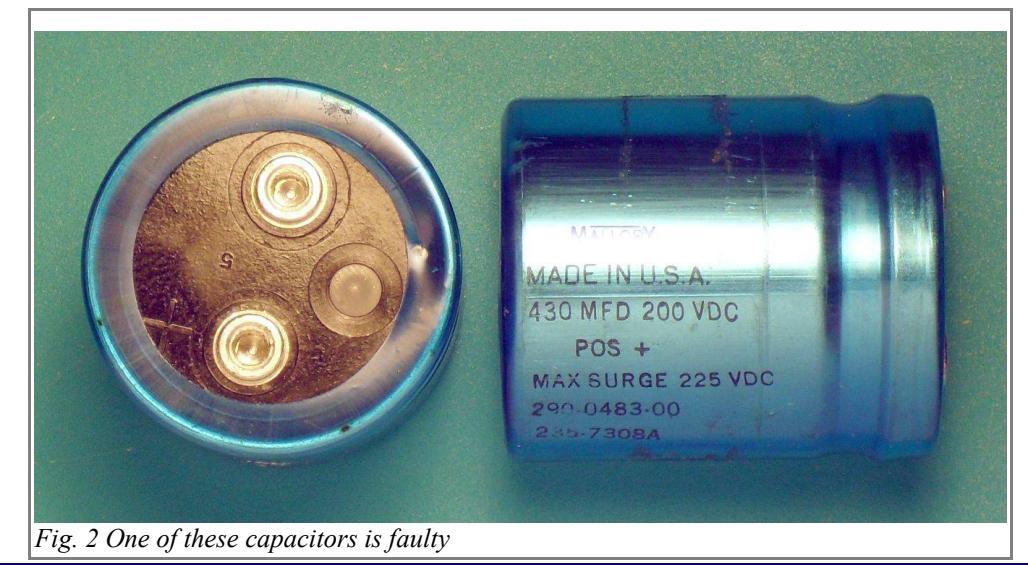
The fuse has been blown off that time also. Then I removed the RT1821 and RT1822 thermistors to determine if the failure was in the mains-bridge part or in the filter part. When I powered up the instrument, nothing bad happened, so I started tracking the filter part. I found that the electrolytic capacitor C1823 had no internal short indeed but it started conducting the current when more than 40V had been applied to it's terminals. I replaced both C1822 and C1823 capacitors with new 470uF/250V snap-in capacitors.

I started with removing the L1825 choke to isolate the inverter circuit and avoid further damages while checking (Fig.3).

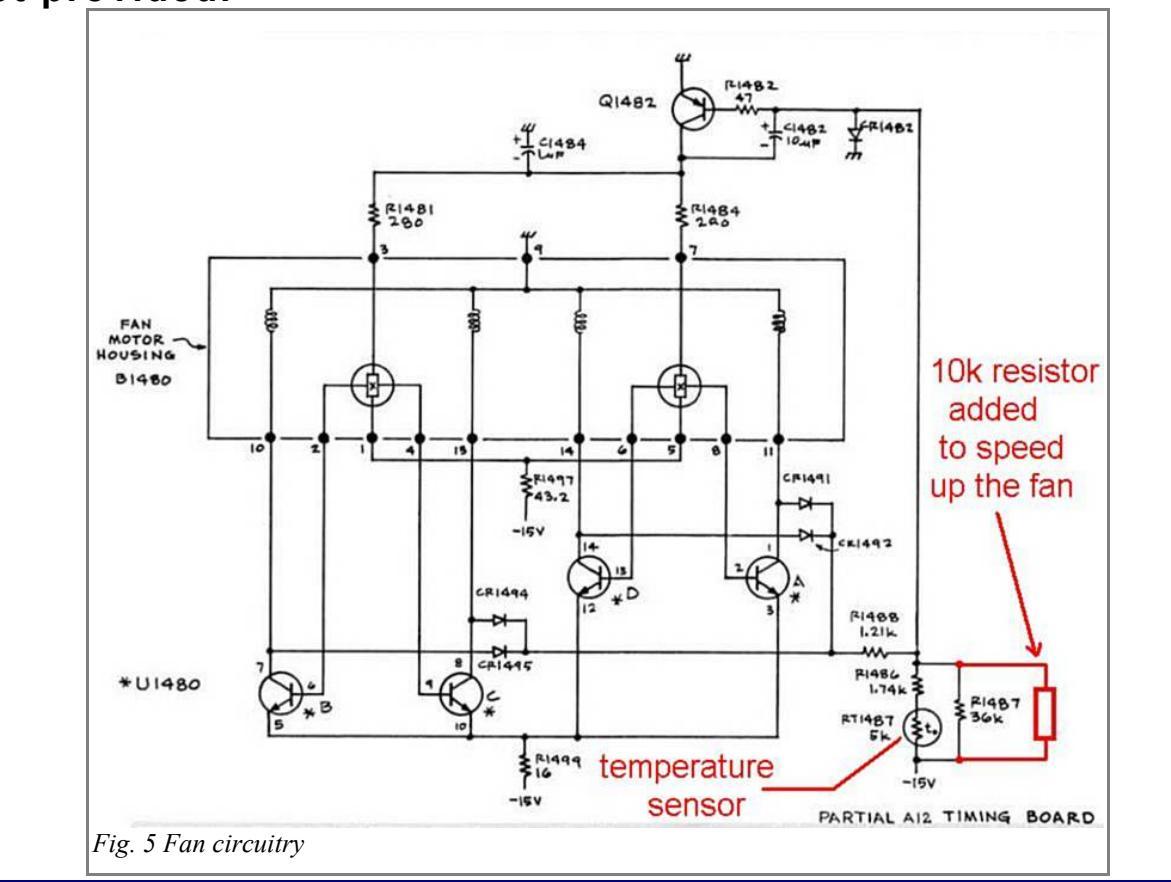
The brushless motor fan placed on the scope's back had not started after powering on.

After some investigation it became obvious that the friction on the bearings have increased after 35 years of intensive usage. An important note should be placed here: the TEK 485, TEK 465, TEK 475 and similar, compact oscilloscopes need the cooling fan very much. It's reported that vertical stage output IC's can suffer overheat damage when the airflow is not provided.

Unfortunately, the SIEMENS- manufactured brushless fan is located in a VERY difficult to reach place. Tektronix engineers used a thermistor to increase the fan efficiency when there is hot inside (Fig.5). I thought it would be good idea to fool the circuit to see the increased temperature. I used an external potentiometer to find the optimal resistor value (R=10k Ω). Now the fan is working in a very reliable way.

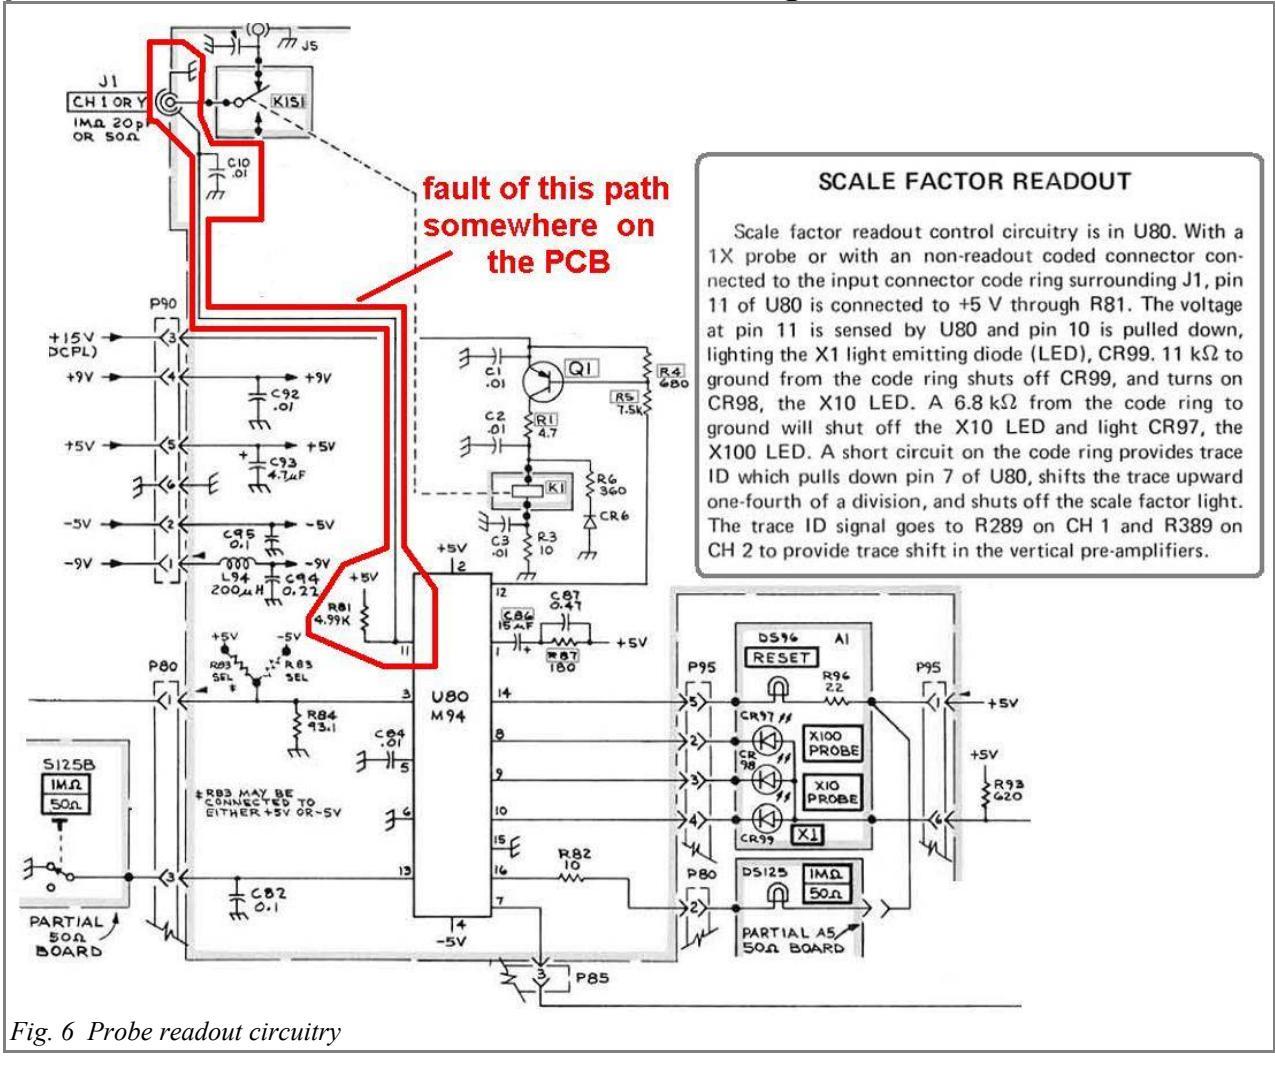
One more repair had to be made. The three lamps ('x1', 'x10', 'x100') showing actual V/div position were blanked. Let's look at Fig.6.

10:1 and 100:1 probes are connecting the ring to the GND through specified value resistor Rp built into the connector. The voltage on the sensing ring is equal to:

The U80 custom IC is a threshold discriminator. The displayed V/div LED mark depends of the voltage on the BNC connector's sensing ring. I checked the voltage on the sensing ring and it was about 180mV. My first thought was that U80 is faulty, so I put the IC from the socket. I measured the ring's potential once again and obtained 180mV. I removed C10 from PCB, unsoldered connections to the BNC socket sensing ring. I measured the R81 value, the result was : $4,99k\Omega$. I checked everything I could and concluded, that there must be some leakage somewhere on the PCB.

I must admit that I had no idea what to do. I decided to use the 'brutal force' technique. Without the U80 in the socket I applied +4V from the bench power supply to the sensing ring. To my surprise the probe readout function started to work properly!

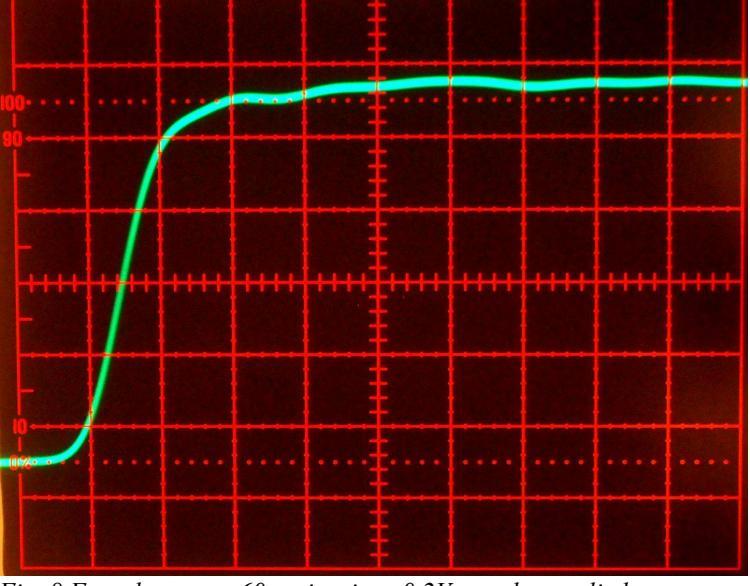
Last step was to check the pulse response of the vertical deflection system. I used the TEK 284 pulse generator having about 60ps of slope rise time and 200mV of pulse amplitude.

Fig. 8 Fast slope test: 60ps rise time, 0,2Vpp pulse applied ; TEK485: vertical: <0,2V/div , horizontal:1ns/div

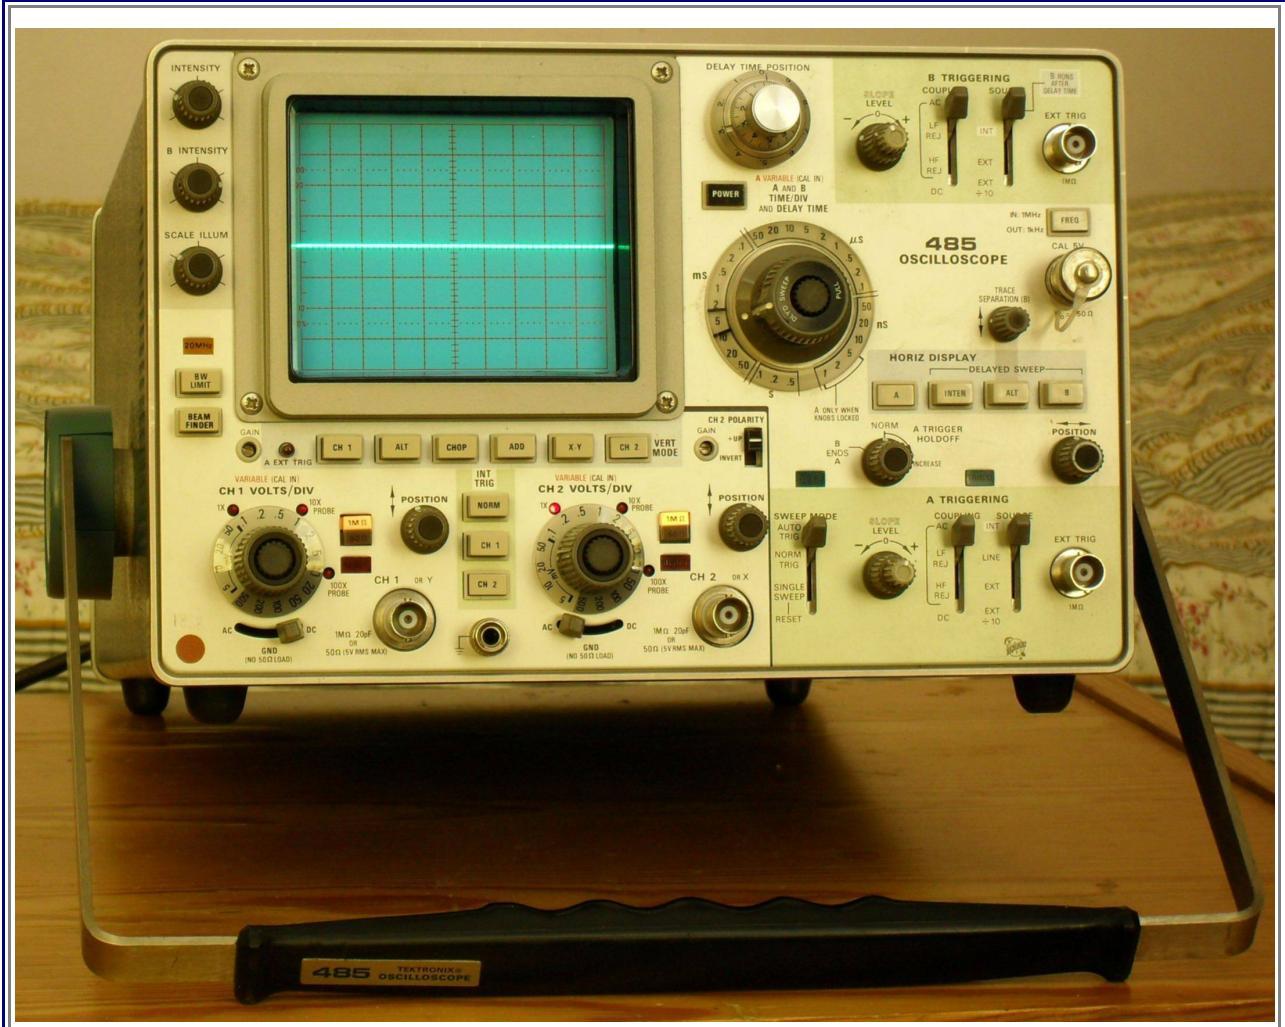
Fig. 9 Tektronix 485 working
