PRODUCT REFERENCE BOOK

for the Tektronix Type

422 PRB

400-SERIES CRT's - PREMATURE FAILURES

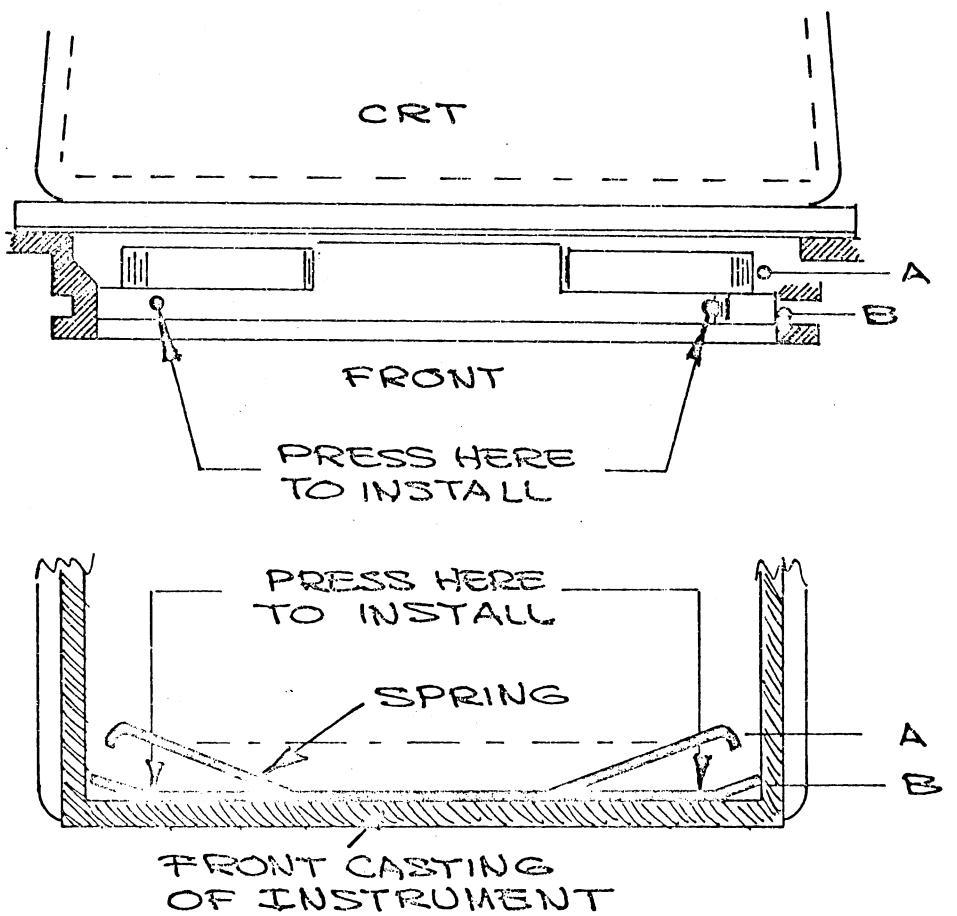
<u>CRT FILTER</u> FOAM SUPPORT PADS REPLACED WITH A SPRING FOR ADEQUATE MESH FILTER SUPPORT	See SQB	M9643
Effective Prod s/n 2070	Usable in field instrun	nents s/n 100–2069
FRONT PANEL SYMPTOM: None.		
PROBLEM: The neoprene foam tape	pads do not provide adequate suppo	rt for the mesh filter.
PRODUCTION CHANGE: The neop	prene foam pads have been replaced	with a filter spring.
Parts Removed:		
Tape, neoprene, 1/2in.	(2)	253-0069-00
Parts Added:		
Spring, filter		214-0654-00
INSTALLATION INSTRUCTIONS:	(See below or MI - 9643)

Replace the 1/2 in. lengths of neoprene foam tape with a filter spring located in the bottom of the CRT front cast opening.

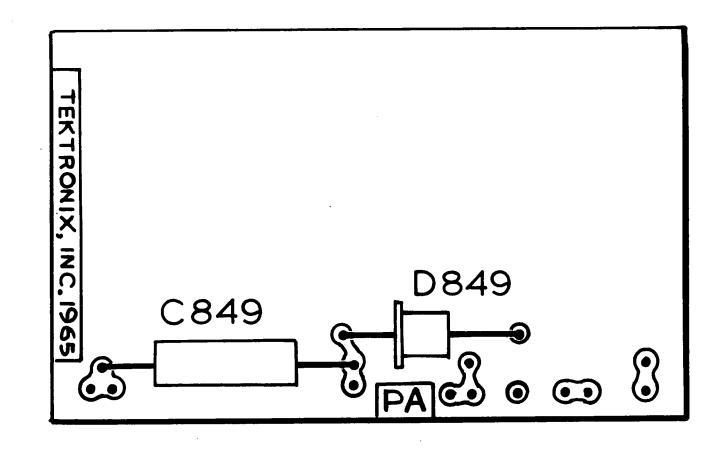
<u>CRT</u> FILAMENT VOLTAGE INCREASED BY CHANGING HV TRANSFORMER AND FILAMENT RECTIFIER -CAPACITOR

- 1) Replace T801 with a 120-0378-01 transformer.
- 2) Replace C849 on the High Voltage Regulator board with a 290–0248–01 capacitor, carefully noting the proper polarity. See drawing for location.
- 3) Replace D849 on the High Voltage Regulator board with a 152–0179–00 diode, carefully noting the proper polarity. See drawing for location.

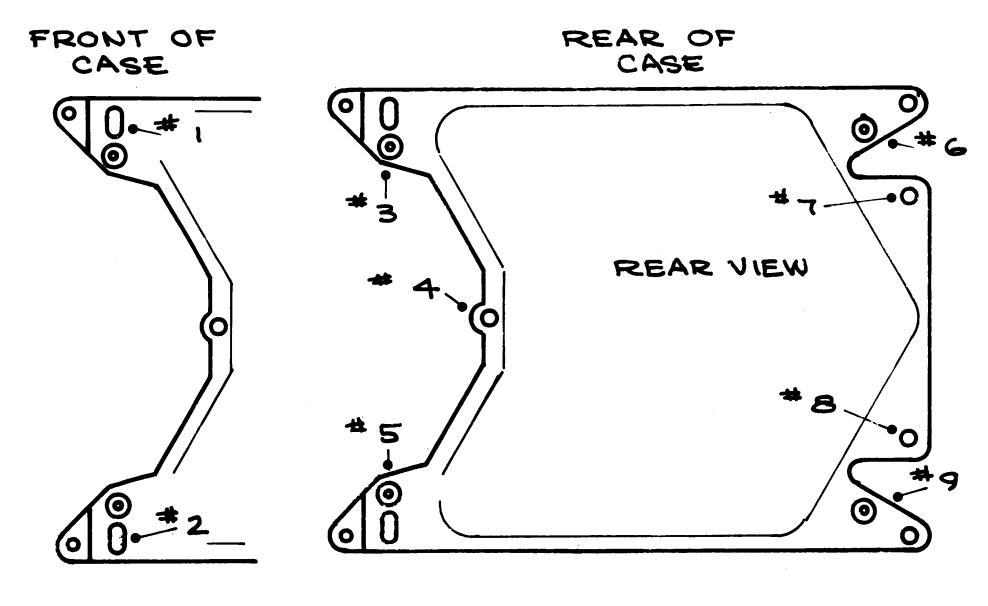
422 BATTERY CASE (NUT LOCATIONS)
and and a structure and a

<u>BATTERY PACK</u> RETAINING NUTS CHANGED TO STAINLESS STEEL TO FACILITATE BATTERY PACK INSTALLATION

Replace the nine $6-32 \times 1/4$ cad plated brass nuts, used for assembling the battery pack, with nine $6-32 \times 1/4$ stainless steel nuts.
