Loma Prieta: Saved by a Short, Sharp Shock

The initial strong tremors were over in less than 10 seconds; had they lasted longer, many more structures might have collapsed

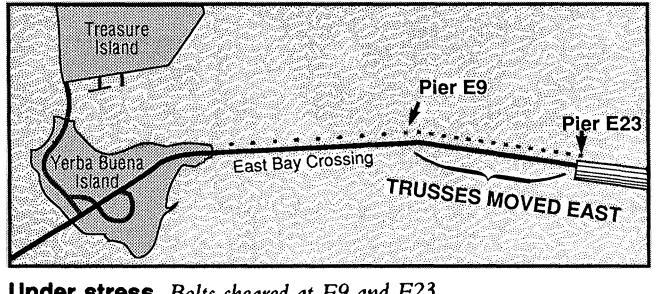
The roadway segments that fell were the upper and lower roadways at pier E9, mid-way across the eastern stretch of the bridge. Abolhassan Astaneh and his engineering research team at the University of California at Berkeley have found evidence that inertial forces within the bridge pulled the trusses and roadway east of E9 toward Oakland by about 7 inches relative to the rest of the bridge.

That movement tugged on the roadway segments over pier E9. Normally, each roadway is held fixed to the pier by 40 1-inch diameter bolts, but those bolts were sheared by the jolt, and the roadways were pulled off the 6-inch shelves that supported their westward ends. If the bolts had held, says Astaneh, the forces would have been transferred to pier E9 itself, possibly leading to an even greater tragedy. "Most likely you would have had collapse of that pier," Astaneh told Science. "The decks, the cars, at least some segments of the bridge would have gone down to the water."

With a bit more movement, the roadways over pier E23-the easternmost pier of the bridge-would have collapsed as well. The anchoring bolts failed there also, according to Astaneh. "Believe it or not, [the roadway] moved so much that it was sitting only 1 half-inch on the seat. So if you had a half-inch more movement, you would have had two parts of the bridge failing the way [E9] did."

Under stress. Bolts sheared at E9 and E23.

The bridge was reopened on 17 November, 1 month after the earthquake. The seats supporting the roadway have been extended 2 inches, to allow more safe slippage in a similar earthquake. The replacement bolts, although stronger than their predecessors, remain the weak link. But if they give way in the next big one, that may again be a blessing in disguise. **M.B.**
