Shuttle Inquiry Focuses on Weather, Rubber Seals, and Unheeded Advice

Thiokol engineers warned against launching because of doubts about the performance of seals between segments of the booster rocket at low temperatures

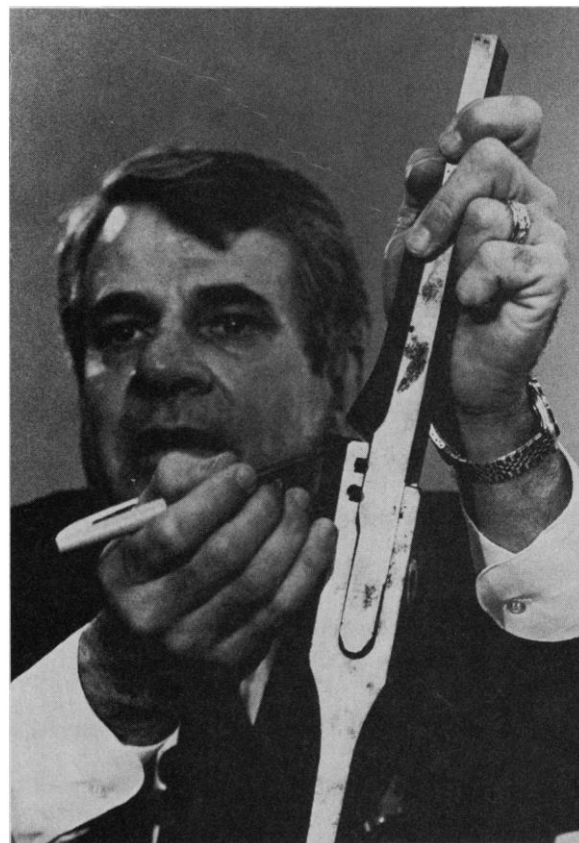
Focus of the investigation

Larry Mulloy, manager of booster programs at Marshall Space Flight Center holds part of joint showing two black rubber O-ring gaskets that form seal between interlocking segments of the rocket casing.

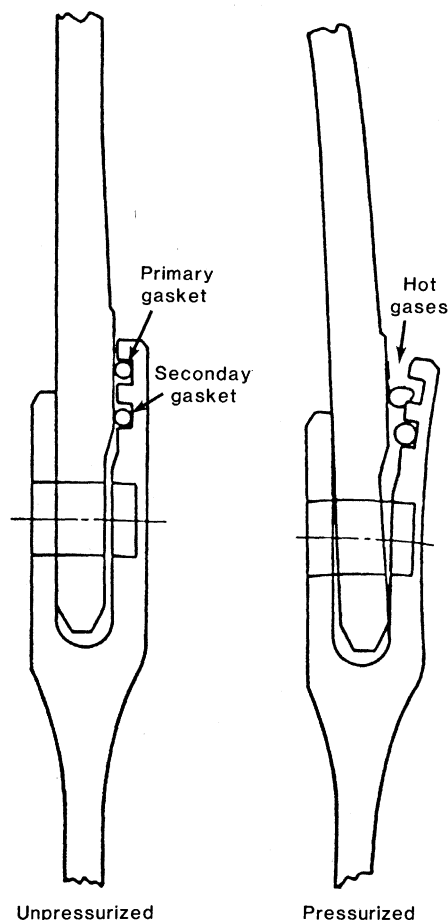
Leaky joints?

A series of shims, added to narrow the joints early in the shuttle program, proved to have little beneficial effect. By late 1982, the agency had learned that rapid pressurization of the booster segments widened the joints by 0.04 to 0.06 inch approximately 20 seconds after launch (see diagram). This was just enough to prevent the backup gasket from forming an effective seal, potentially eliminating any redundancy for this portion of the flight. Instead of repairing the defect, the agency formally waived the redundancy requirement in a memo dated March 1983 that explicitly listed the danger of "loss of mission, vehicle, and crew due to metal erosion, burnthrough, and probable case burst resulting in fire and deflagration" if just a single gasket failed. It did so because test results and previous flight experience appeared to indicate that such a failure was unlikely.

Where segments of the solid-fuel booster rockets fit together, a seal is provided by two "O" shaped rubber gaskets. Moments after ignition, pressure in the booster causes the joints to open up, as shown in exaggerated form in the diagram on the right. If the gaskets fail to seat properly in the gap, hot gases could escape through the joint.
