## AR7030 technical bulletin 004

## **Audio Output Instability**

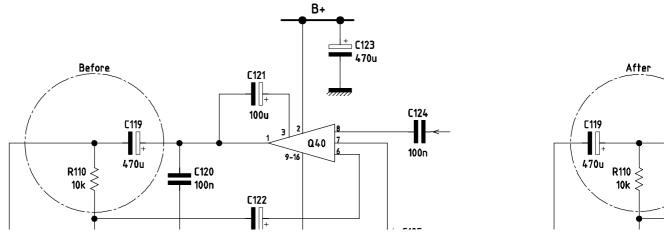
It has been found that when using certain high quality external "Hi Fi" speakers there is a possibility that the audio stage may become unstable and oscillate at a very low frequency, typically < 10Hz.

The modification involves the repositioning of C119 and R110 in the audio amplifier output feed as shown in the diagrams above.

In practice the modification is carried out simply by removing the SMD resistor R110 and repositioning it using a conventional component on the underside of the board. Connect the new resistor between the +ve leg of C119 and the -ve leg of

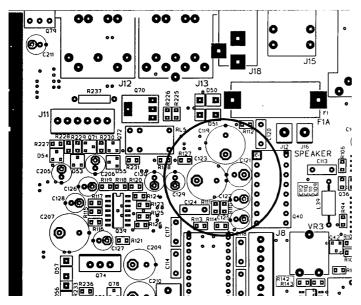
C122. The components are located near the fuse in the left hand corner of the set as shown in the PCB layout alongside.
