IC-7000 driver amplifier self-oscillation problem

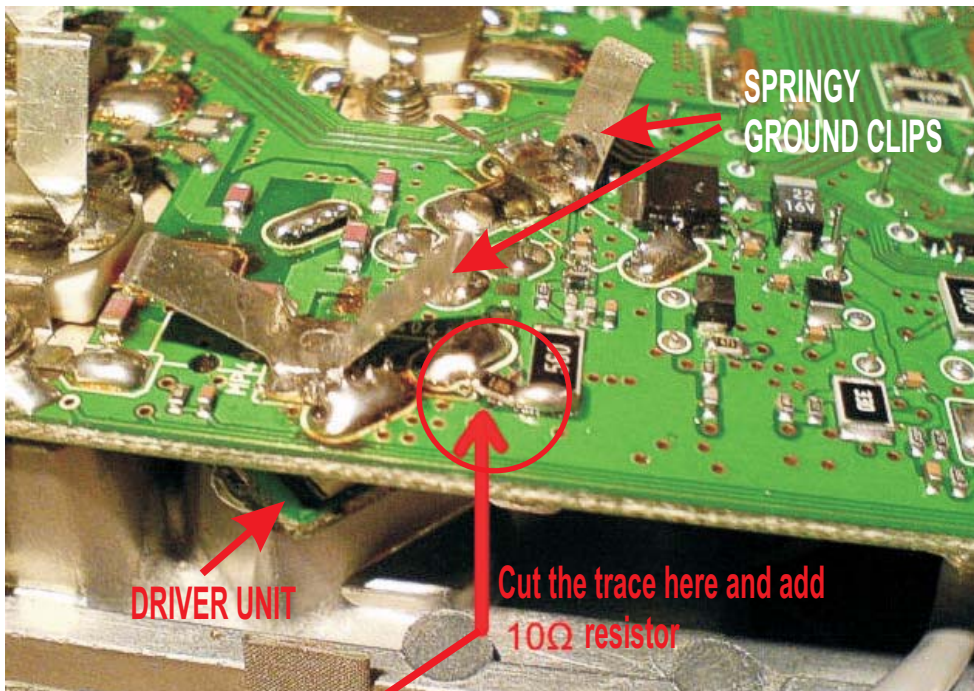
The problem probably lies with self-oscillation of the common driver stage of the TX amplifier chain. A series resistance of a few ohms is placed in series with the input (gate) of the FET amplifier, by cutting the appropriate PCB trace. The photos and schematic explain the modification. It is very simple to do, and can help prevent this "smoking" failure mode, without any side-effects and at negligible cost.

This mod lowers the Q of the copper trace circuits feeding the driver amplifier's input, therefore quenching any tendency of the stage to self-oscillate at some VHF frequency, with destructive results.

IMPLEMENTATION: After removing the covers, locate the driver unit's input trace (see photo), cut it carefully and scrape the solder resistant enamel to expose the copper surface. Then, solder an 10 Ohm (or so...) SMD resistor across the cut of the PCB. That's all!

IMPORTANT: After you have finished, carefully check and clean all of the springy ground clips on the PCB. Also, clean

carefully and apply a thin protective film of grease or vaseline to the points on the covers where the grounding clips of the PCB make contact. The deterioration of this grounding scheme due to oxidation of the inside surface of the covers has been proposed as a possible reason for the driver unit self-oscillation and destruction.
