## DG1 DISPLAY

## TS820S DISPLAY PROBLEMS

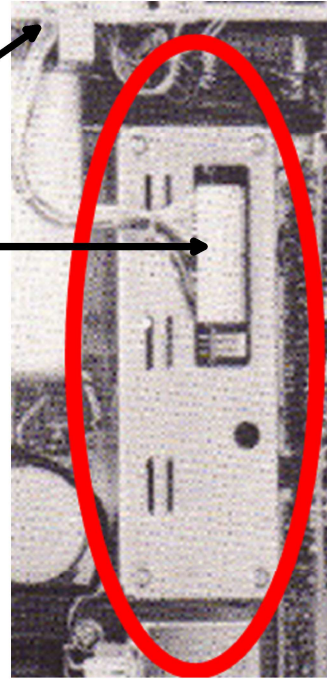
Review Service Bulletin #26 & 53. Remove Molex plugs from display & electronic unit.

Some DG1 displays do not have molex connector but are soldered.

Apply a small amount of DeOxit cleaner to both plug and pins.

Put connectors back on and test.

Remove DG1 module and remove cover.

Refer to bulletin #53. Instead of resoldering each pad, put a small wire through each hole and solder on both sides of the board.
