## W6NL Mods for the TS-930

## Replacing TS-930 Resistors and Shunt Zeners with Series Regulators

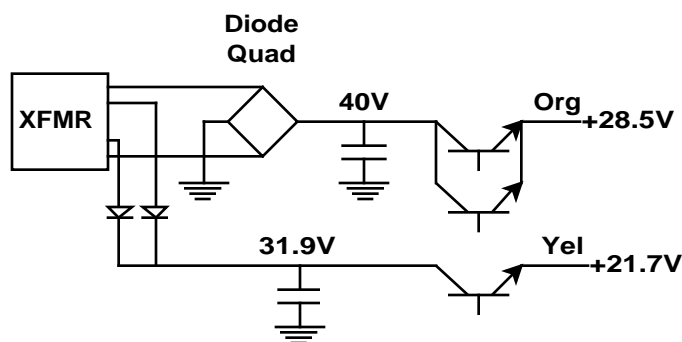
The TS-930 power supply for serial numbers higher than 310xxxx generates two voltages, 28.5V for the power amplifier and antenna tuner, and 21.7V for the digital board and the signal board. The 28.5V is regulated by the two TO3 pass transistors on the heat sink, and the 21.7V is generated by separate transformer secondary taps and diodes that generate 31.9V which is reduced to 21.7V by the TO220 transistor on the power supply heat sink.

The power switch has a pole that opens the +28.5V to most of the radio, including the circuit that runs the 21.7V regulator. This is apparently so the radio will just turn off without the time delay and rude noises of the filter capacitors discharging.

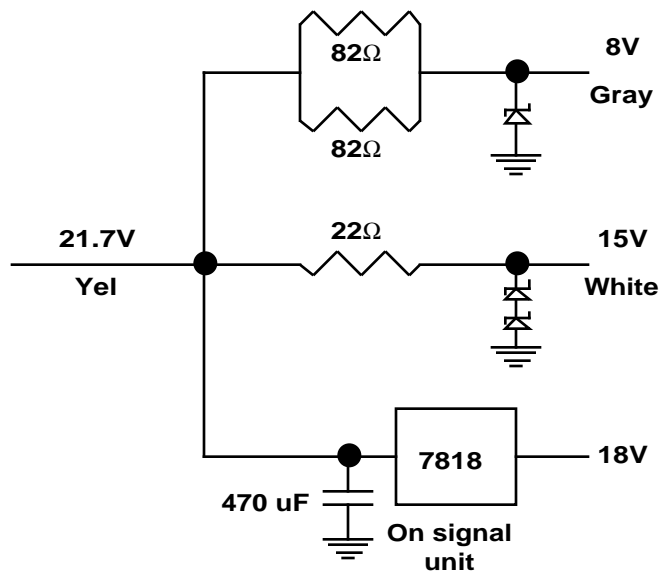
The power supply uses high-wattage resistors and zener diodes in the power supply fan case to reduce the 21.7V secondary supply voltage 7.5V and 15V for the digital board (which has 5V and 12V regulators) and for the signal unit, which has an 18V regulator. The 21.7V is distributed by the yellow wires via a black terminal block between the antenna tuner and the filter unit; this block also has the switched +28.5V orange wires. The original circuit looks like this:

The main schematic diagram of the radio is wrong, it shows the 33Ω resistor that is the third supply voltage for the digital board connected to the 21.7V instead of the 28.5V line.

The dissipation in the resistors and diodes is above their ratings, and this could be a reliability

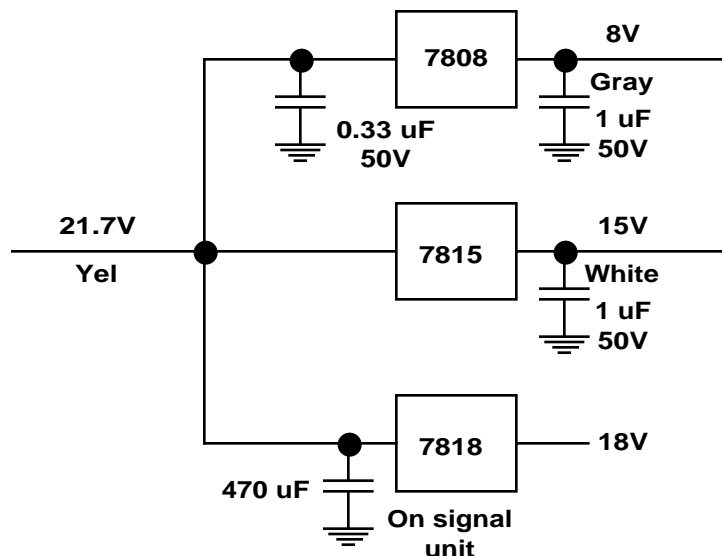
problem. This new circuit replaces the resistors and diodes with 78xx 1 A. TO220 regulators mounted on the power supply heat sink. In addition to having less dissipation, the regulators are short-circuit proof. There are holes in the heat sink, and the TO220 tabs can be bolted with 4-40 small-pattern nuts and bolts. I use a locking compound on the bolts so they won't vibrate loose later.

The regulators need capacitors near them, especially if they are driving the PIEXX board, which has switching regulators with inductors at the input. The regulators should be prewired, and the wires are connected to the voltage points inside the power supply fan case.

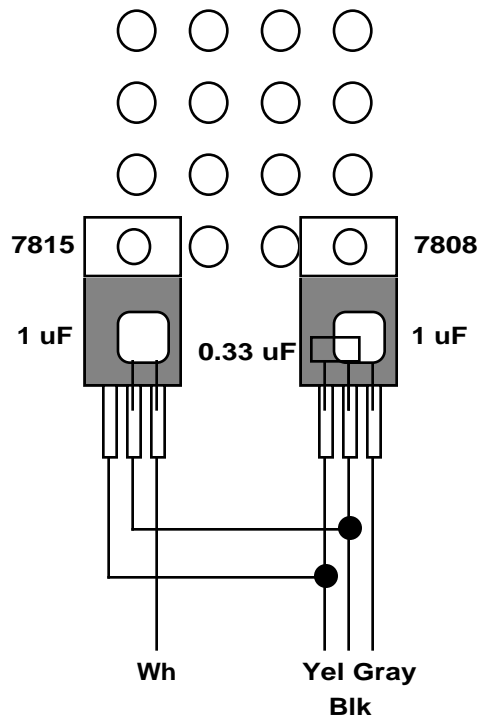
7. Locate the field of small holes near the upper edge of the heat sink, near the outside edge of the radio. As viewed from inside the radio, the two regulators mount to the holes in the bottom row (the top row is also OK, and easier to reach if you are not removing the heat sink). Before you do anything else, route the wires from the regulators beneath the heat sink so they can be connected to the terminal strips in the fan case.

8. The 4-40 small pattern nut just fits between the heat sink fins. Use a thin tool that can hold the nut on the end, and orient the flats of the nut to go between the fins. It's helpful if the parts are magnetic, so you can recover a dropped nut (be sure to cover the holes in the chassis with tissue or a rag). Use a 4-40x3/8" screw to fasten the regulators to the heat sink. The same nuts and screws are used in DB9 and DB25 connector shells. I use some heat sink compound on the back of the regulators. No insulation is required. Check again to be sure the screw for the TO220 pass transistor is tight and the transistor is oriented up so you can get to the terminals.

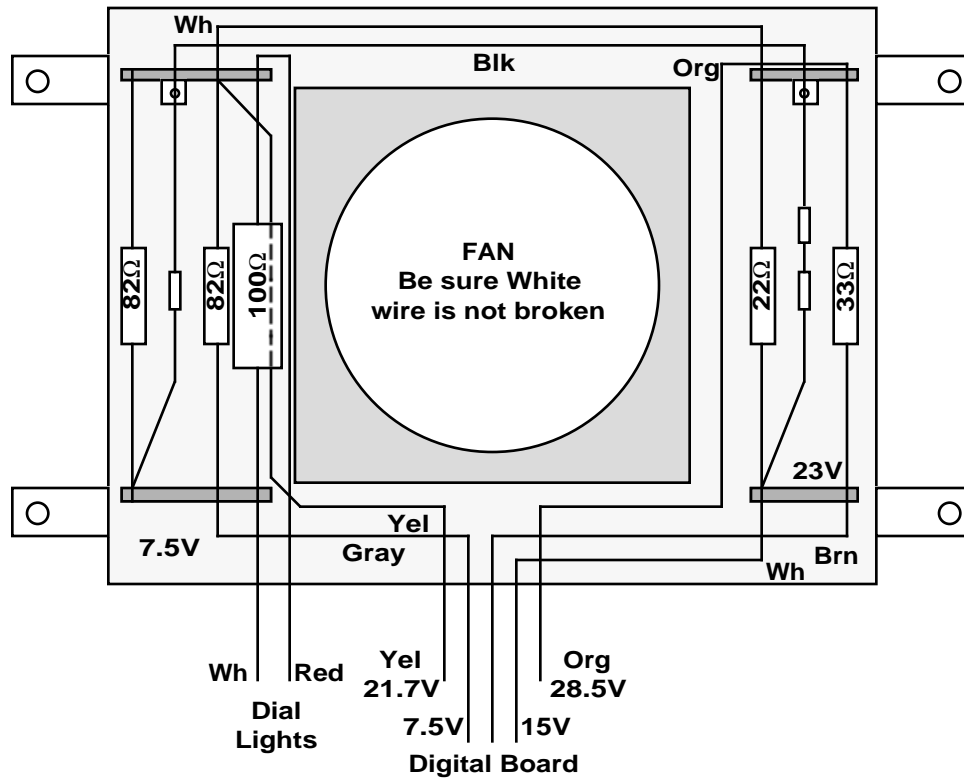
11. The resistors to be replaced are inside the power supply fan case. You will notice that the resistors will have lost their color coding from overheating, and the terminal strips may be somewhat charred, from overheating. Cut out the two 82Ω resistors and their zener diode, and cut out the 22Ω resistor and its two zener diodes. You can save these in case of trouble, but the new circuit should be more reliable.

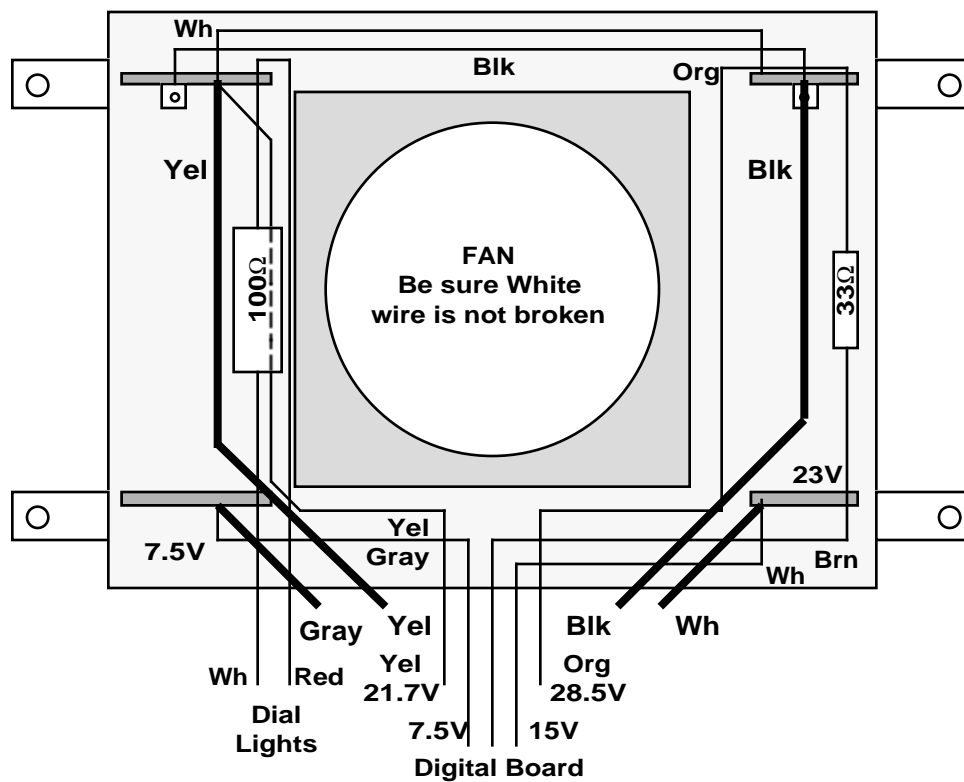
The fan case should now look like this:

Cut to length and solder the Yellow, Black, Gray and White wires to the terminal strips, making sure they are connected to the same color wire that is already there. Dress the wires in place to avoid the fan with a tiny nonmetallic cable tie or twister.

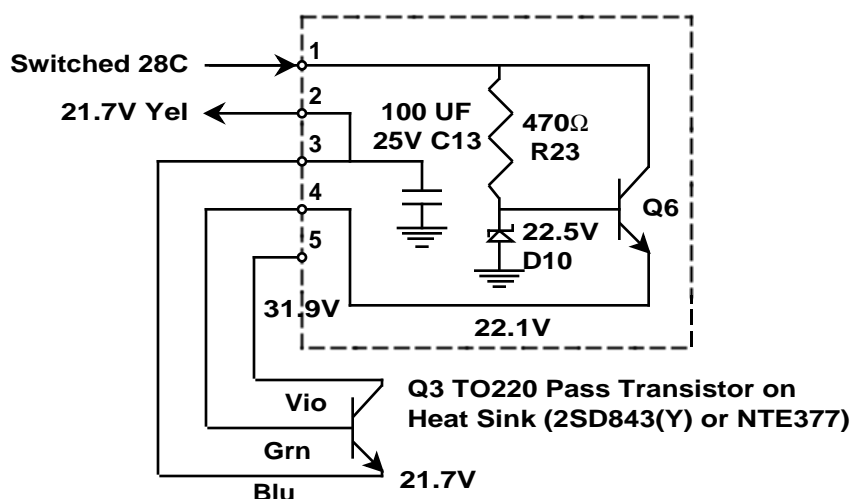
Despite the attention in the literature to the 28.5V TO3 regulators that supply the power amplifier, almost all of our power supply failures have been traced to the 21.7V regulator circuit. As the pass transistor is failing the radio will typically exhibit unusual operation, such as chirpy signal or intermittent display.

The 21.7V regulator is a pair of cascaded emitter followers driven by a 22.5V zener diode fed from the 28.5V supply switched through the power switch. The zener diode D10 and the first transistor Q6 are on the power supply board, and the second transistor Q3 is the TO220 transistor on the heat sink. The schematic incorrectly shows C13 to be 25 uF 100V (it is 100 uF 25V).

If the voltage is not correct, it will typically be either 31.9V or near 0V (say, 0.5V). This means the pass transistor Q3 is either shorted or open.

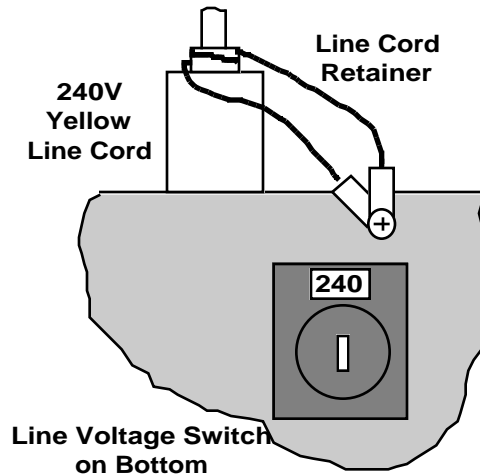
If the 120V line voltage is low, use the 240 or 220 volt switch position.

- Replace the 6A fuse with a 4A fuse; retain the 6A fuse if it is desired to change back later
- Turn the switch on the bottom of the radio to 240V, or 220V if the voltage is low
- Plug in special yellow 240V line cord, attach to rear panel so it won't be used on a 120V radio
- Plug into a 240V outlet or extension cord (surge absorber preferred, make sure ground is OK)

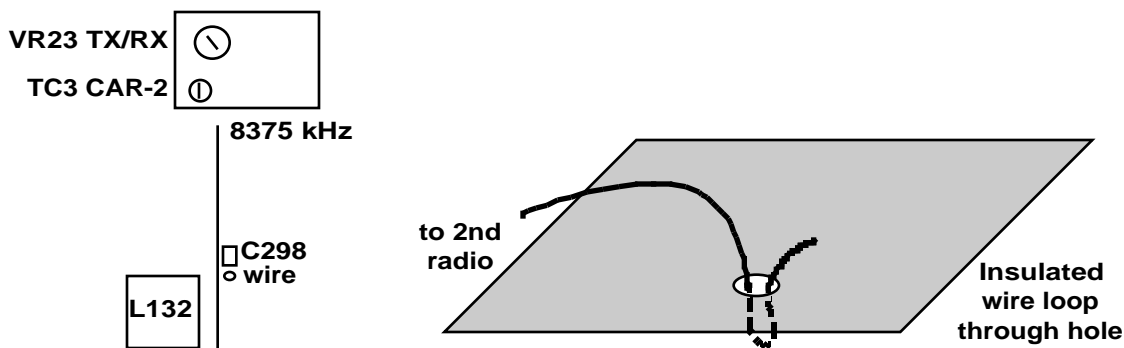
As another example, consider the alignment of the Carrier-2 oscillator used to provide variable bandwidth. The variable bandwidth tuning (VBT) uses two IF filters, one at 8830 kHz and the other at 455 kHz. The conversion oscillator at 8375 kHz determines the degree of overlap of the filter passbands. If the VBT knobs are set to widest position, the conversion oscillator should be at exactly 8375.0 kHz.

This can be done by connecting a counter (for example, an antenna impedance bridge counter) through a DC-isolated probe to C298 of the signal board, but if there's no other work to be done leave the case closed and use an insulated wire loop poked into the hole as an antenna to hear the oscillator on a second radio.

The radio should be set up (see Service Manual, pg. 67, adjustment and test points are on pg. 77)

Mode: USB  
Transmit: REC  
VBT: CW, High Cut fully CW, Low Cut fully CCW (no narrowing)

- Measure the frequency at 8375 kHz
- Adjust VR23 so there is no change in frequency from transmit to receive
- Adjust TC3, the small trimmer capacitor, so the frequency is exactly 8375.0 kHz

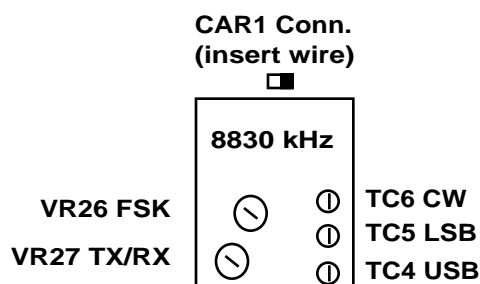
At this time you should also check the carrier oscillator at 8830 kHz

The radio should be set up (see Service Manual, pg. 66, adjustment and test points are on pg. 77)

Mode: USB  
Transmit: REC  
VBT: CW, High fully CW, Low fully CCW

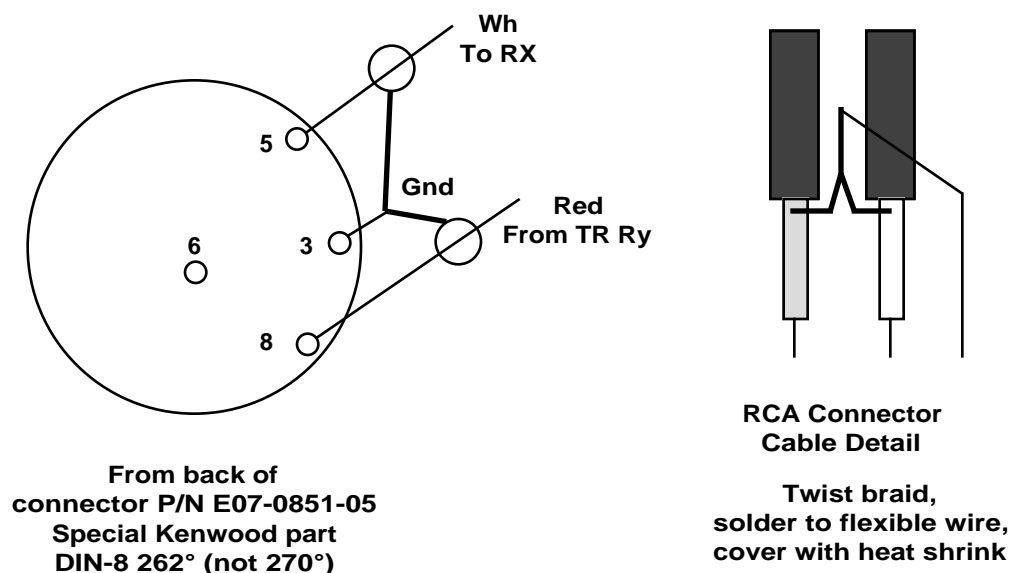
For use with an external receiving antenna, one needs the hard-to-find 262 degree 8-pin "horseshoe" DIN-8 connector used to bring a separate receiving antenna in and out of the transverter socket (available from Kenwood and Yaesu, and HRO, but seldom found when needed). In an emergency we found that a standard DIN-5 connector will plug in and provide access to the receiver input and ground, while the small slide switch makes the transmit antenna output available at the adjacent RCA phono connector to connect to an receive-antenna selector switch (inadvertent mis-setting of this switch is a source of occasional complaints of deaf receiver).

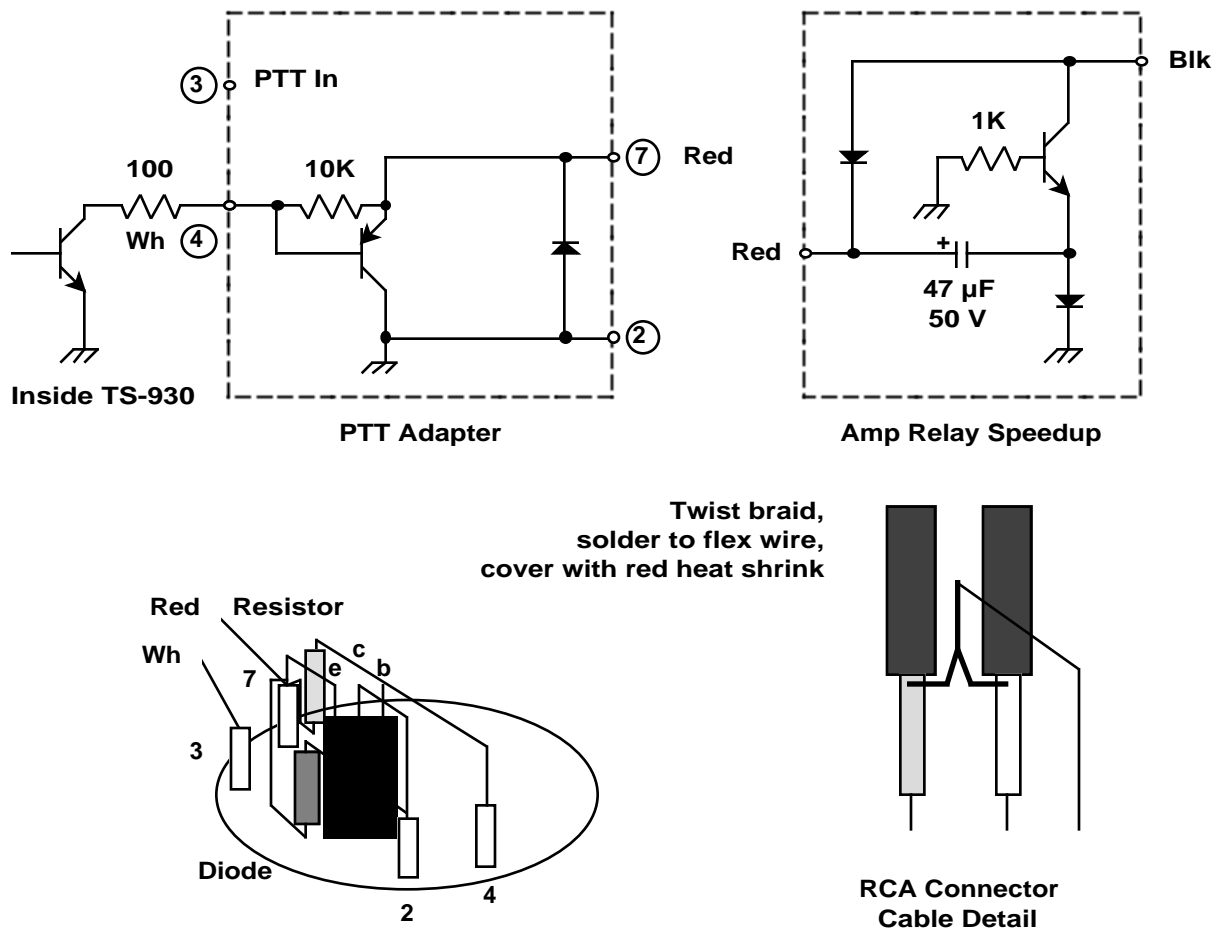
It's good practice to have a relay that disconnects the receiver input from any antenna and shorts it to ground during transmit, so the transmit power isn't returned to the receiver from a separate receiving antenna. When used as a second receiver in a multi-op setup, this relay can also be run by the AMP relay line of the transmitter on the same band.

We don't use the noisy and slow amplifier relay (28V to NC pin), but make a transistor switch adapter in the DIN-7 plug for the PTT input and AMP output. This is faster, less noisy and more reliable. With the AL-1200s we use the speedup circuit found on K6XX's web site.
