A Practical and Simple Keypad Bounce Filter for the Kenwood R-5000

This modification was reported in the Kenwood R-5000 Yahoo! Group by Ron Hankins (KK4PK). This documents my implementation of Ron's solution to this annoying and long lived problem with this otherwise good communications receiver.

Mike VE3JBT

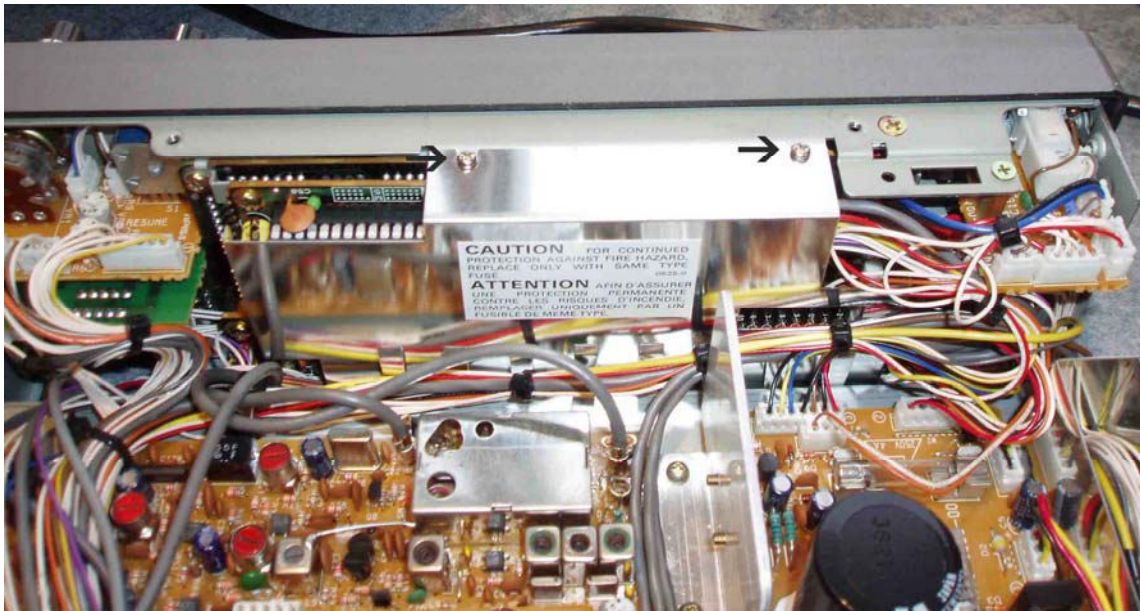
Top view

Remove the top and bottom covers and set them aside after disconnecting the speaker wire, Loosen but do not remove the small screws indicated by the arrows as shown in the two pictures below.

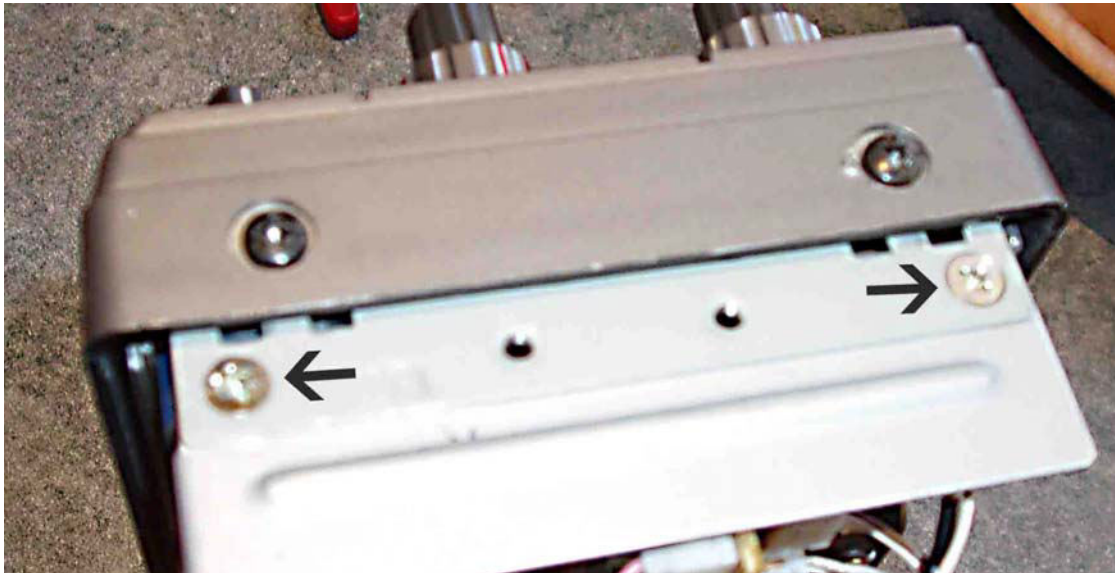
Front panel attachment screws

Remove the two countersunk screws holding the front panel in place as shown below.

Remove the screws from both sides and gently separate the front panel from the chassis. The shield can now be removed by sliding it towards the back and carefully removing it.

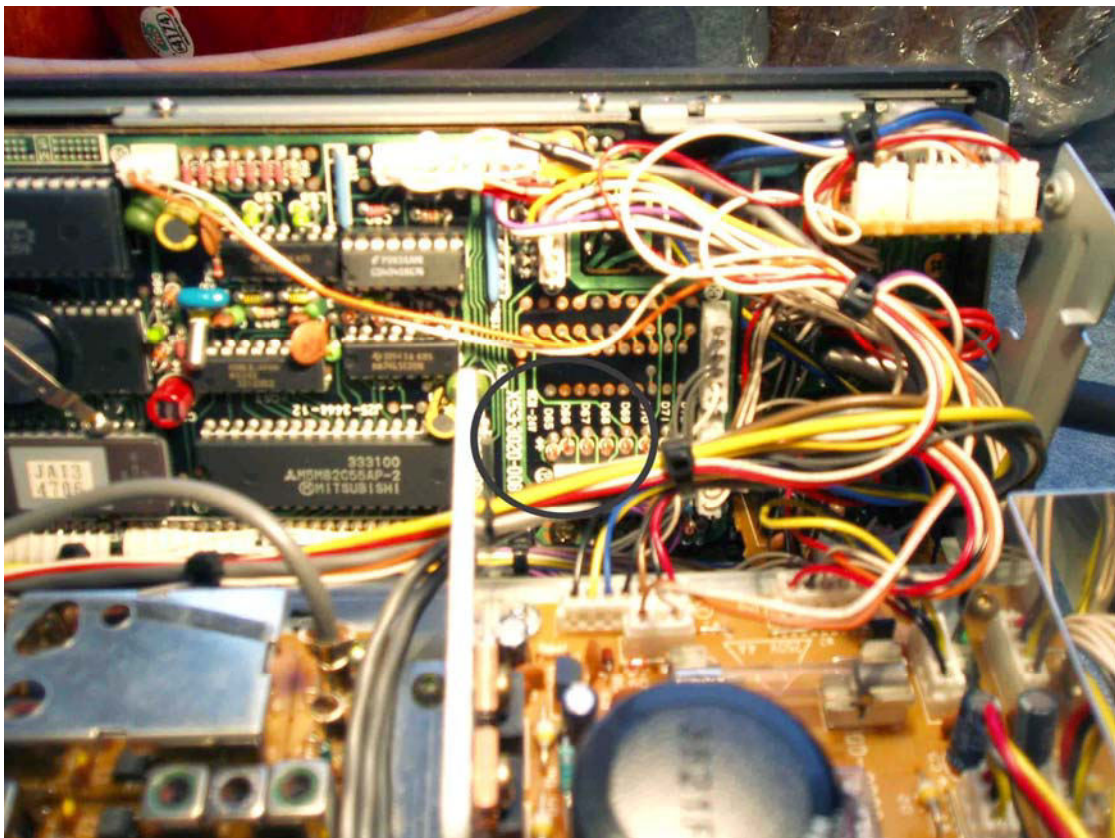
With the shield removed, you should be able to locate the circled area shown in the image below.

The area where the caps will be attached

Ron's post in Yahoo! Groups indicated that you should place a .01 ufd cap between pins 2 and 7, and pins 3 and 7, on IC 53. The following describes an easy way to do that.

If you examine the R-5000 Service manual, you see that the anodes of diodes D65 and D66 connect to pins 2 and 3 on IC 53. Pin 7 of IC 53 simply goes to circuit ground.

My implementation attaches the caps to D65 and D66.

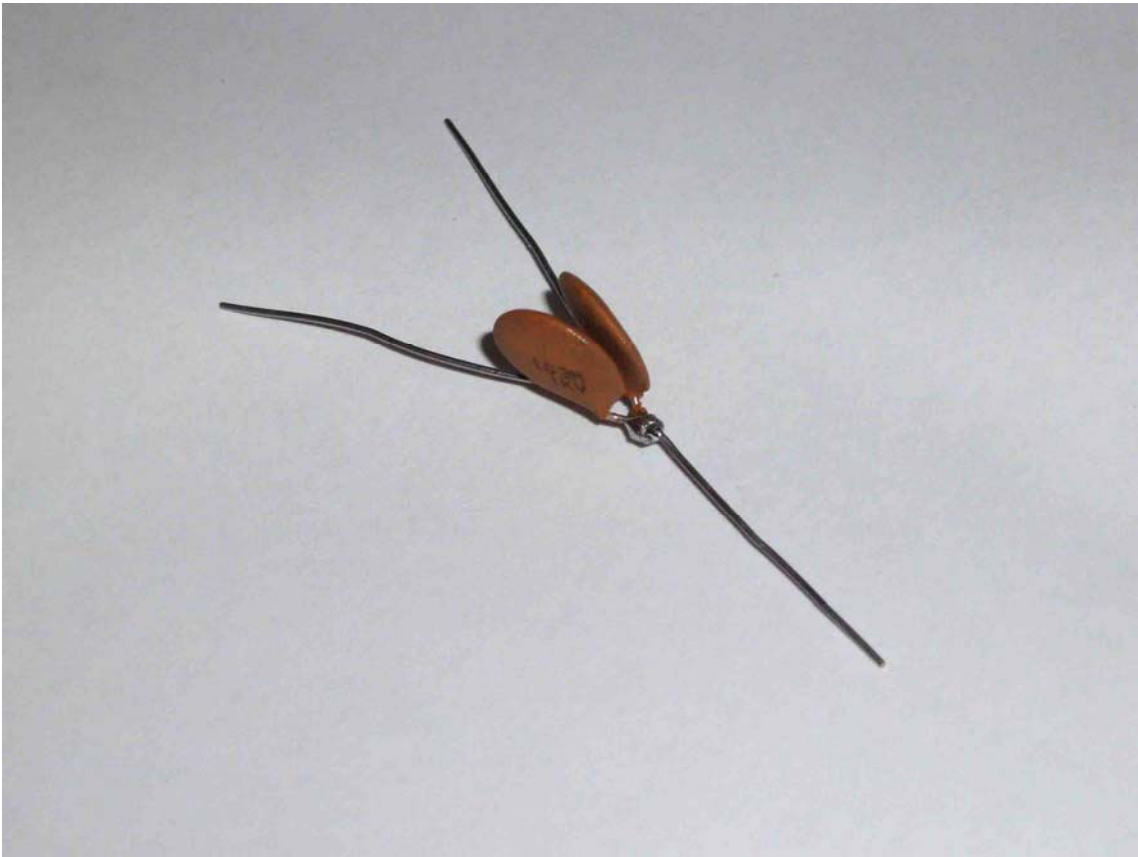
Preassemble two .01 ufd disc ceramic caps as shown in the picture below.

Capacitor assembly

My caps happened to be 1Kv types and were 10mm (3/8") in diameter.
Now turn the radio so the bottom side is up and locate the solder pad located between the pc board mounting screw and C52 as shown in the picture below

Do not be tempted to use caps larger than .01 uF (10 nF). Larger caps will cause strange problems.

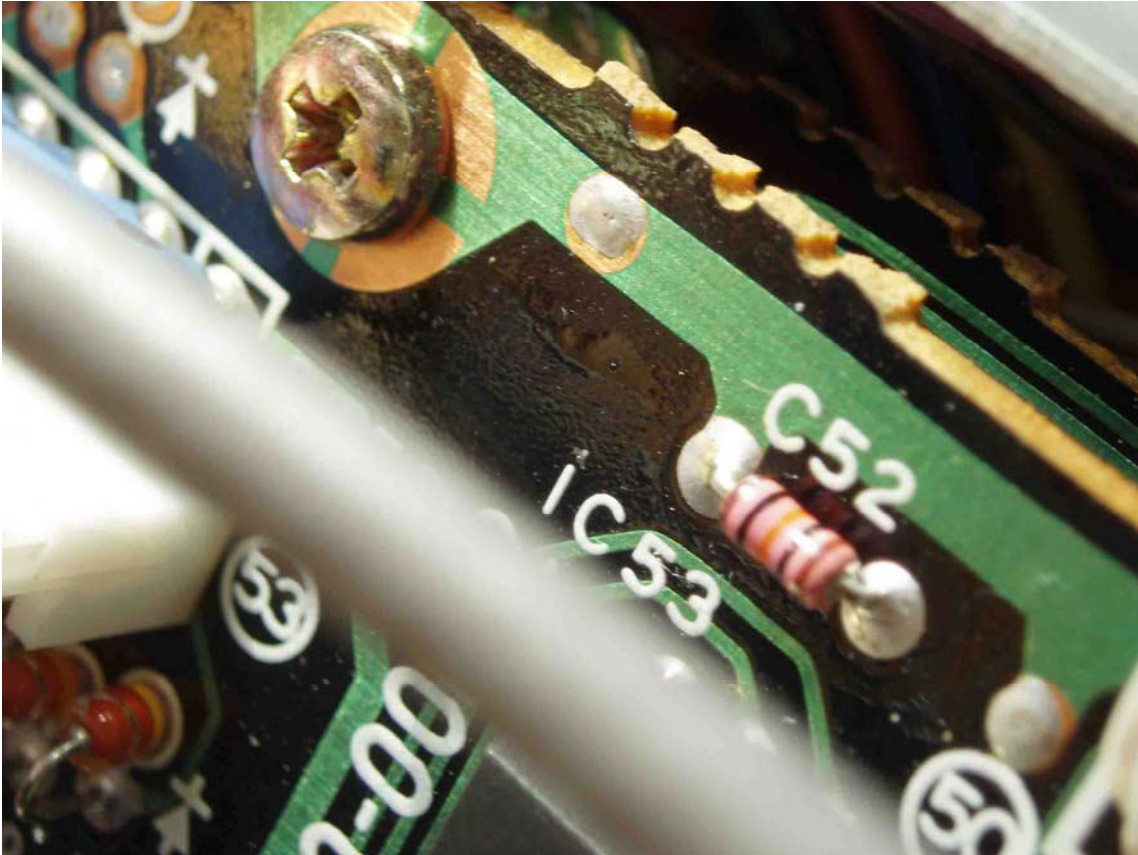
Ground solder pad

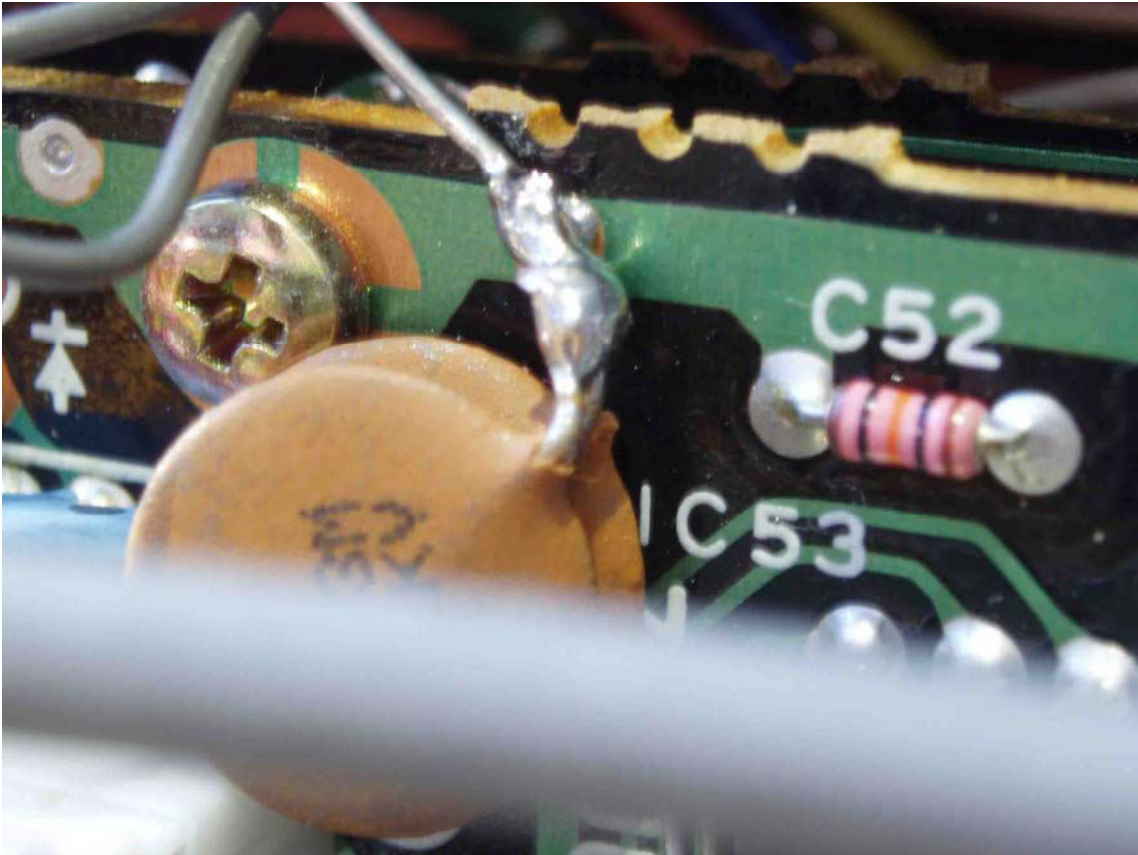
Using a small pencil soldering iron, tack a small blob of solder to this pad and attach the cap assembly as show below. Cut the wire tail off after you have made a good solder connection.

Capacitor assembly ground side attachment

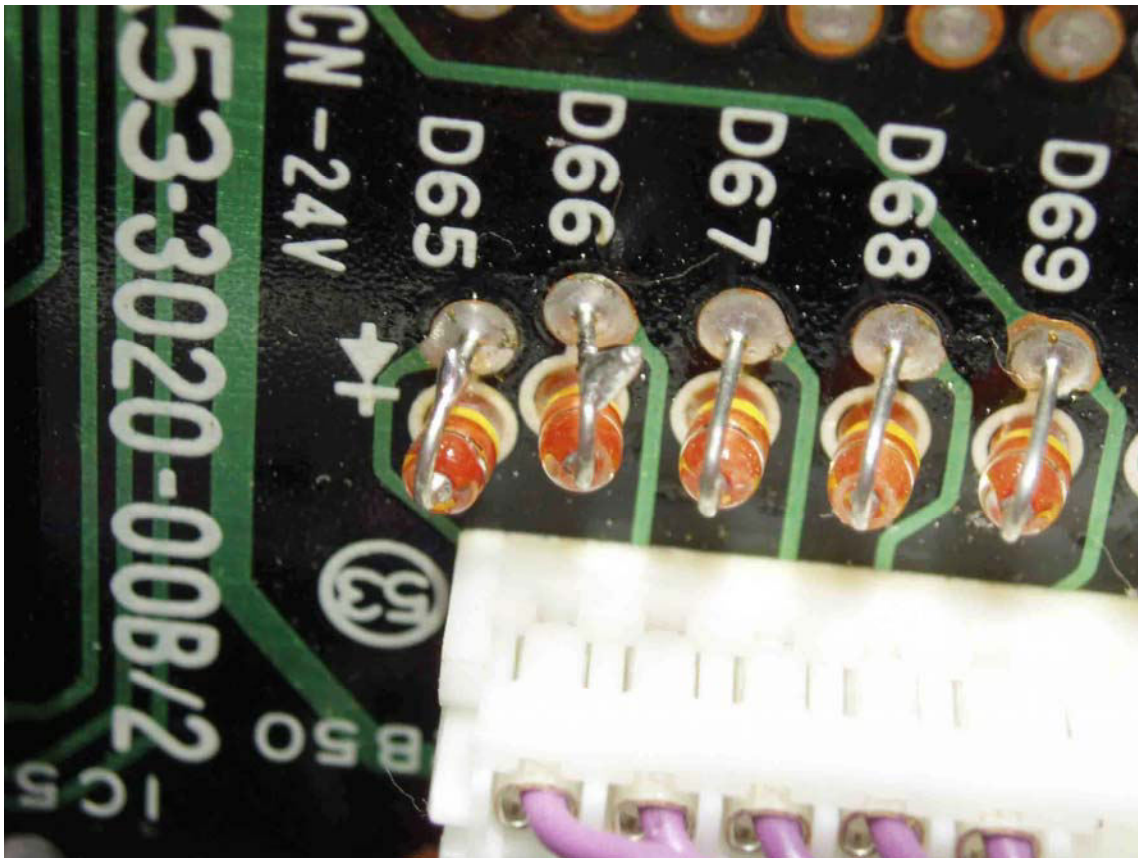
Now turn the radio right side up. and locate the anodes for diodes D65 and D66.
Using a low wattage pencil iron, Tin the wire loops on these two diodes as shown below.

D65 and D66 Anode connections

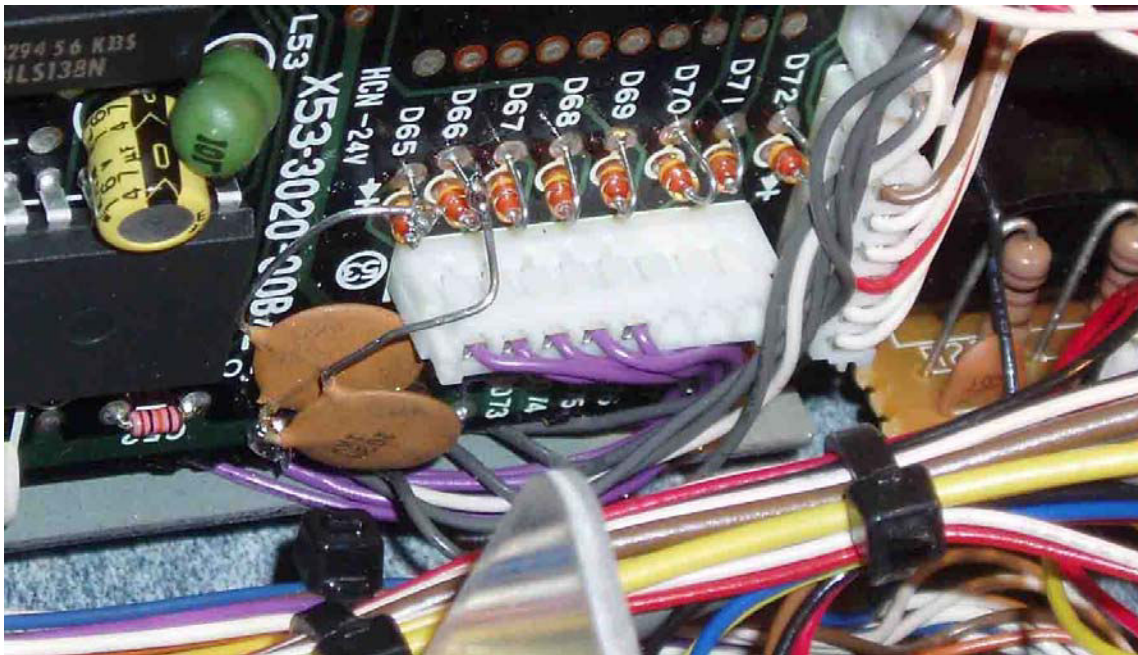
The final step is to solder the two remaining capacitor leads to the diodes. Carefully dress the capacitor leads so that they do not touch anything other than D65 and D66 anode leads.

Pre-tin the capacitor leads and tack them into place as shown below

D65 and D66 Attached to the caps
