Lowe HF-125, HF-225, HF-235 and HF-250 (HF-150?) Common Electrolytic Capacitor Failures

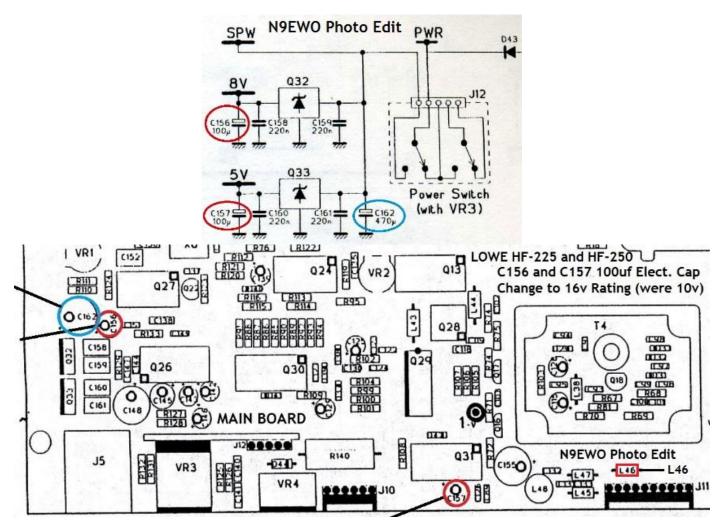
With the front of the cabinet facing you C156 is located on the far left side, just right of the 2 voltage regulators IC's. C157 in located right in the middle of the PC board FRONT edge. It's a bit tight with the front panel metal shield cut out area. Or see the HF-225 service manual for the detailed board location (it's in the same location and part numbers).

Even with the HF-250's extremely cool operation, there are TWO electrolytic capacitors on the main board that should be replaced in **EVERY** Lowe HF-125, HF-225, HF-235 and HF-250 (HF-150?) receiver on the planet. This is a very common failure trait. Voltage stressed electrolytic capacitors C156 and 157 (both **100 uf** at <u>10 volt</u> rating) go bad or we should say are BAD. These should both be replaced with **100 uf ones having a <u>16 volt</u> rating**. Of course this is for the electronic savvy person and be sure NOT to use too much heat and a small soldering iron tip and proper de-soldering device (otherwise damage will happen to the board), WARNING : Uses plated through holes. Be sure and use QUALITY replacement capacitors (nichicon etc) and some TLC.
