SWAN 100MX MODIFICATIONS

Published by PA0FRI – Summarized by DJ7TH

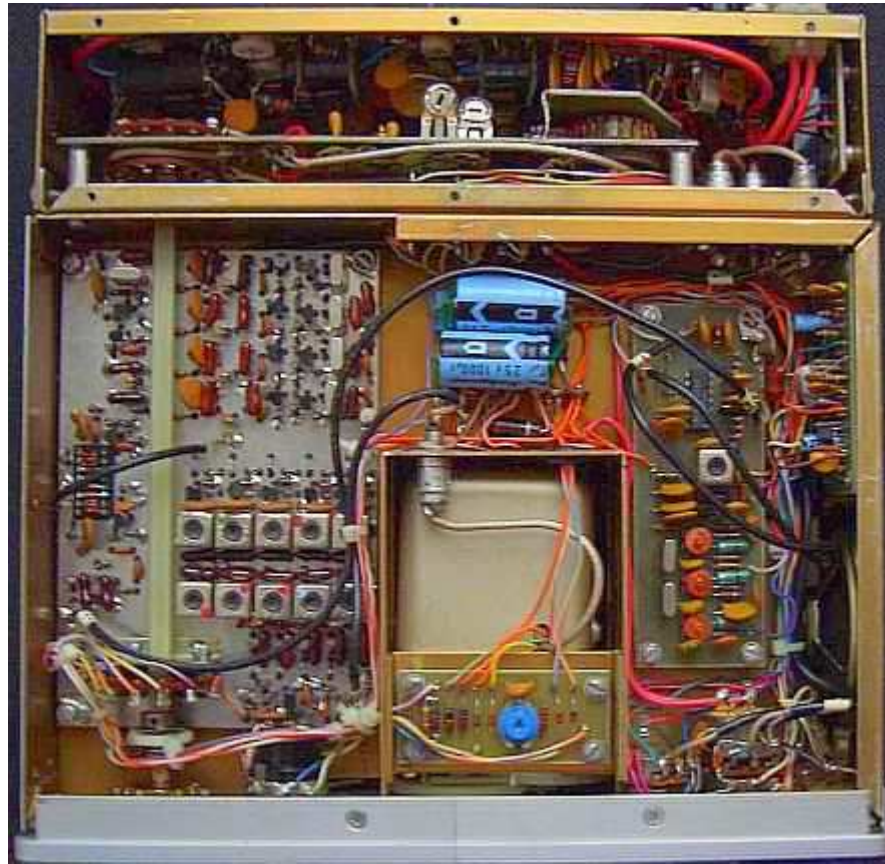
SELF OSCILLATING (10m)

If the *PRESELECTOR* is tuned for 10 m resonance, the set oscillates already when PTT is pressed in USB or LSB mode. I was days and nights searching for failures. Damping circuits, reducing gain or more feedback in the transistor amplifier was not a real improvement. However, the conclusion was that for almost 100% the malefactor was in the Preselector.

PAØFVE pointed me to an irregularity in the schematic that might cause an unwanted positive feedback. However it was a drawing error, and (fig») the proper connections are now marked with an arrow.

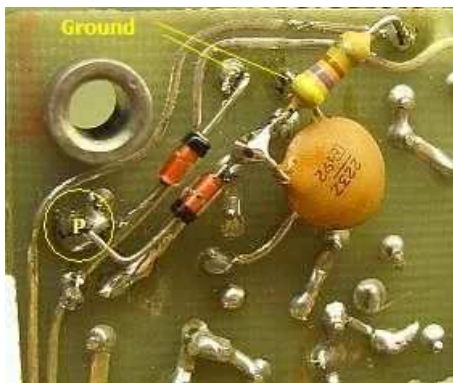
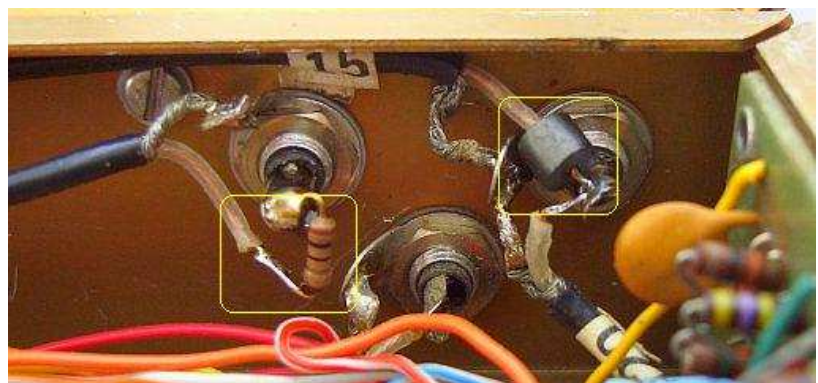
Components at the track side

Right: a ferrite bead over the inner conductor

Because the phenomenon only occurred at 10 m, I suspect the (zero) capacitance of CR115 (BA244) as culprit. When the relevant coax cable was disconnected, the 10 m band was pretty stable with nice "trees" pictures on a scoop. Indeed, both transmitter and receiver sections uses the Preselector, e.g. the signals passes through the Antenna Relay to input

and output. In transmit mode a leakage RF current passes as positive feedback through C125 and CR115 to T101.

The schematic shows how the fix is done. During transmit the input of capacitor C125 is electronically short-circuit to ground with two diodes. Desolder the inner conductor of the cable and mount a 22-100 nF capacitor into the hole. That is the point P in the diagram. Then solder the coax at the other side of the capacitor and mount the rest of the components on the track side, see the first photo. After this operation the stability was not always good and it was solved by sliding a ferrite bead over the inner conductor at the "beginning" of the coaxial cable.

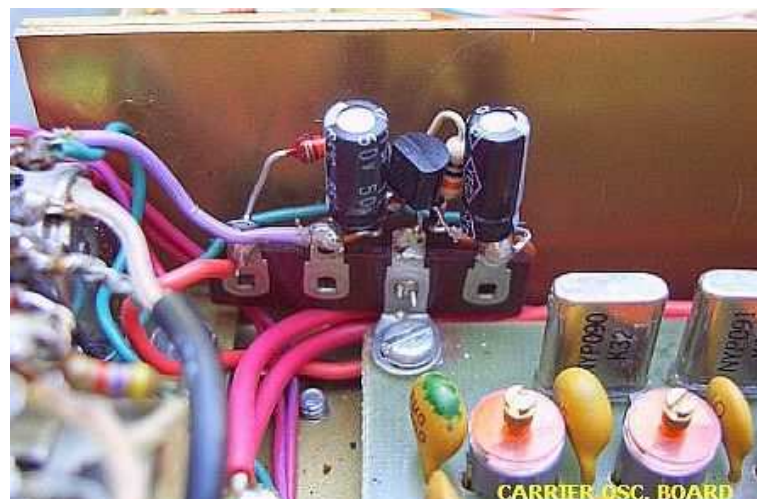
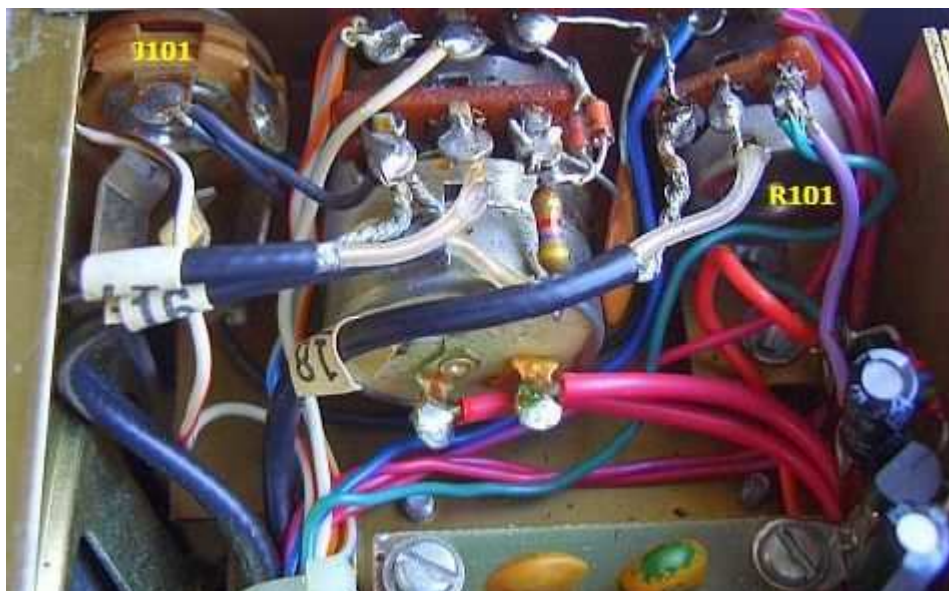
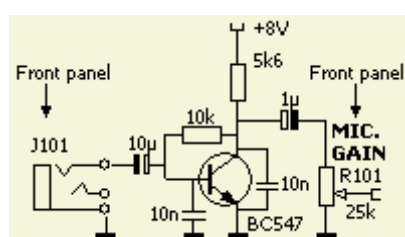
According to the manual, the impedance of microphone input (J101) is 25 k Ω . That was in the last century well suited for an average 50 k Ω microphone, but today is 200-600 Ω a more normal value. Unfortunately, the level is too low for this transceiver and therefore I used an earlier [design](#) for a Heil 4 & 5

microphone as amplifier.

The components had to be mounted in the transceiver on the *CARRIER OSC. BOARD* because without damage of the set, on the front plate was no room for J101 («fig) to be replaced by a 4 pin microphone system. The extra pin was needed to provide a positive voltage for the preamplifier.

Hams reported the modulation sounded pinched with or without preamplifier. The audio on the *Exciter BOARD* was modified by respective a 100 nF capacitor in parallel with C163 (10 nF) and 4.7 nF in parallel with C164 (470 pF). Furthermore, the additional 4.7 nF capacitance is an extra RF decoupling of IC A103.

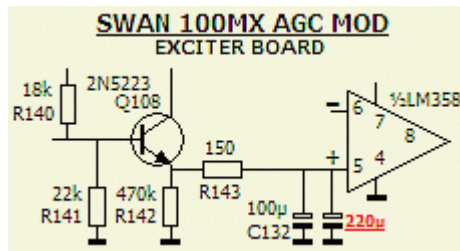
Personally I prefer a slower AGC which was obtained by the 220 μ F capacitor in parallel with C132 (100 μ F) at the *EXCITER BOARD*. Of course one may replace C132 by a 330 μ F capacitor type.

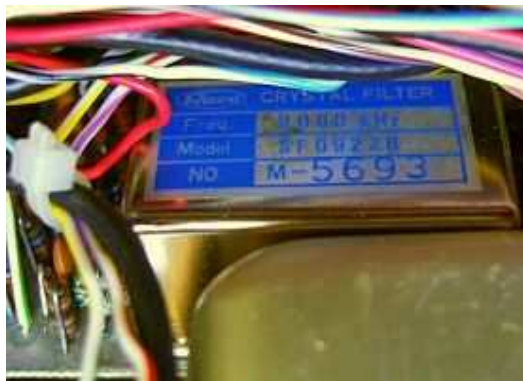
Full size SHOWA filters.

Model SF0922B: 8 pole 9000 kHz

In en output impedance: 500 Ω

BW: 2.30 kHz/-6 dB, 4.14 kHz/-60 dB

The original SHOWA IF crystal filter model SF0927A is 9001.65 kHz, BW 2.7 kHz. The plan was to replace with a KVG XF-9B, but I had a SHOWA («fig) SF0922B model in stock. It appeared that the assembly and pin connections were exactly the same as the original model, so it is like drop-in types, only the height was less. Because my experience with this filter in an FT7 was good, I decide to mount the narrow filter into this SWAN 100MX.

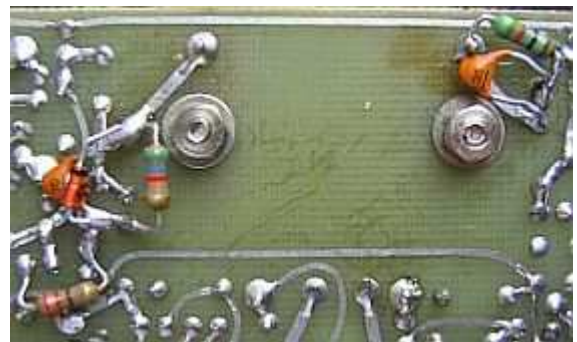
Initially the filter was installed without any modification to the circuit. Because it turned out to be a minor effort to load the filter with the correct impedance, I calculated («fig) the value of the additional components as close as 500 Ω . The resistors causes a drop of the gain and that was increased with a 220 Ω resistor in parallel to R105 (470 Ω). One can solder the new components at the trackside without damaging of the PCB.
