## Gallien-Krueger Service Center Memo

**Model**        **400RBIII power amp board rev. D**  
**Subject**      **Fan circuit**  
**Date**         **7-30-01**  
**Memo ID**     **Sm400III-01 fan**

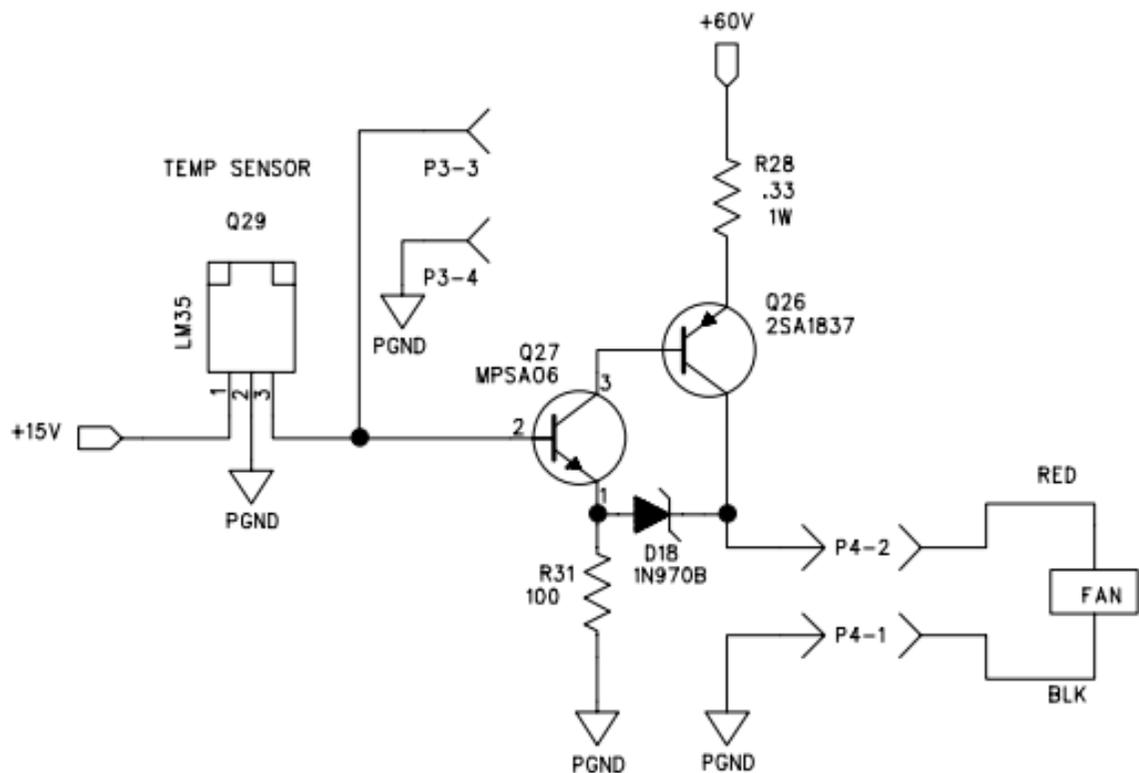
1. Replace Q26 and the fan
2. Solder a 1N970B (24V 500mW zener diode) across the emitter of Q27 and the collector of Q26. The cathode (striped end) goes to the collector of Q26 and the anode side goes to the emitter of Q27. See schematic on next page.

Removal of the power amp board and the heatsink are necessary to replace Q27. The 24V zener should be soldered on the bottom of the board and oriented so its leads do not short out against the chassis or any other leads.

Part #: 012-1002-0 2SA1837  
      020-0240-0 1N970B 24V zener  
      086-0000-0 24VDC fan
