PIC16C63 Rev. A Silicon Errata Sheet

The PIC16C63 (Rev. A) parts you have received conform functionally to the Device Data Sheet (DS30234D), except for the anomalies described below.

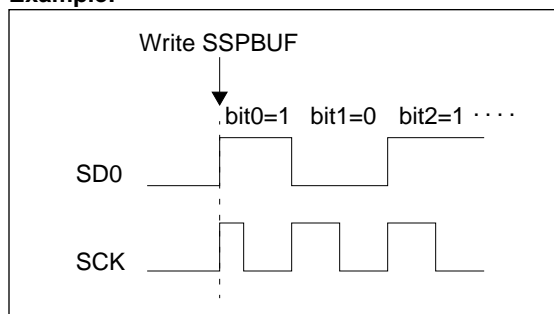
Example:

4. Module: SSP (SPI Mode)

When the SPI is using Timer2/2 as the clock source, a shorter-than-expected SCK pulse may occur on the first bit of the transmitted/received data.

Work Around

To avoid producing the short pulse, turn off Timer2 and clear the TMR2 register, load the SSPBUF with the data to transmit, and then turn Timer2 back on.

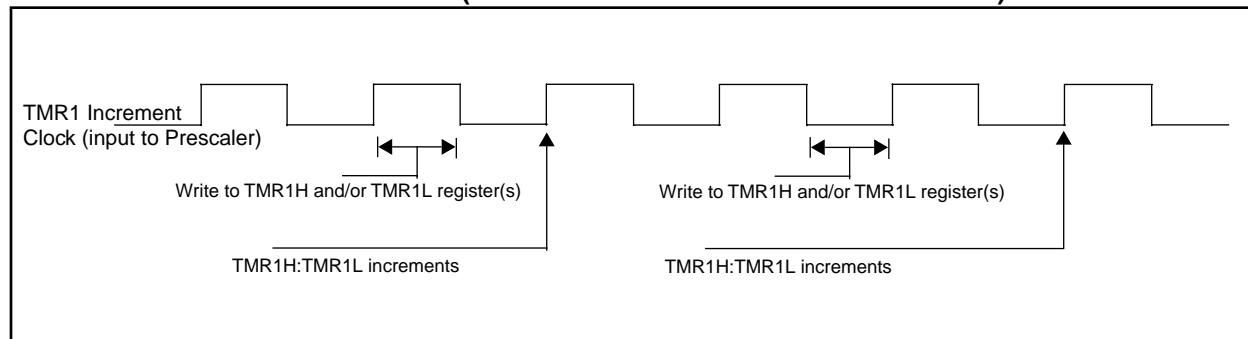
FIGURE 1: WRITES TO TIMER1 (EXTERNAL CLOCK / OSCILLATOR MODE)

The internal clock signal that is the input to the TMR1 prescaler affects the incrementing of Timer1 (TMR1H:TMR1L registers and the Timer1 prescaler). When the Timer1 registers are NOT written, the Timer1 will increment on the rising edge of the TMR1 increment clock.

When the TMR1H and/or TMR1L registers are written while this clock is high, TMR1 will increment on the next rising edge of this clock.

When the TMR1H and/or TMR1L registers are written while this clock is low, TMR1 will not increment on the next rising edge of this clock, but must first have a falling clock and then the rising clock for TMR1 to increment.

Figure 1 shows the two cases of writes to the TMR1H and/or TMR1L registers. Due to the V_{IH} and V_{IL} thresholds on the oscillator/clock pins, external Timer1 oscillator components, and external clock frequency, the Timer1 increment clock may not be of a 50% duty cycle.

The TMR1 increment clock is out of phase of the T1OSO/T1CKI pin by a small propagation delay.
