PIC16C65A Rev. A Silicon Errata Sheet

The PIC16C65A (Rev. A) parts you have received conform functionally to the Device Data Sheet (DS30234D), except for the anomalies described below.

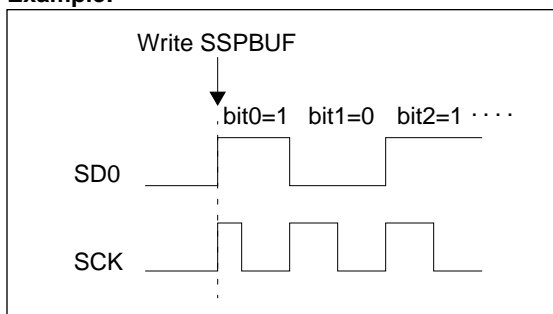
Example:

4. Module: SSP (SPI Mode)

When the SPI is using Timer2/2 as the clock source, a shorter-than-expected SCK pulse may occur on the first bit of the transmitted/received data.

Work Around

To avoid producing the short pulse, turn off Timer2 and clear the TMR2 register, load the SSPBUF with the data to transmit, and then turn Timer2 back on.

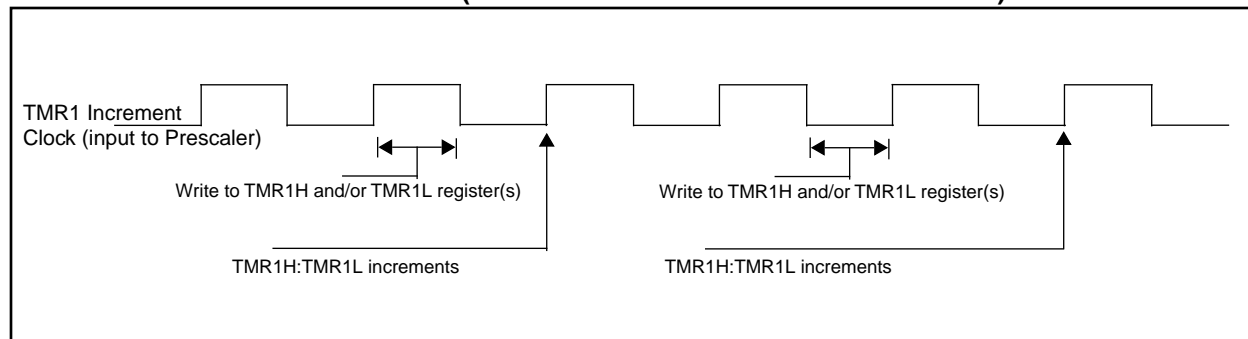
FIGURE 1: WRITES TO TIMER1 (EXTERNAL CLOCK / OSCILLATOR MODE)

- a) The operation of Timer1 needs some clarification when the timer registers are written when the TMR1ON bit is set.
- The internal clock signal that is the input to the TMR1 prescaler affects the incrementing of Timer1 (TMR1H:TMR1L registers and the Timer1 prescaler). When the Timer1 registers are NOT written, the Timer1 will increment on the rising edge of the TMR1 increment clock.

When the TMR1H and/or TMR1L registers are written while this clock is high, TMR1 will increment on the next rising edge of this clock.

When the TMR1H and/or TMR1L registers are written while this clock is low, TMR1 will not increment on the next rising edge of this clock, but must first have a falling clock and then the rising clock for TMR1 to increment.

Figure 1 shows the two cases of writes to the TMR1H and/or TMR1L registers. Due to the V_{IH} and V_{IL} thresholds on the oscillator/clock pins, external

Timer1 oscillator components, and external clock frequency, the Timer1 increment clock may not be of a 50% duty cycle.

The TMR1 increment clock is out of phase of the T1OSO/T1CKI pin by a small propagation delay.
