## PIC16C72 Rev. A Silicon Errata Sheet

The PIC16C72 (Rev. A) parts you have received conform functionally to the Device Data Sheet (DS39016A), except for the anomalies described below.

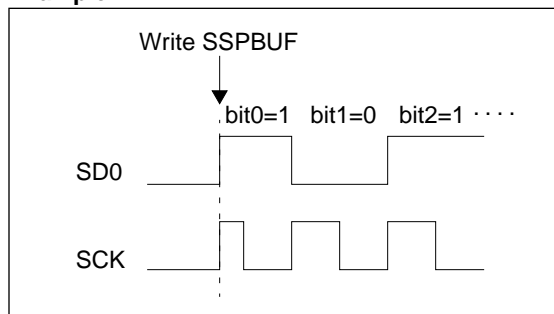
### Example:

When the SPI is using Timer2/2 as the clock source, a shorter-than-expected SCK pulse may occur on the first bit of the transmitted/received data.

To avoid producing the short pulse, turn off Timer2 and clear the TMR2 register, load the SSPBUF with the data to transmit, and then turn Timer2 back on.

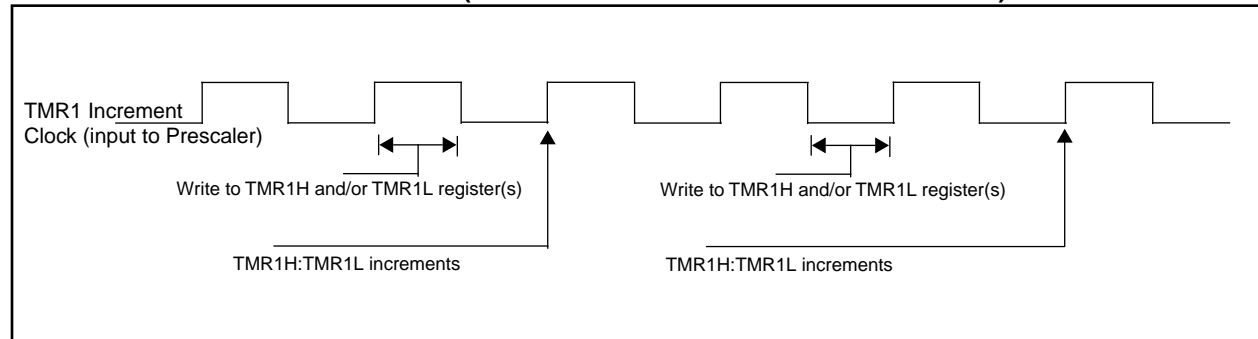
**FIGURE 1: WRITES TO TIMER1 (EXTERNAL CLOCK / OSCILLATOR MODE)**

Figure 1 shows the two cases of writes to the TMR1H and/or TMR1L registers. Due to the  $V_{IH}$  and  $V_{IL}$  thresholds on the oscillator/clock pins, external Timer1 oscillator components, and external clock frequency, the Timer1 increment clock may not be of a 50% duty cycle.

The TMR1 increment clock is out of phase of the T1OSO/T1CKI pin by a small propagation delay.

The internal clock signal that is the input to the TMR1 prescaler affects the incrementing of Timer1 (TMR1H:TMR1L registers and the Timer1 prescaler). When the Timer1 registers are NOT written, the Timer1 will increment on the rising edge of the TMR1 increment clock.

When the TMR1H and/or TMR1L registers are written while this clock is high, TMR1 will increment on the next rising edge of this clock.

When the TMR1H and/or TMR1L registers are written while this clock is low, TMR1 will not increment on the next rising edge of this clock, but must first have a falling clock and the rising clock for TMR1 to increment.
