Adequate Shelters and Quick Reaction to Warning: A Key to Civil Defense

Abstract. *Case histories collected by investigators in Japan during 1945 illustrate both the effectiveness of shelters and the dangers inherent in apathy of the population, which suffered needless casualties by ignoring air raid warnings. Adequate shelters and immediate response to warnings are essential to survival in nuclear attack.*

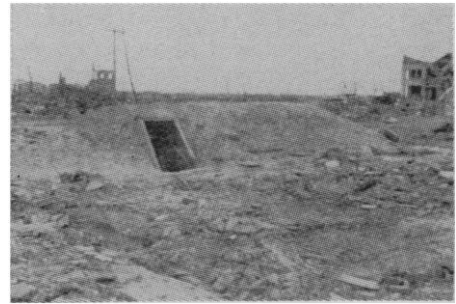
Fig. 1. "Hiroshima. Typical, part below ground, earth-covered, timber framed shelter 300 yds. from the centre of damage, which is to the right. In common with similar but fully sunk shelters, none appeared to have been structurally damaged by the blast. Exposed woodwork was liable to 'flashburn'. Internal blast probably threw the occupants about, and gamma rays may have caused casualties." (Reprinted by permission from Report of the British Mission to Japan (3) and the Imperial War Museum, London.)

Hiroshima. The city of Hiroshima had provided sufficient shelters to accommodate approximately one-third of the population along the river banks and at the military headquarters nearby. The shelters were built of reinforced concrete or consisted of excavations supported by beams and roofed with wood and earth. These withstood the blast even at 300 yards (275 m) (Fig. 1). Many of the unsupported, excavated shelters within the first 1000 yards (900 m) collapsed, however.

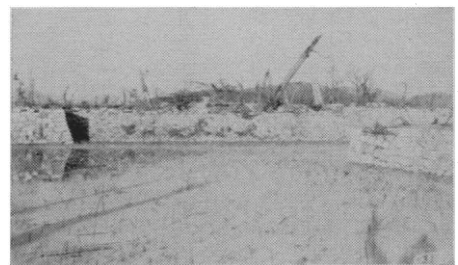
Fig. 2. Chugoku Army Headquarters (750 m from ground zero). View of the underground communications trench from across the moat, looking away from the center of the explosion, with which the optical axis of the camera is in line. The ventilator of the communications trench is just visible near the center, above the stone facing of the moat. (AFIP Neg. HB 209.)

ted about 750 yards (685 m) east from ground zero. (At this distance most of the people outdoors were killed.) It was a concrete structure largely below ground level (Fig. 2); the side of the building facing the explosion received additional protection from the stone facing of a moat. The strong construction of this shelter is apparent from an inspection of Figs. 3-5.

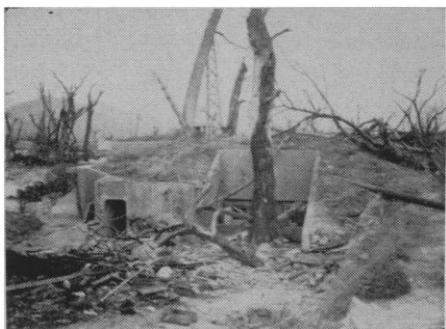
Fig. 3 (left). Chugoku Army Headquarters (750 m from ground zero). Underground communications trench. Entrance at left. (AFIP Neg. HB 321.) Fig. 4 (right). Chugoku Army Headquarters (750 m from ground zero). Underground communications trench. Open metal port. This is a view looking away from the center of the explosion, with which the optical axis of the camera is in line. (Reprinted by permission from A. W. Oughterson and S. Warren, *Medical Effects of the Atomic Bomb in Japan* (McGraw-Hill, New York, 1956), p. 61.) (AFIP Neg. HB 320.)

On the basis of the group studied, therefore, it appears that the Communications Building furnished complete protection against burns and probably against radiation sickness, despite its proximity to the explosion. The doors and windows (Figs. 3 and 4) on the west face of the building were open at the time of the explosion and the blast was clearly perceived by those present.

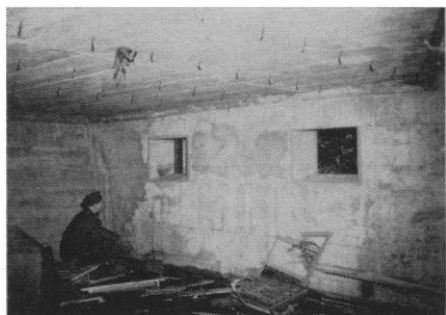
Fig. 5 (left). Chugoku Army Headquarters (750 m from ground zero). Room whose ports are seen from the outside in Figs. 3 and 4. (Reprinted by permission from A. W. Oughterson and S. Warren, *Medical Effects of the Atomic Bomb in Japan* (McGraw-Hill, New York, 1956), p. 61.) (AFIP Neg. HB 322.) Fig. 6 (right). "Nagasaki. Typical small earth-covered backyard shelter with crude wooden frame, less than 100 yds. from the centre of damage, which is to the right. There was a large number of such shelters, but whereas nearly all those as close as this one had their roofs forced in, only half were damaged at 300 yds. and practically none at half a mile from the centre of damage." (Reprinted by permission from Report of the British Mission to Japan (3) and the Imperial War Museum, London.)
