Surveyor V: Lunar Surface Mechanical Properties

Abstract. *The mechanical properties of the lunar soil at the Surveyor V landing site seem to be generally consistent with values determined for soils at the landing sites of Surveyor I and III. These three maria sites are hundreds of kilometers apart. However, the static bearing capability may be somewhat lower than that at the previous landing sites (2×10^5 to 6×10^5 dynes per square centimeter or 3 to 8 pounds per square inch). The results of the erosion experiment, the spacecraft landing effects, and other observations indicate that the soil has significant amounts of fine-grained material and a measurable cohesion.*

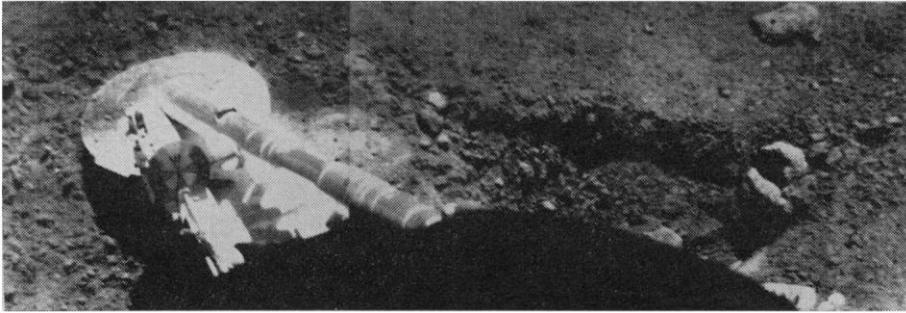
Fig. 1. During the landing, the spacecraft slid down the slope. The 0.8-m trench made by footpad 2 is shown in this picture. Most of the clumps of soil near the circular footpad were ejected during the landing. Soil clumps fell into the trench after the footpad had moved past (catalog No. 5-MP-19. GMT day 257; approximately 05).

The Surveyor V terminal landing maneuver resulted in nominal landing velocities of 4.2 m/sec vertically and 0.5 m/sec horizontally. After the initial touchdown, the spacecraft slid about 0.8 m before reaching its final position on a 20-degree slope. The trench dug by one of the footpads during landing is shown in Fig. 1. As indicated by the appearance of the disturbed soil, the penetration into the soil by the footpads during landing, and landing loads in the leg shock absorbers, the mechanical properties of the lunar soil at the Surveyor V landing site seem to be generally consistent with values determined for the soils at the Surveyor I (1) and III (2) landing sites. However, the values for static bearing capability of the lunar soil at the landing site may be somewhat lower than the previous range of values, which is 2×10^5 to 6×10^5

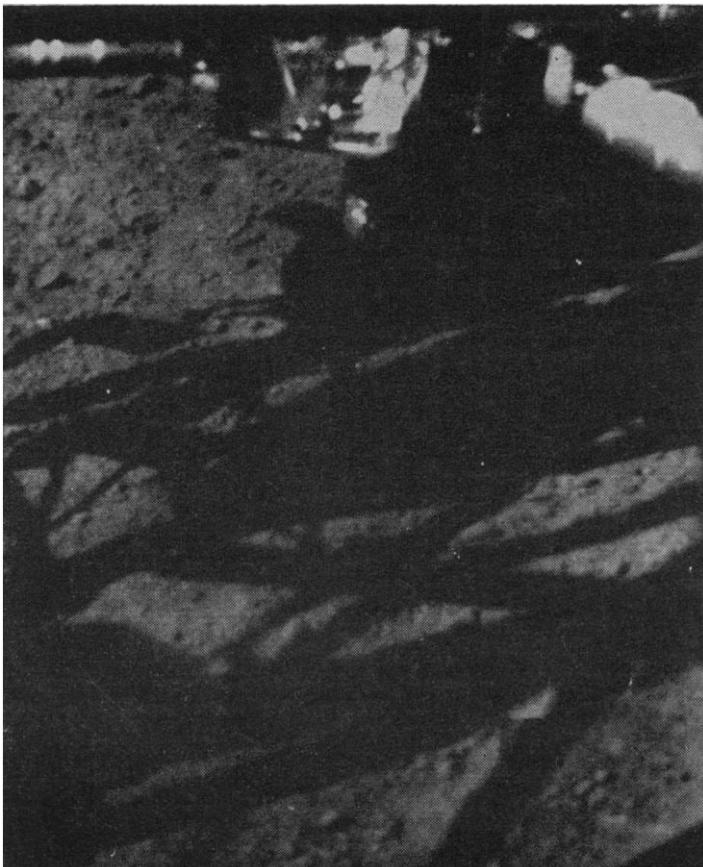
Fig. 2. Mosaic of narrow-angle television pictures of the lunar surface under vernier engine 3, as seen through the auxiliary mirror, before the engine firing. Sun elevation was 44 degrees, relative to the lunar surface beneath the spacecraft, and came from the left. The shadows of the spacecraft cover part of the surface. The wavy shadow is caused by the flexible cable to the sensor head and not by surface contours (catalog No. 5-MP-17. GMT day 256; approximately 01).

There is evidence that both types of erosion occurred. Effects attributed to viscous erosion (from vernier engine 3) are shown by comparing Fig. 2

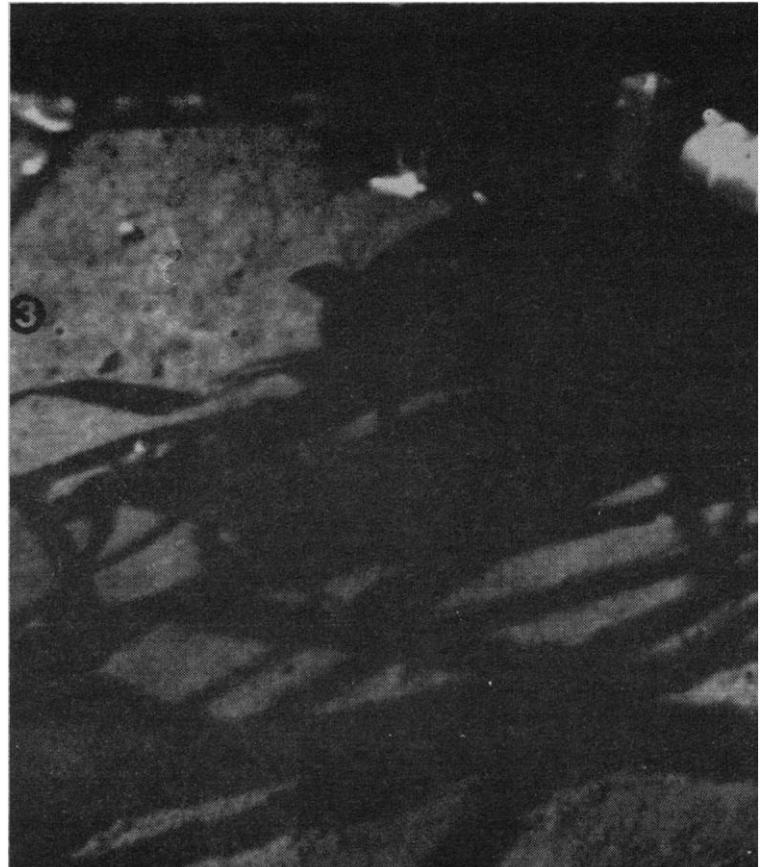
Fig. 3. Mosaic of narrow-angle television pictures of the lunar surface under vernier engine number 3, as seen through the auxiliary mirror, after the engine firing. The depression created by erosion (visible in Fig. 7) was not visible because of the high Sun angle and spacecraft shadows. Sun elevation was 47 degrees, relative to the lunar surface beneath the spacecraft. Compare with Fig. 2 and note the smoother appearance of the lunar surface and the removal of fragments or clumps (catalog No. 5-MP-18. GMT day 256; approximately 07).

(before firing) to Fig. 3 (after firing), and Fig. 4 (before firing) to Fig. 5 (after firing). Some displacement of fine soil, and of rock or soil fragments (or both) has occurred. During the erosion experiment, the alpha-scattering instrument sensor head (mass, 2.2 kg) was moved approximately 11 cm away from vernier engine 3. The material impinging on the sensor head changed the appearance of the vertical side (Fig. 5, smudge on the lower part) facing the engine, but produced no significant change to the top of the sensor head.

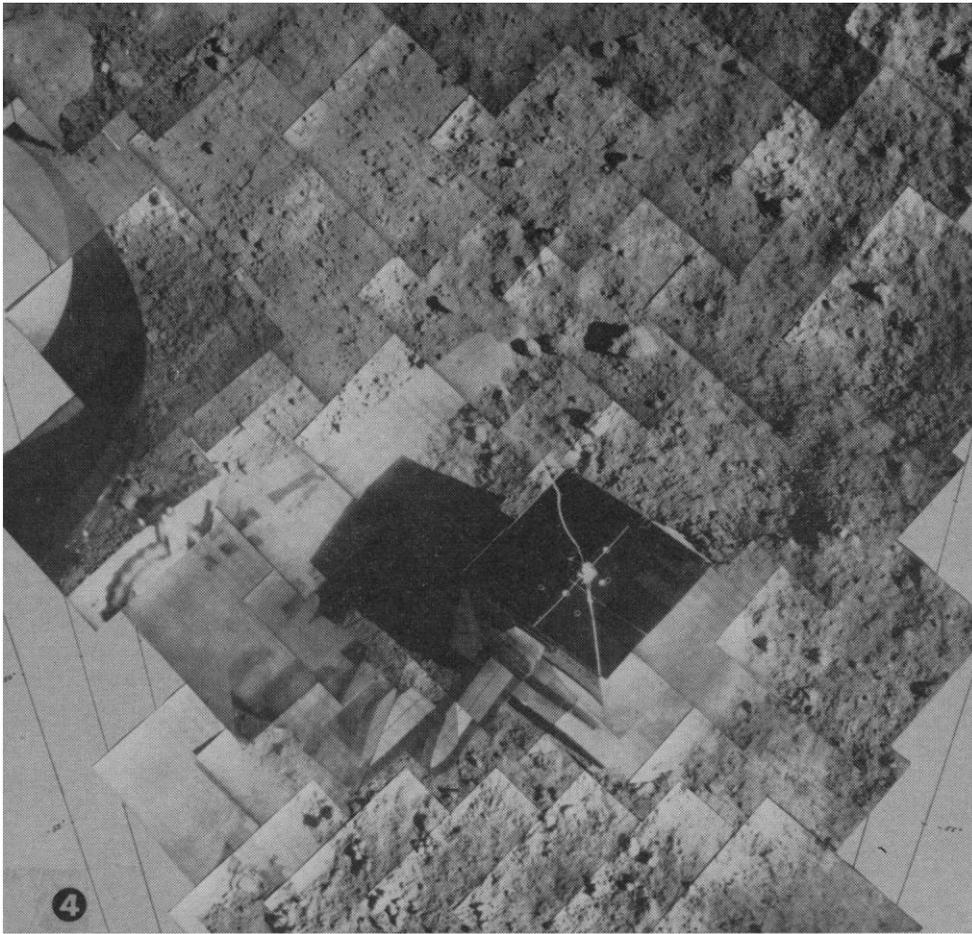
Fig. 4. Mosaic of narrow-angle television pictures showing the sensor head and the lunar surface area near it. The wide distribution of rock and soil fragments existed before the vernier engines were fired. The wavy cable in the foreground created the shadow seen in Fig. 2. Sun elevation was 35 degrees, relative to the lunar surface beneath the spacecraft (catalog No. 5-MP-16. GMT day 255; 04:53 to 05:26).

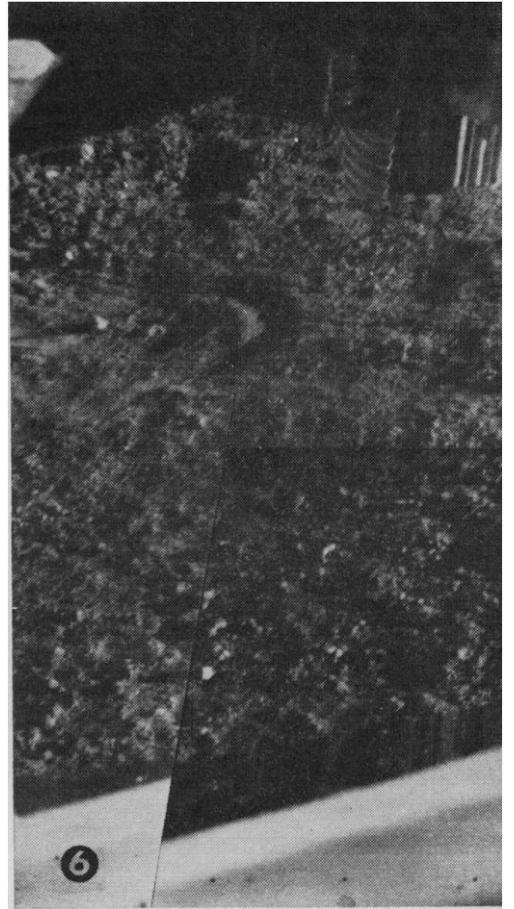
Fig. 6. Mosaic of narrow-angle television pictures showing the lunar surface under vernier engine 3, as seen through the auxiliary mirror, 9 Earth days after the firing of the vernier engines. The horseshoe-shaped depression is 20 cm across and less than 2 cm in depth and was formed by the firing of the vernier engines. The open end of the depression faces toward the sensor head. Afternoon elevation of the sun was 15 degrees, relative to the lunar surface beneath the spacecraft (catalog No. 5-MP-22. GMT day 265; approximately 14:00).

The diffused gas blowout probably was the predominant cause of the horseshoe-shaped depression, 20 cm wide and less than 2 cm deep, which is visible in Figs. 6 and 7. The movement of soil resulting from blowout is generally upward, in contrast to the horizontal movement during viscous erosion. The broken clump and spray of soil on top of compartment B (Fig. 8) apparently are results of this blowout. The compartment top was 1.1 m above the lunar surface.

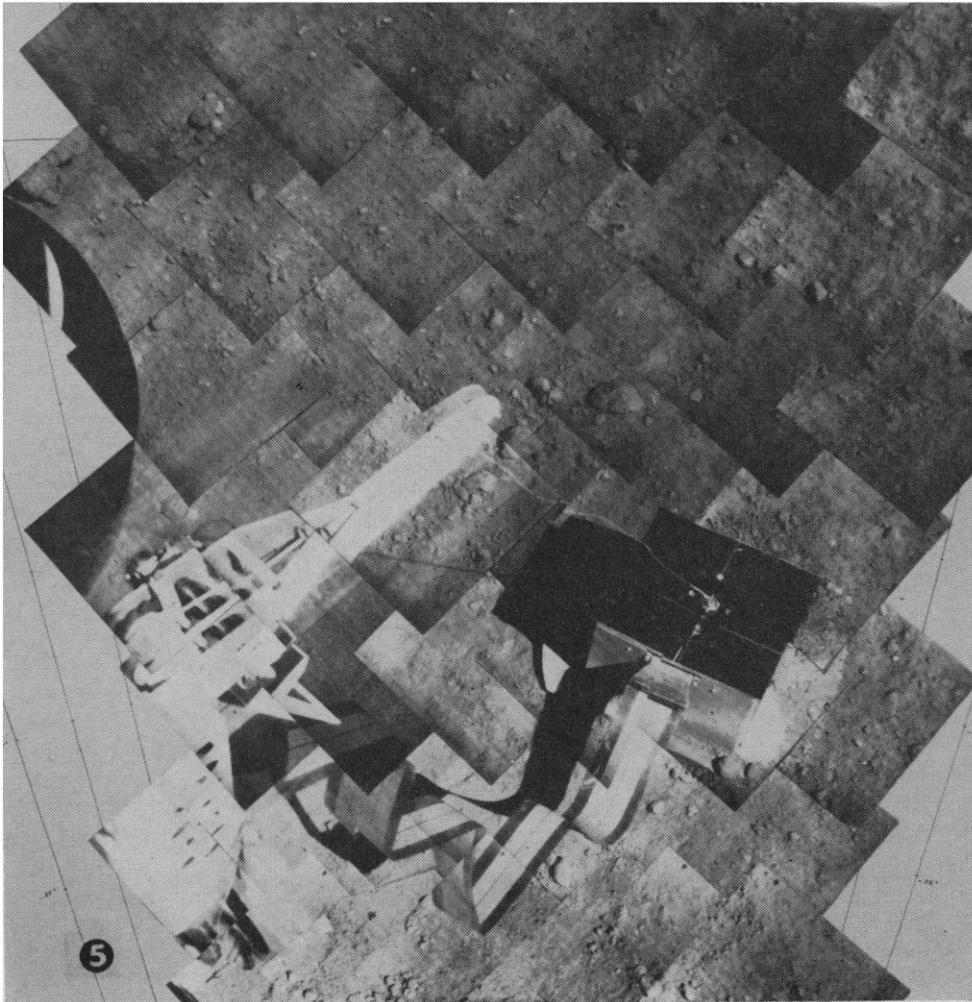
Fig. 5. Mosaic of narrow-angle television pictures showing the area around the sensor head after the spacecraft vernier engines were fired. The sensor head moved approximately 11 cm down a 20-degree slope. Compared to Fig. 4, there is evidence of fine soil and large fragment movements toward the upper right-hand corner. Sun elevation was 57 degrees, relative to the lunar surface beneath the spacecraft (catalog No. 5-MP-20. GMT, day 257; 06:58 to 07:01).

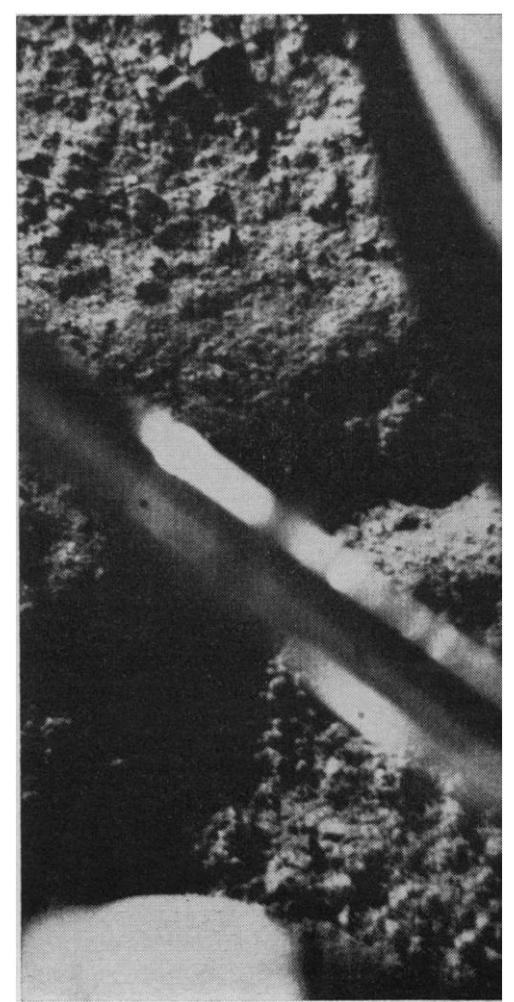
Fig. 7. Mosaic of narrow-angle television pictures showing a direct view of part of the crater formed under vernier engine 3 during the firing of the vernier engines. We estimate that the exit plane of the engine nozzle was between 40 and 45 cm above the lunar surface. The engine thrust level was approximately 115 newtons (26 lb). Sun elevation was 15 degrees, relative to the lunar surface beneath the spacecraft (catalog No. 5-MP-21, GMT day 265; 13:37).

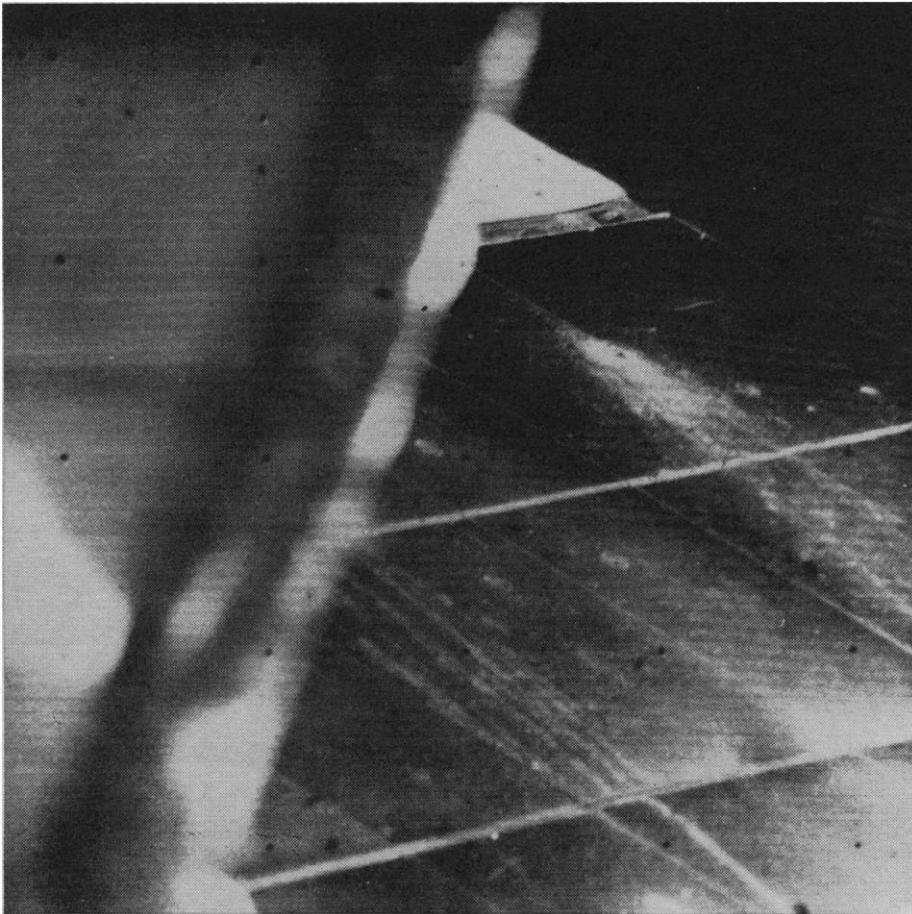
Fig. 8. Narrow-angle television picture showing a part of the top of electronics compartment B. Sprays of fine material that resulted when the vernier engines were fired (GMT day 265; 05:48:58).
