The Magnitude 6.7 Northridge, California, Earthquake of 17 January 1994

Scientists of the U.S. Geological Survey and the Southern California Earthquake Center

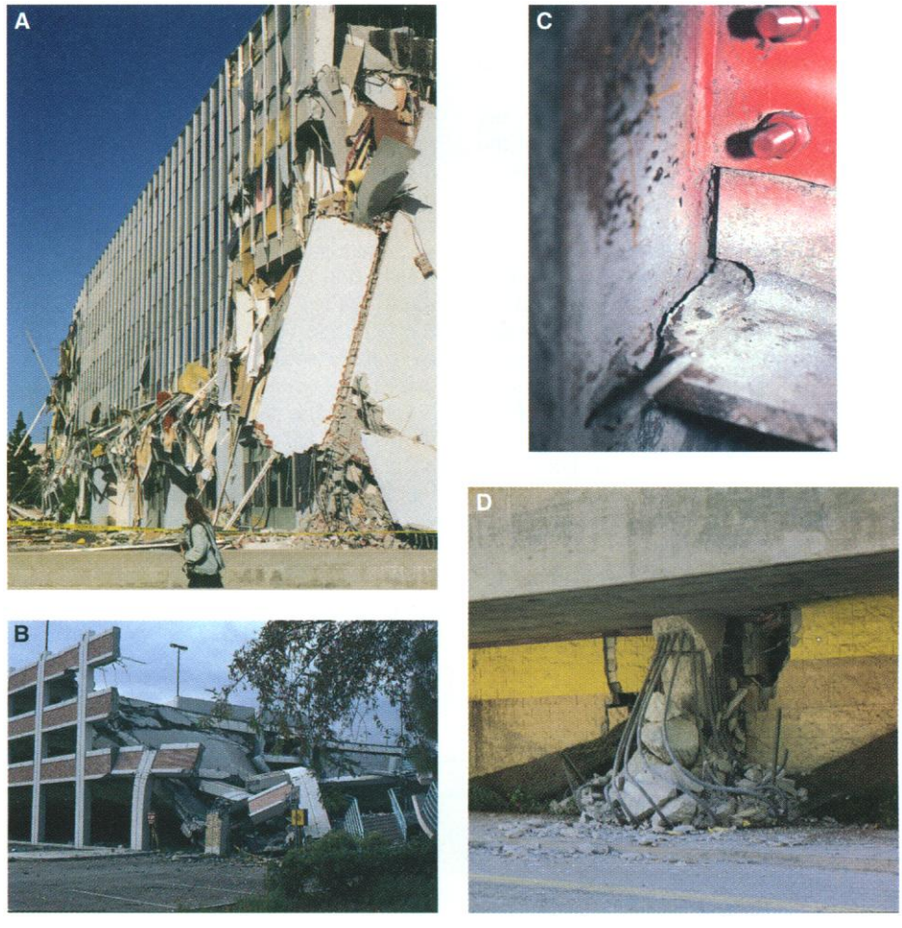
Nonductile reinforced concrete buildings built before the mid 1970s, when lessons from the 1971 San Fernando earthquake were incorporated into the codes, behaved poorly, with partial collapses of a multistory medical clinic (Fig. 6) and of a mall, both high-occupancy structures during business hours. In addition, a hotel, condominium tower, hospital, and office building were severely damaged. Modern reinforced concrete structures fared fairly well, with the exception of pre-cast concrete parking garages (Fig. 6), six of which partially collapsed. Inadequate connections and poor lateral deformation capability of components intended to carry only vertical load may have contributed to these collapses.

Fig. 6. Illustrations of structural damage from the Northridge earthquake. (**A**) This medical clinic in the northern San Fernando Valley is an older, nonductile concrete building. Its second story completely collapsed as did both ends of the building in the stories above. (**B**) The collapse of this parking garage probably originated in the interior, and the post-tensioning cables in the slabs pulled down surrounding areas. (**C**) A close-up photo of part of a beam-to-column joint in a steel building that suffered a weld fracture between the lower flange of the beam and the column. The bolts shown are replacements of original ones that sheared off when the lower flange weld broke. (**D**) This failed column supported a section of Interstate 10 and is another example of the poor behavior of nonductile concrete. The bridge deck fell onto some masonry walls of a leased storage space. {Photos courtesy of Marvin Halling [(A) and (D)] and John Hall [(B) and (C)]}

The most disturbing structural behavior, with potentially great economic implications, was the brittle fracture of welded connections in steel-frame buildings, most often the beam-to-column connections (Fig. 6) that give a building its lateral earthquake resistance. The steel used in buildings is commonly believed to possess excellent ductility, but apparently the welding procedures currently in use do not achieve this desired behavior. Laboratory shaking tests sometimes show poor behavior but not to the extent seen in this earthquake. Although the problem seems serious, none of the 100 or so buildings identified as having connection fractures collapsed or even developed a serious lean. Some damaged buildings are yet to be identified, because the cracks are hidden behind fireproofing and architectural finishing materials. Many aspects of the problem, including proper repair strategies, remain to be resolved (*41*).
