SERVICE BULLETIN

MODEL: IC-R7000 SN AFFECTED: ALL BULLETIN # 35187-001

SUBJECT: **SUPERSEDES SB# 32787-001 (11/25/87)** PROBLEM: AUDIO OUTPUT BECOMES

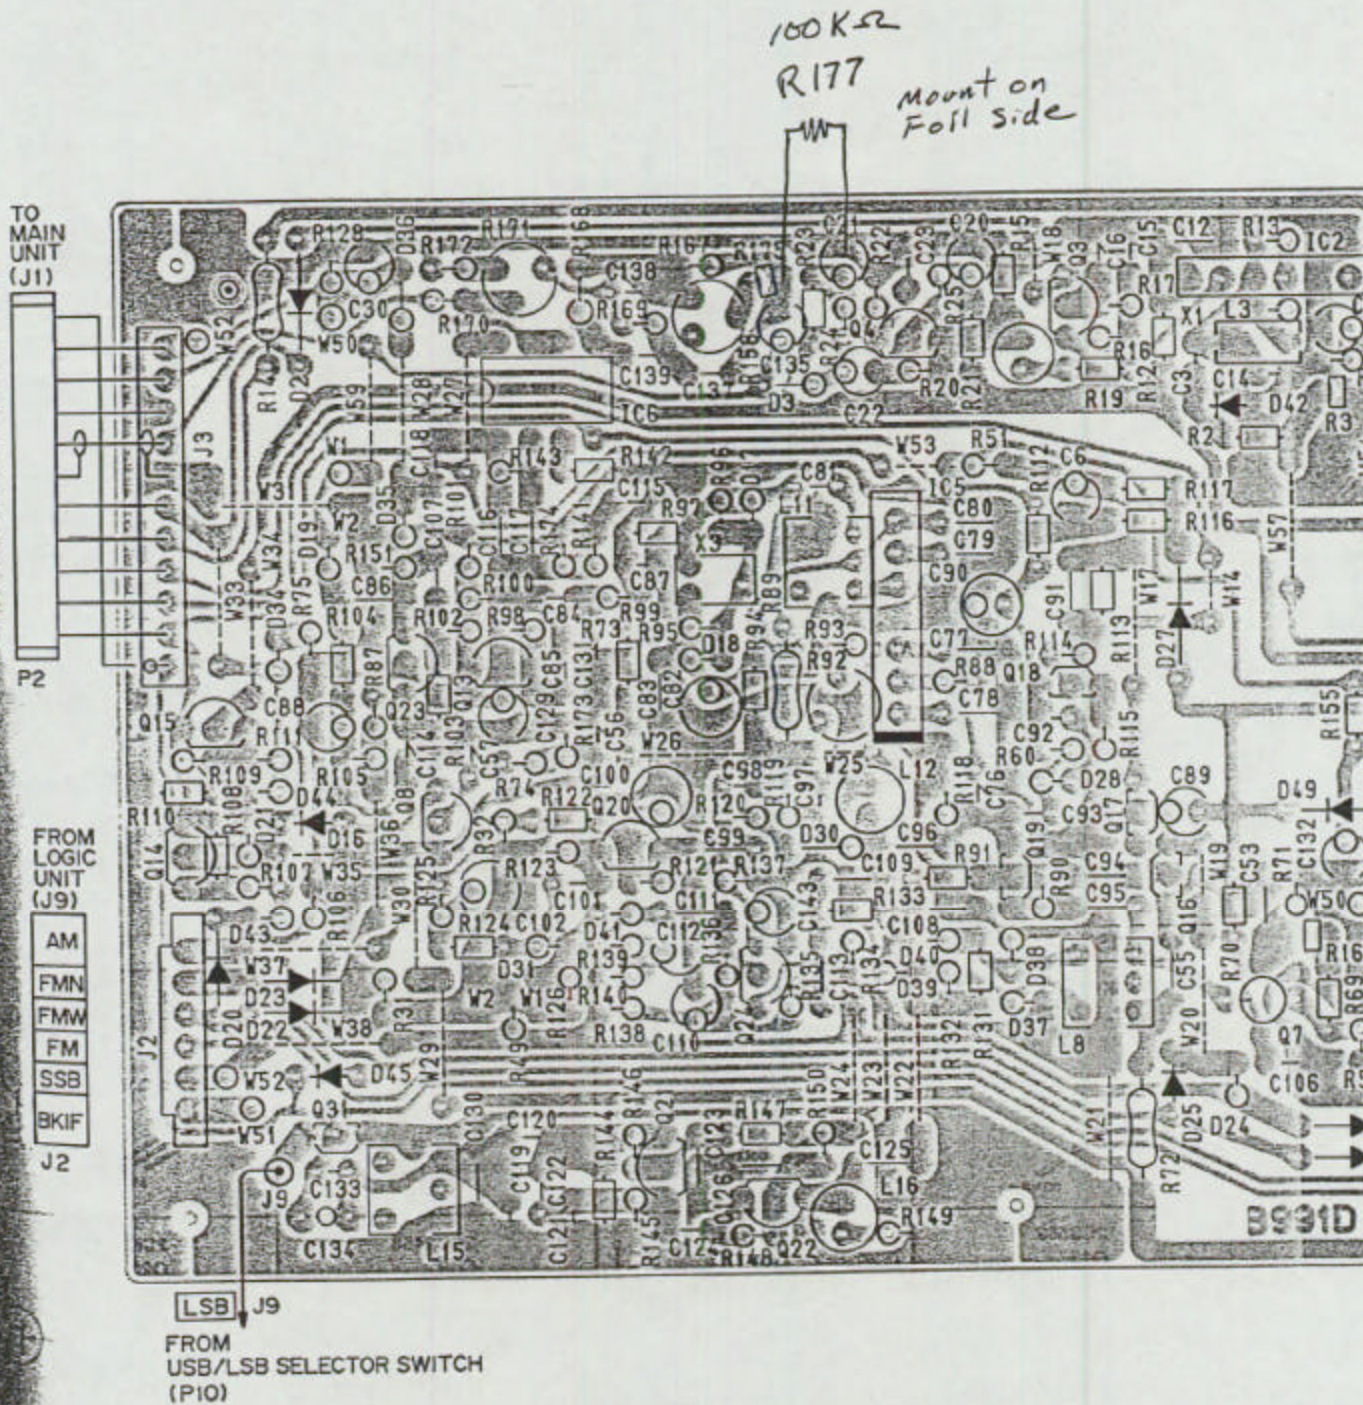
R-7000 IF Board

Add R-177
at this
point on the
foil side

1. REMOVE THE TOP COVER AND DISCONNECT AND REMOVE MAIN I.F. BOARD.
2. ADD R-177 (P/N 915-01187 100 K) TO THE POINT SHOWN ON DIAGRAM 1 (FOIL SIDE)
3. RE-INSTALL BOARD AND TEST IT. REPLACE COVERS AND WARM UP FOR A MINIMUM OF TWO HOURS IN ORDER TO CHECK FOR DISTORTED AUDIO.
4. RETURN TO SERVICE
