Ten Tec Titan 425 Amplifier with Ameritron AL800H P. S. Transformer

John, W1AN 8/7/2014

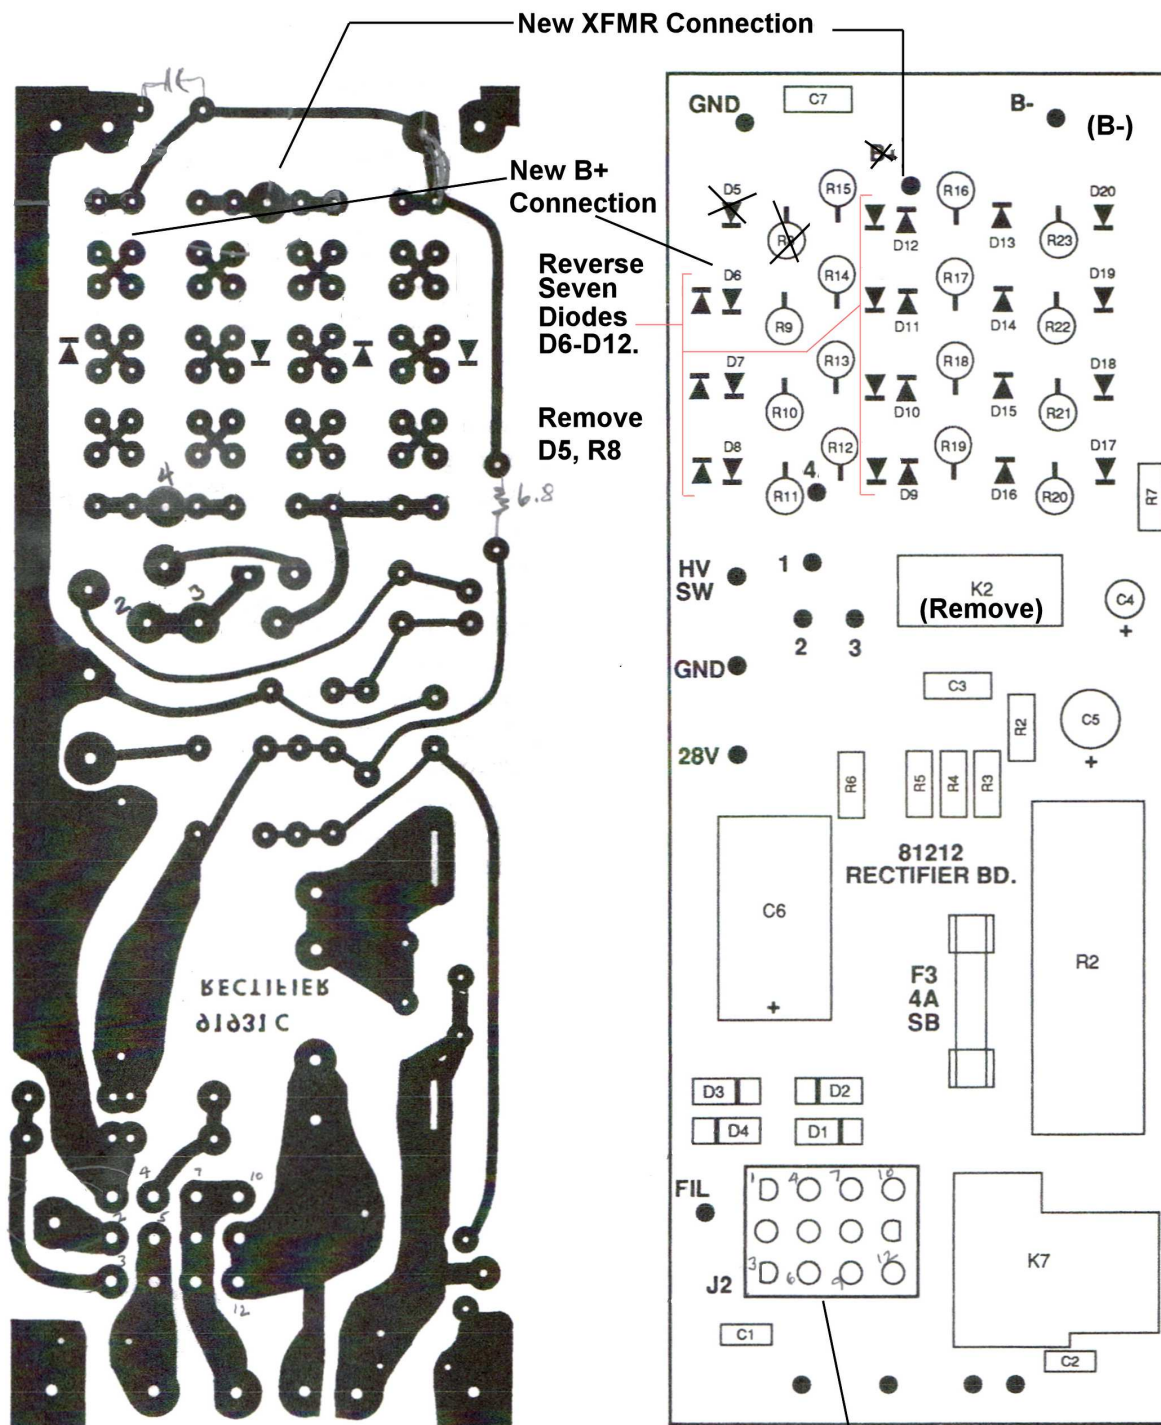
VOLTAGE DOUBLER MODIFICATIONS

On the Rectifier board D6-D12 diodes were removed, reversed and replaced. (Seven diodes) Several of the original diodes were bad so it was easy just to reverse several with the new ones. (Suggest 1N5408).

The Rectifier and Filter boards show the connection point and diode changes required to change from a full wave bridge to a voltage doubler. The schematic shows the wiring, and other interconnections within the power supply.
