PRODUCT REFERENCE BOOK

for the Tektronix Type

422 PRB

400-SERIES CRT's - PREMATURE FAILURES

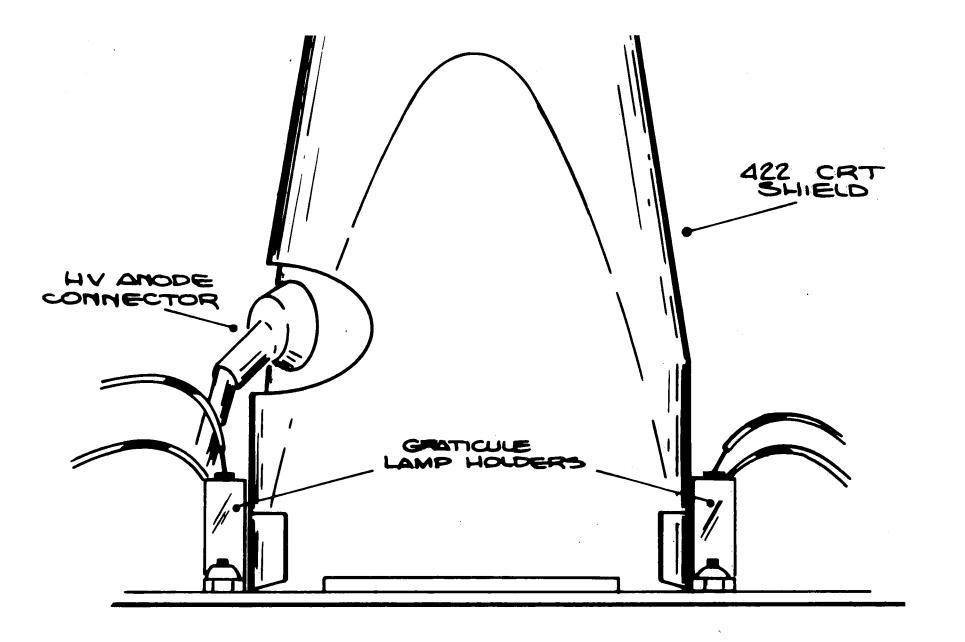
The installation involves removing the AC Power Supply and instrument cabinet to replace the circuit board and two graticule bulbs, B725 and B726. The new value of R657 is present on the new board and does not require replacement.

- A. TO REPLACE THE GRATICULE BULBS
- () 1. Remove the instrument AC Power Supply and cabinet.

Refer to drawing while performing steps 2 through 4.

- () 2. Remove the graticule lamp holder nuts, located above the CRT shield.
- () 3. Replace graticule lamps B725 and B726 with the new lamps from the kit.
- () 4. Reinstall the graticule lamp holders.

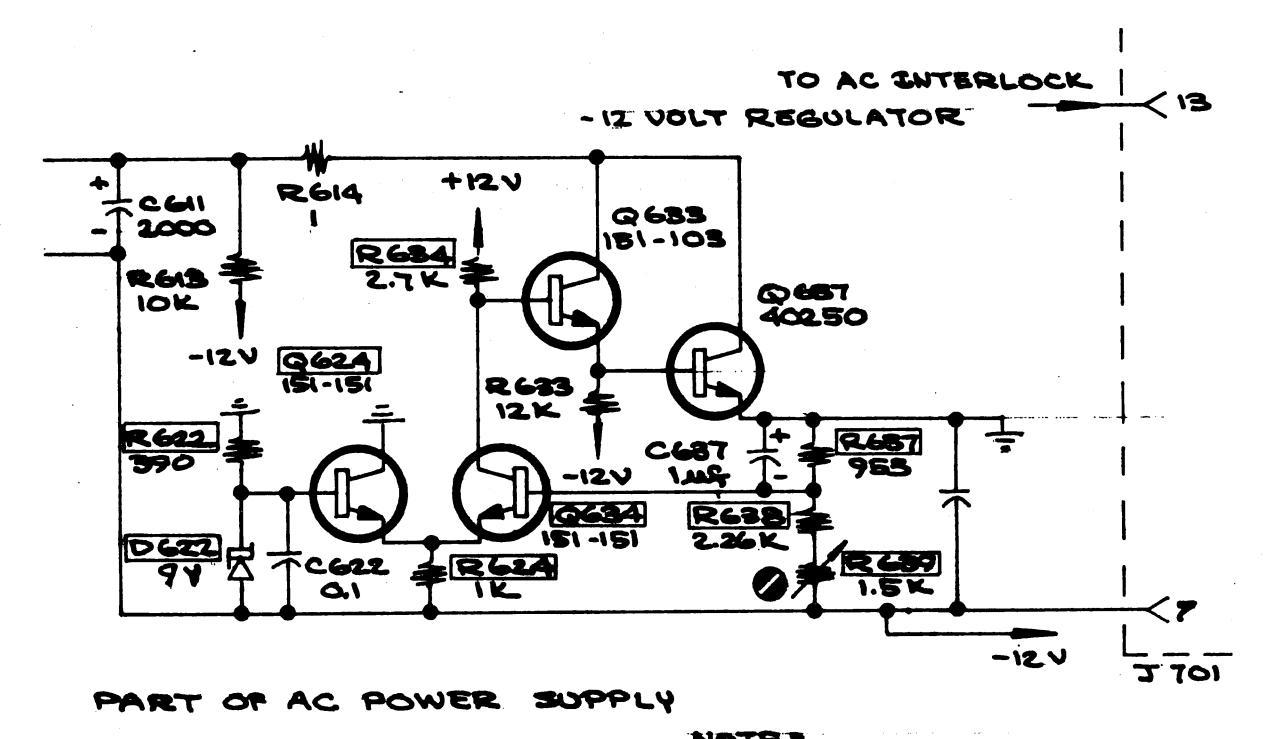
M9303 (cont)

- 1) The -12v reference zener diode D622 is no longer available with the desired temperature range compensation.
- 2) Resistor R639 (-12v) is prone to change resistance under humid conditions.
- 3) -12v power supply transistors C624 and Q634 were changed to reduce costs while providing equal quality.

- 1) Change R639 from a 2.5k composition potentiometer to a 1.5k wirewound potentiometer.
- 2) Change R622 from 1 k 1/4 W 5% to 390Ω 1/4 W 5%.
- 3) Change R634 from 2.4 k 1/4 W 5% to 2.7 k 1/4 W 5%.
- 4) Change R624 from 620Ω 1/4W 5% to 1 k 1/4W 5%.
- 5) Change R638 from 4.02 k 1/8W 1% to 2.26 k 1/8W 1%.
- 6) Change R637 from 6.34 k 1/8W 1% to 953Ω 1/8W 1%.
- 7) Replace D622 with a 1N936 zener diode as needed.

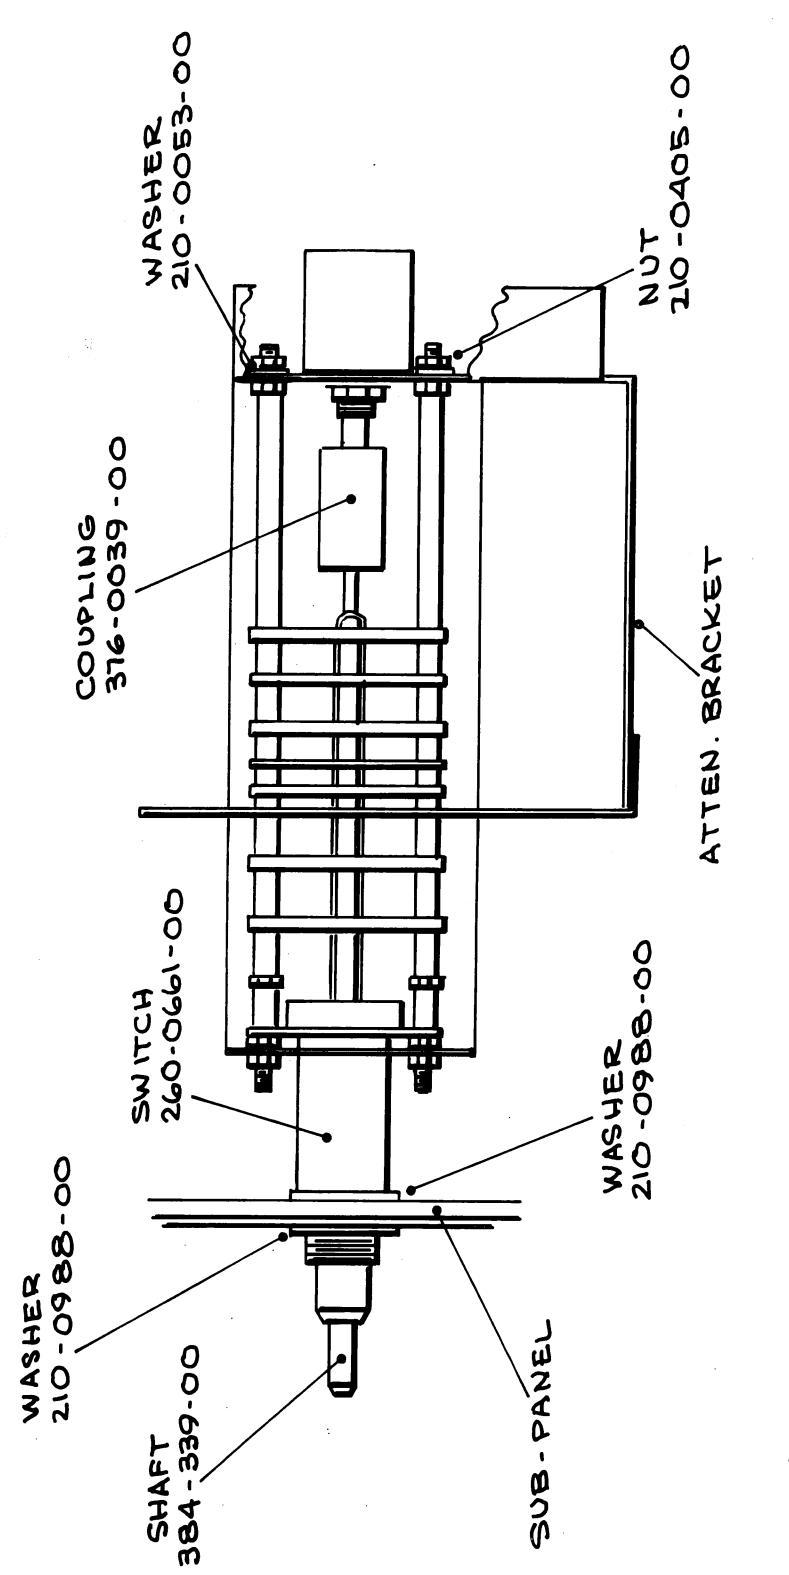
422 ATTENUATOR ASSEMBLY CBEFORE MOD)

- PROBLEM: A misalignment of the attenuator switch and variable attenuator pot causes interference between the rotor and stator insulators. This results in mechanical noise when the attenuator is rotated.
- PRODUCTION CHANGE: The variable attenuator mounting and coupling was changed to more properly align the attenuator switch and variable attenuator pot (see sketch).
 NOTE: Serial numbered instruments 2440-2689 used the old shaft and coupler because of a parts shortage on 103-0049-00 and 103-0050-00.

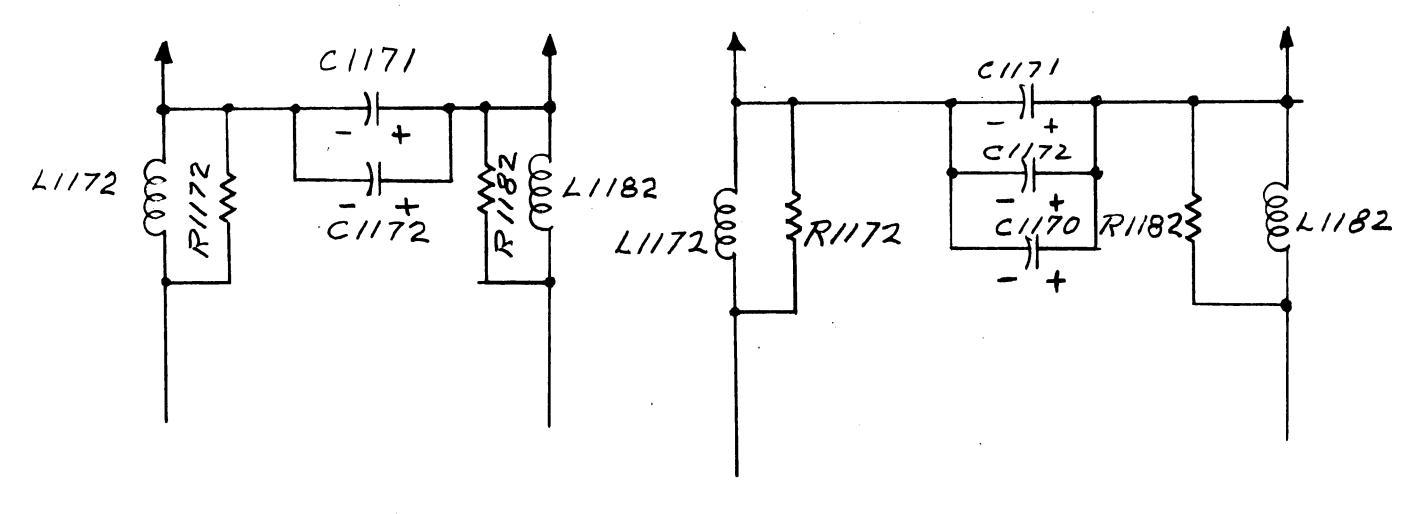
POWER REGULATOR HIGH FREQUENCY SHUNT CAPACITOR ADDED TO REDUCE RFI

Add C1170, a 0.1 µf 50 V capacitor, in parallel with C1171 and C1172 located on the lower left hand corner of the DC power connector circuit board. "C1171" and "C1172" are stamped on the board. Also, see the AC-DC power supply instruction manual (page 4-3) for additional locational information.

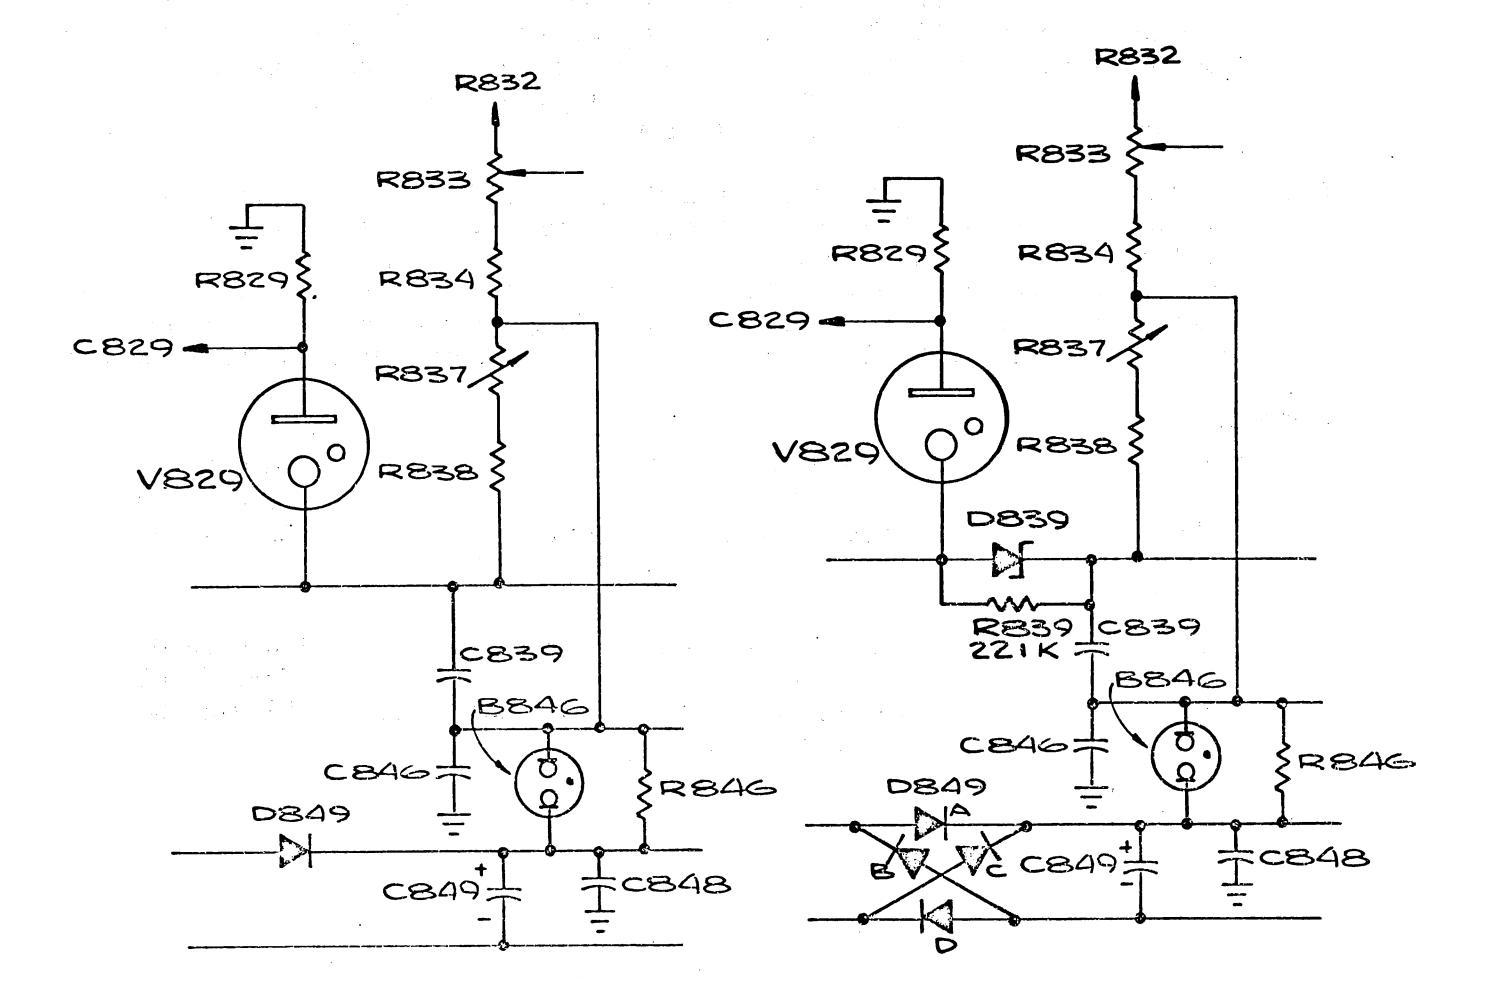
M10517-1 (cont)

CRT CIRCUIT ZENER DIODE AND RESISTOR ADDED TO ELIMINATE CHANGE IN DEFLECTION SENSITIVITY

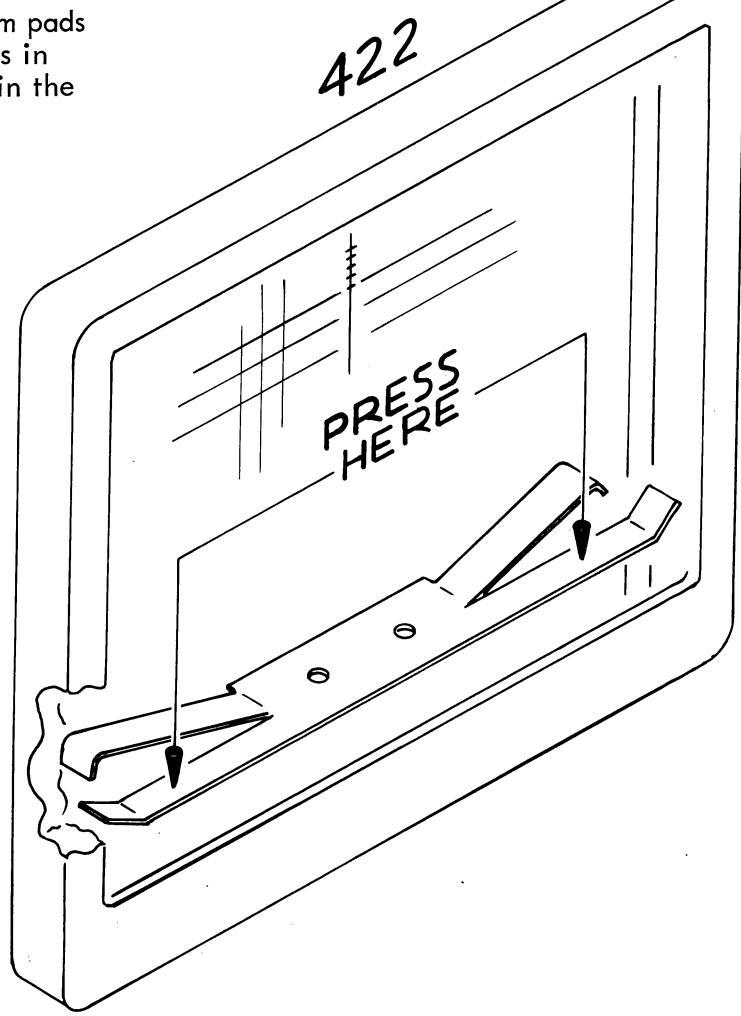
<u>CRT FILTER</u> FOAM SUPPORT PADS REPLACED WITH A SPRING FOR ADEQUATE MESH FILTER SUPPORT	See SQB	M9643
Effective Prod s/n 2070	Usable in field instrun	nents s/n 100–2069
FRONT PANEL SYMPTOM: None.		
PROBLEM: The neoprene foam tape	pads do not provide adequate suppo	rt for the mesh filter.
PRODUCTION CHANGE: The neop	prene foam pads have been replaced	with a filter spring.
Parts Removed:		
Tape, neoprene, 1/2in.	(2)	253-0069-00
Parts Added:		
Spring, filter		214-0654-00
INSTALLATION INSTRUCTIONS:	(See below or MI - 9643)

Remove the adhesive backed foam pads from in front of the CRT and press in the new support spring as shown in the illustration.

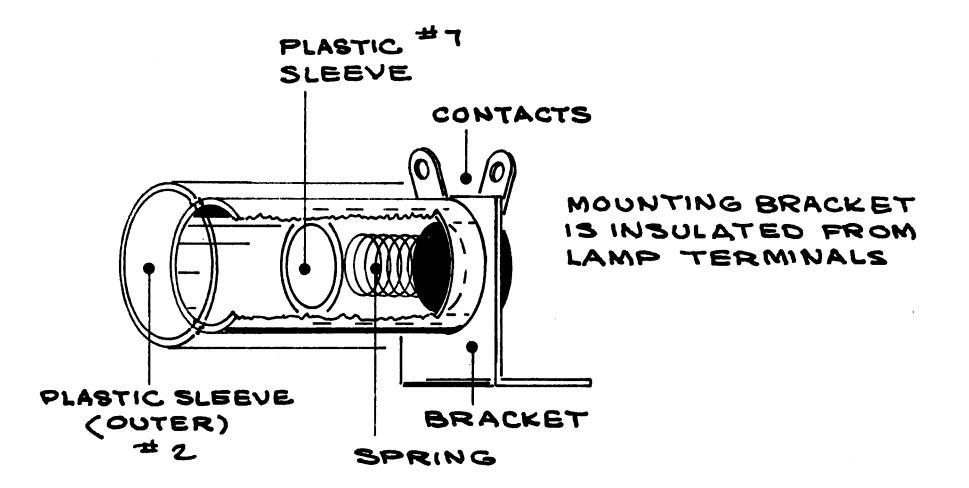
Graticule lamp sockets may short to the CRT shield. This may overheat R657 in the AC power supply, and may damage D1214 and D1215 in the AC-DC power supply. Some instruments may have been shipped with +12v connected in error to the outside terminal of the socket.

- 1) Remove the light sockets from the front casting and remove the bulbs from the sockets.
- 2) Install the 5/32 in. #7 clear vinyl tubing inside the sockets over the contact springs.
- 3) Install the 1/2 in. #2 clear vinyl tubing over the outside of each lamp socket.
- 4) Re-install the bulbs in the sockets and then install the sockets onto the front casting.

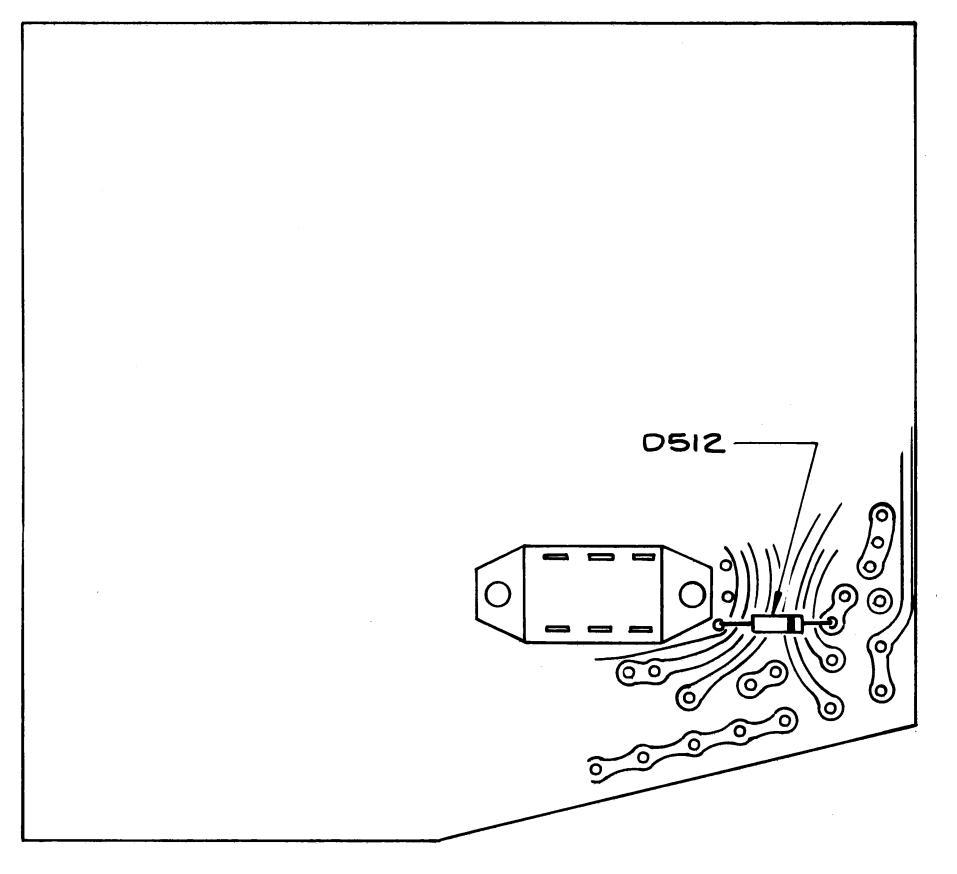
FIG. 1

Linearity at the start of the CRT display, in the X10 MAG mode can be improved by adding a diode (D524) between the collector and base of Q524 and rewiring diode, D512, to connect its anode to the emitter of Q513 instead of ground. The diodes prevent Q524 from saturating, thereby reducing the storage time, and improving the linearity.

- Remove D512, a 6185 diode, from its location as shown in Fig.1. Save for later use.
- 2) Remove the three mounting screws from the Horizontal Amplifier circuit board and lift the board so the bottom side is readily accessible.

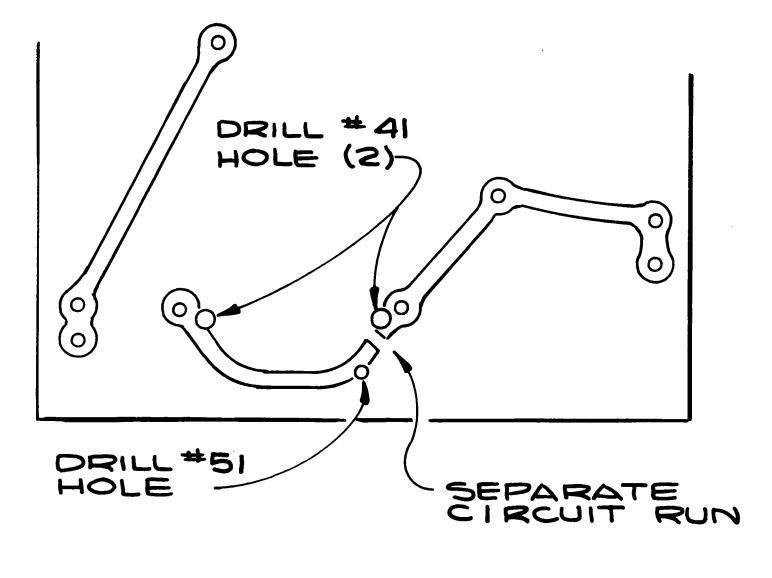
FIG. 1

Immunity to changes in CRT sensitivity with changes in the CRT display intensity can be improved by installing a 51 V zener diode in parallel with a 221 k precision resistor as shown in the included schematic. The addition of these two components helps to maintain a more constant CRT cathode voltage with respect to the potential of the deflection plate area. This difference in potential is the major sensitivity determining factor in the CRT.

- 8) Drill a hole, using a #51 drill, in the location shown in Fig.1.
- 9) Install the small eyelet into the hole from the Fig. 1 side of the board. Crimp the eyelet, using a pair of rivet pliers from the FMS Switch Repair Kit, and solder the rivet to the run. Do not fill the eyelet with solder.

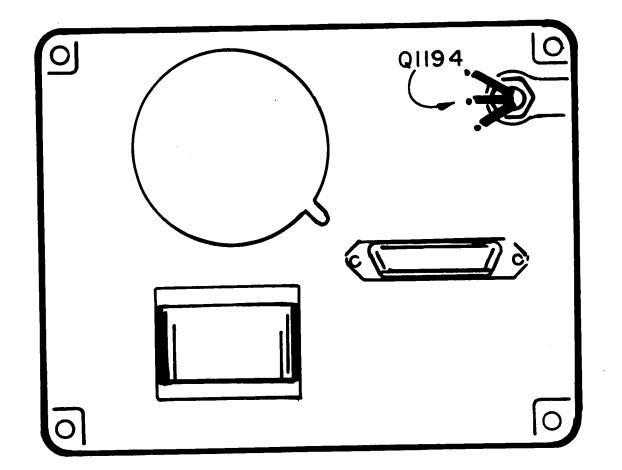
The reliability of the Power Supply can be improved by changing the transistor type used for Q1194 to a 2N4036. Occasionally at turn on, the breakdown voltage of the type presently used can be exceeded, resulting in secondary breakdown which causes the supply to go out of regulation.

Install a 210-0909-00 mica washer between the DC POWER CONTROL circuit board and the flat washer of the heat sink on transistor Q1194. Refer to the illustration for the location of Q1194.

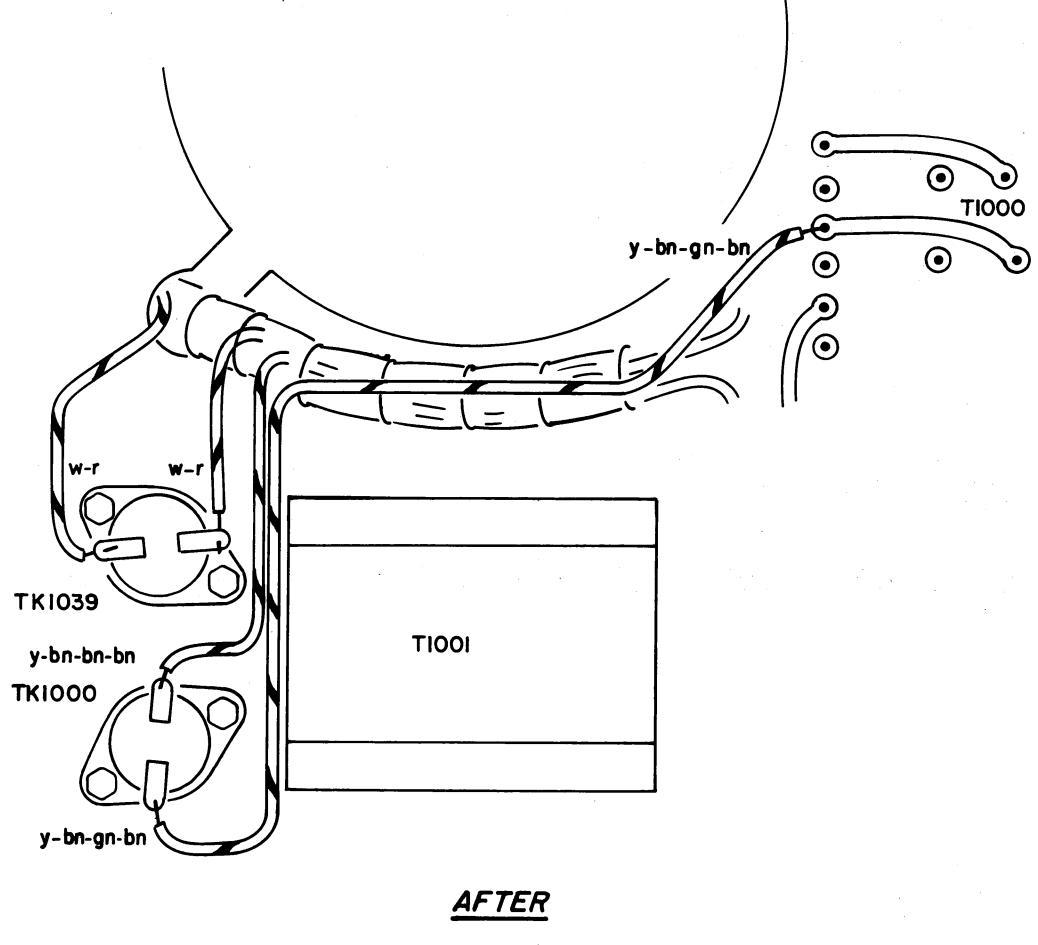
FIG.4

Reduced shock hazard and increased protection against accidental circuit damage can be obtained by rewiring the power input circuitry to place all switching (On-Off switch, fuse, and thermal cutouts) in the "hot" side of the power line. With the present wiring method, it is possible for the transformer to remain "hot" after the fuse has blown.

- 8) Install a new 6" piece of yellow-bronw-green-brown wire and dress along the existing cable above transformer T1001 as shown in Fig. 4.
- 9) Unsolder the yellow-brown-brown-brown wire connected to thermo cutout TK 1039.
- 10) Relocate the two white-red wires connected to TK1000 to TK1039 (inboard and outboard terminals respectively).
- 11) Solder the yellow-brown-brown-brown wire (removed in step 9) to TK1000 (inboard terminal nearest TK1039) as shown in Fig. 4.
- 12) Solder the yellow-brown-green-brown wire (installed in step 8) to the outboard terminal of thermo cutout TK1000 as shown in Fig. 4.
- 13) Reinstall the AC-DC POWER SUPPLY in the housing.

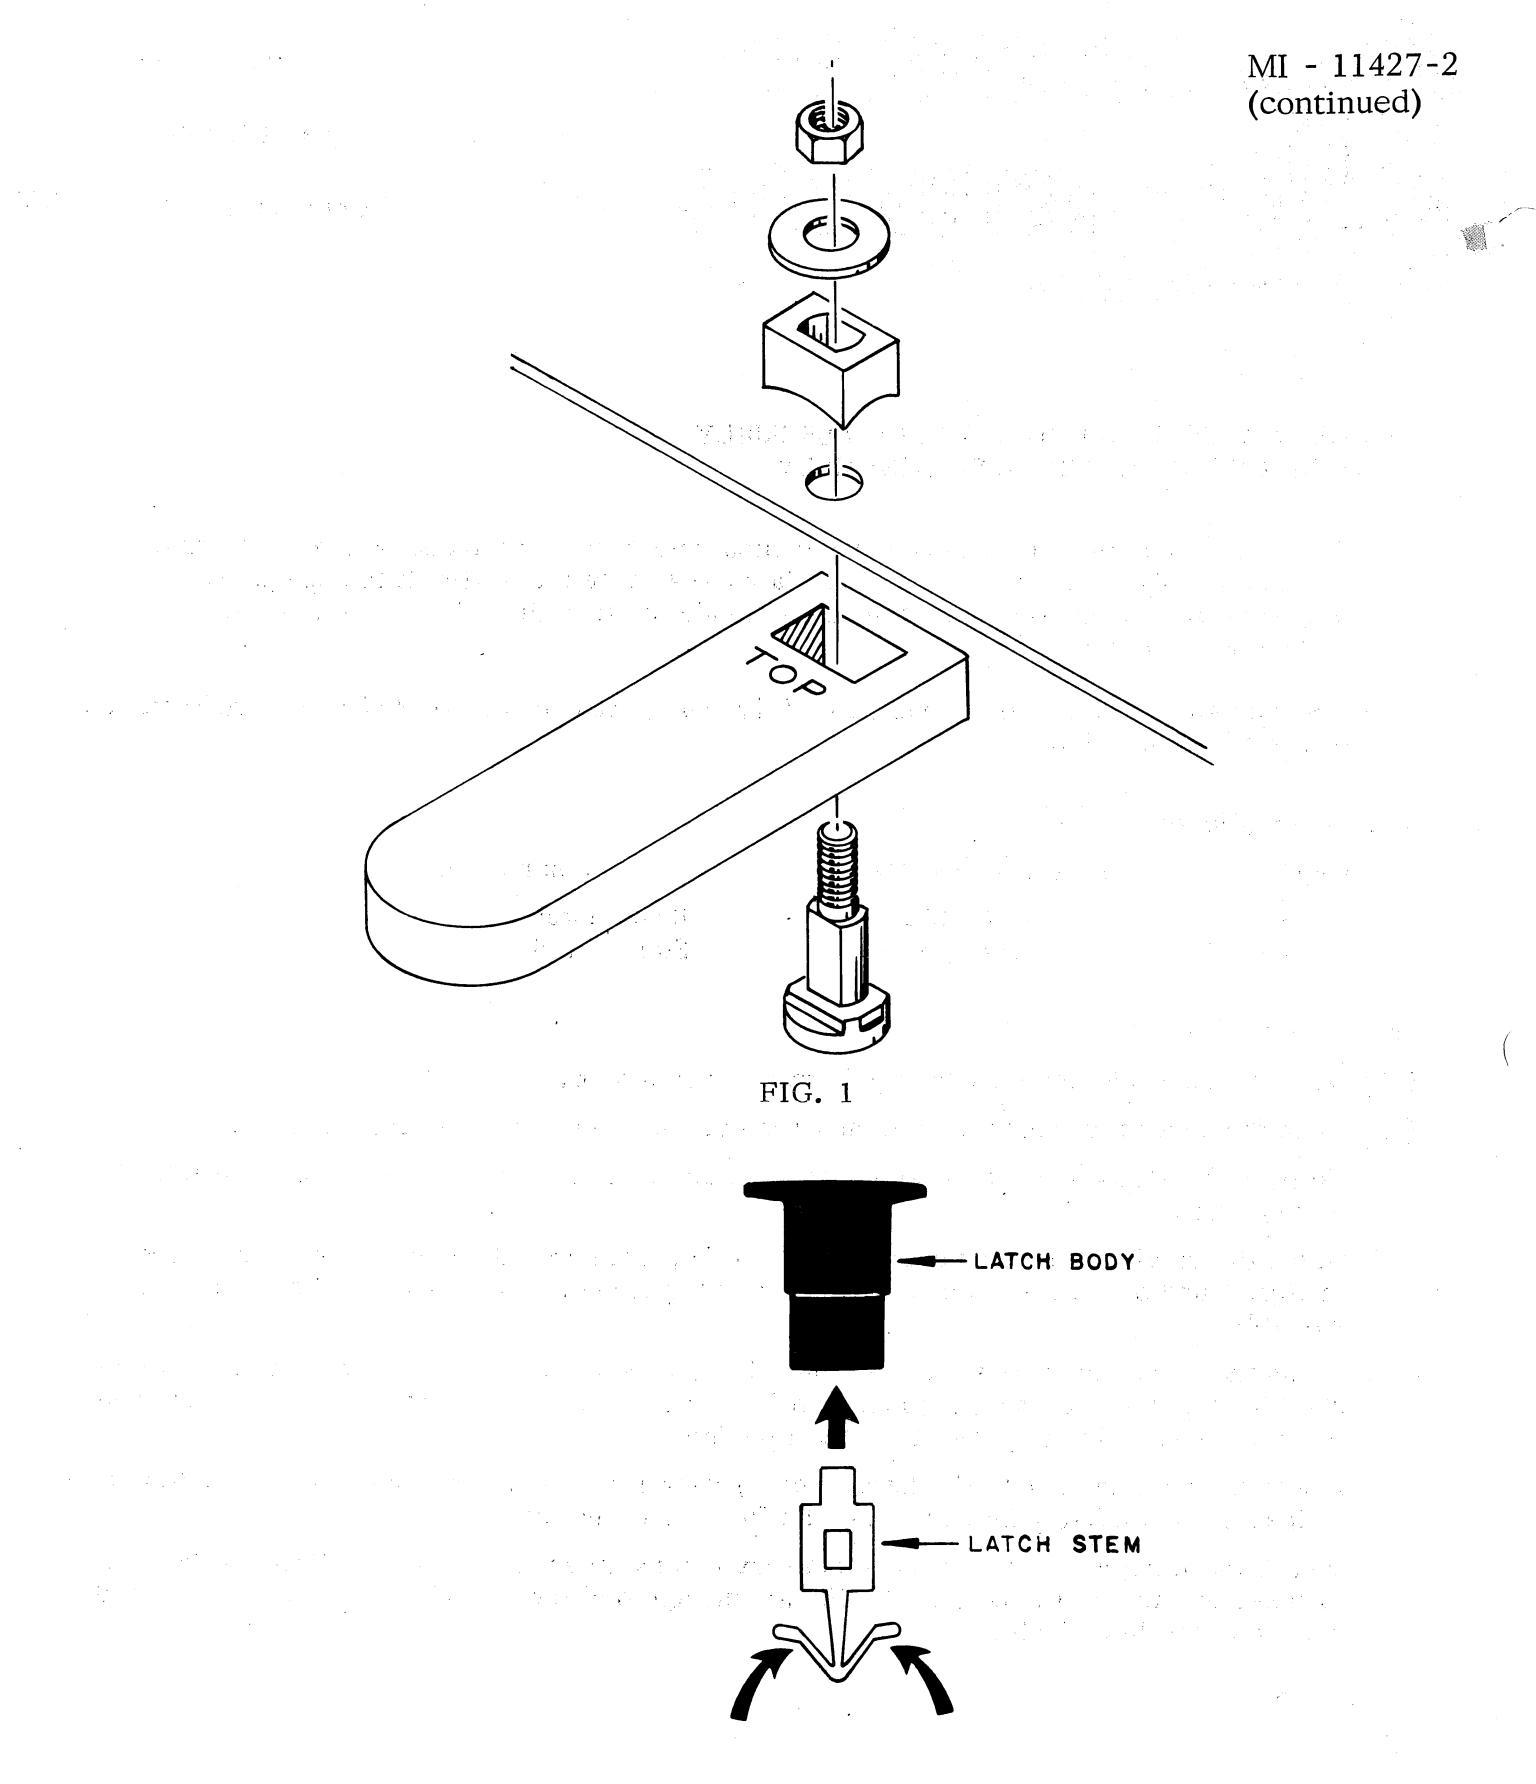
FIG. 2

The latch assembly on the accessory compartment lid is replaced by a new, improved latch assembly. The previously used latch assembly was difficult to engage and occassionally broke when an attempt was made to close the lid with the latch in the locked position.
