'67 FENDER BAND-MASTER AMP AB763

'67 Band-Master

Original project by dbishopbliss, Oct, 2013

Revised by sluckey, Mar, 2019

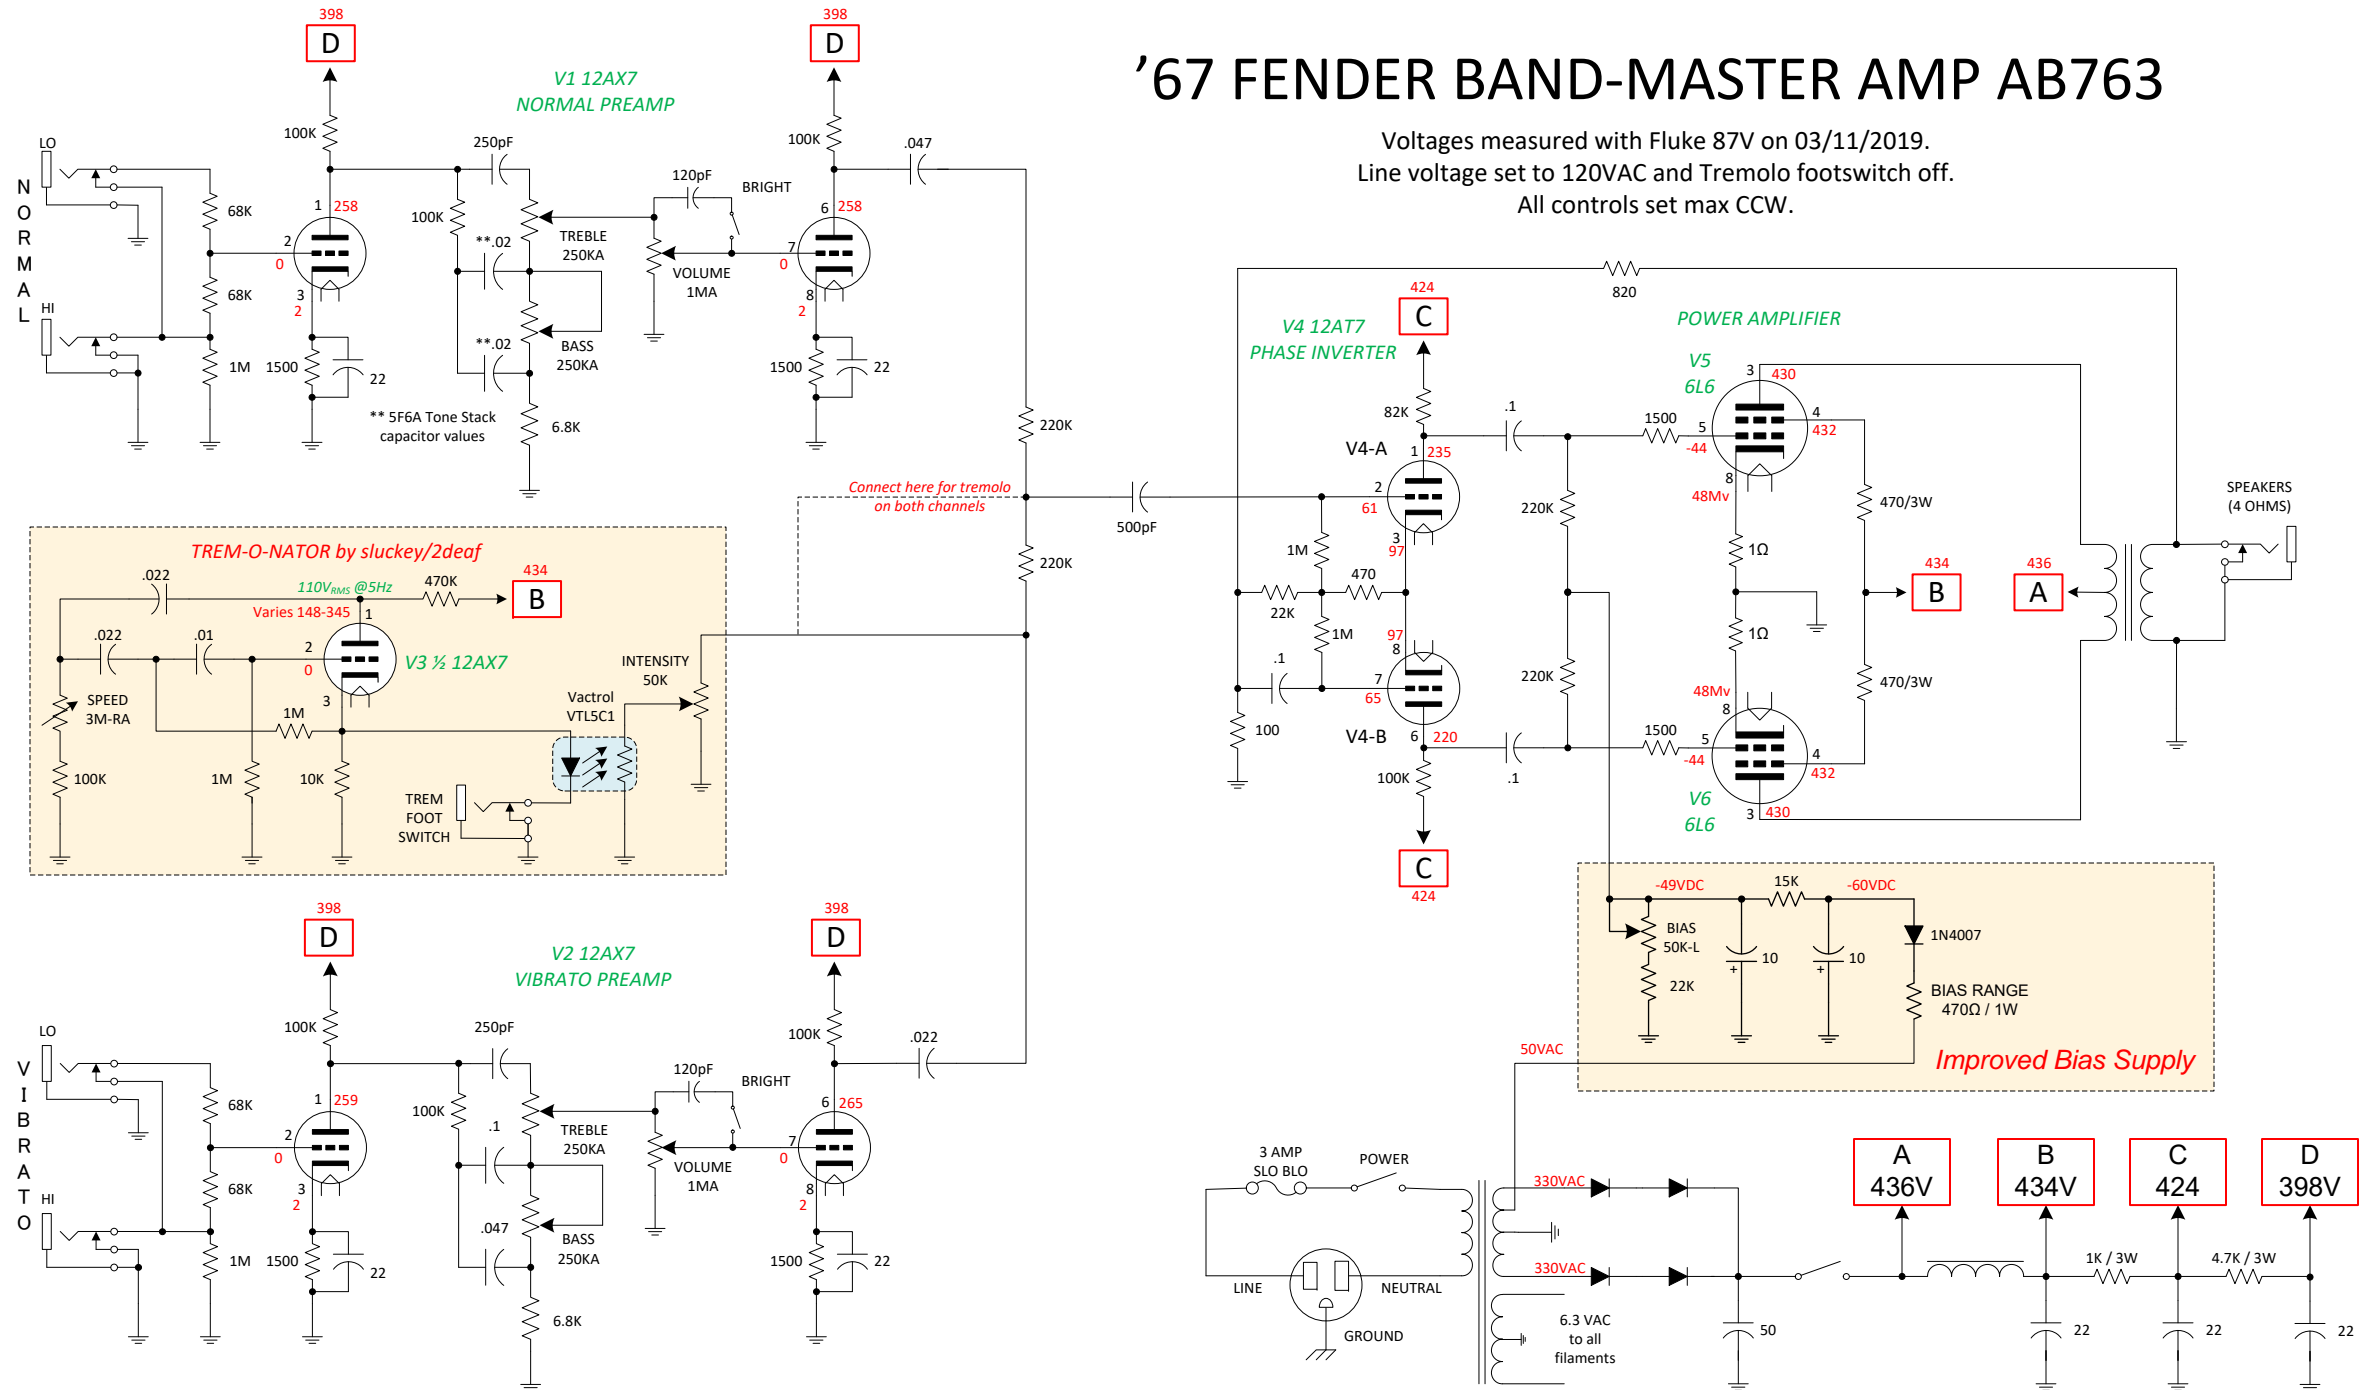
As found issues:

- Black wire on B+ diode terminal strip never soldered..
- Bad solder connection/broken lead on top 100 μ F/450V reservoir cap.
- Second bias cap positive end never soldered.
- 47K resistor in bias circuit never soldered to ground turret.
- 220K grid bias resistor for V6 never soldered.
- CHNL 1 250pF treble cap never soldered.
- 50K INT pot should be 250K.

Changes

- Removed reservoir cap/terminal strip assembly.
- Removed diode/terminal strip assembly.
- Added cap can for reservoir cap.
- Installed diodes on board.
- Replaced INT pot with correct pot.
- Replaced 47K bias resistor with 22K for proper 6L6 bias range.
- Replaced 4.7K/25 μ F tremolo oscillator cathode components with red LED.
- Modified tremolo circuit to Trem-O-Nator circuit. (shown below)
