PIC16C923

PIC16C923 Rev. A Silicon Errata Sheet

The PIC16C923 (Rev. A) parts you have received conform functionally to the Device Data Sheet (DS30444**D**), except for the anomalies described below.

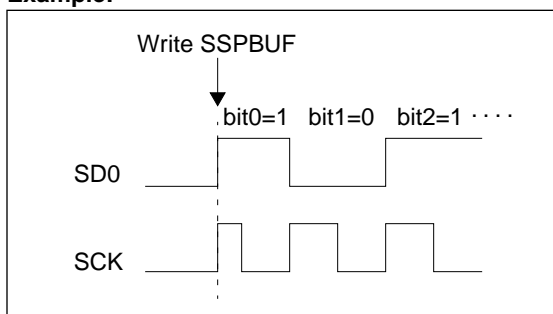
Example:

5. Module: SSP (SPI Mode)

When the SPI is using Timer2/2 as the clock source, a shorter-than-expected SCK pulse may occur on the first bit of the transmitted/received data.

Work Around

To avoid producing the short pulse, turn off Timer2 and clear the TMR2 register, load the SSPBUF with the data to transmit, and then turn Timer2 back on.
