## ST75C520 REVISION 1.4

## I - INTRODUCTION

The purpose of this document is helping the customer to use the Revision 1.4 of the ST75C520. So the ST75C520 Revision 1.4 Application Guide answers some questions as :

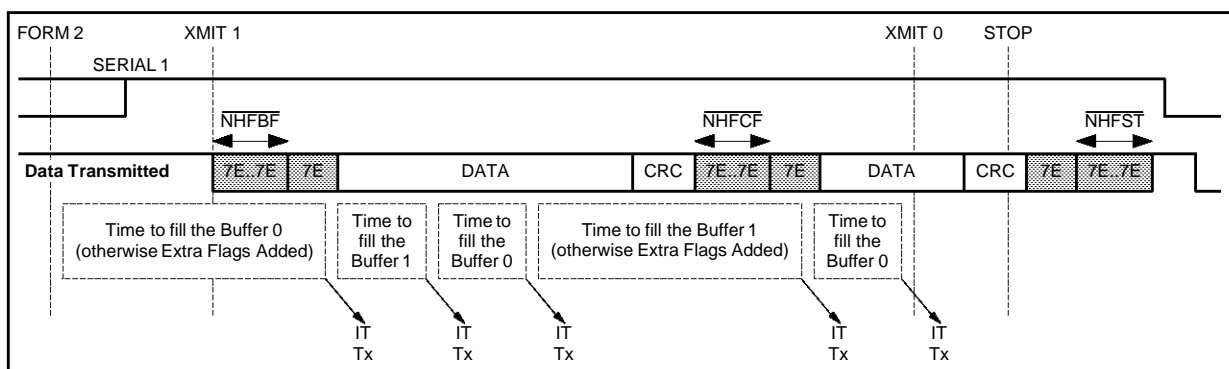
**Figure 1 : Detailed Timing Diagram**

The default value for these three variables is 0. The programming range is from 0 to 7FFF (32767) (see Figure 1).
