PIC16CR65

PIC16CR65 Rev. A Silicon Errata Sheet

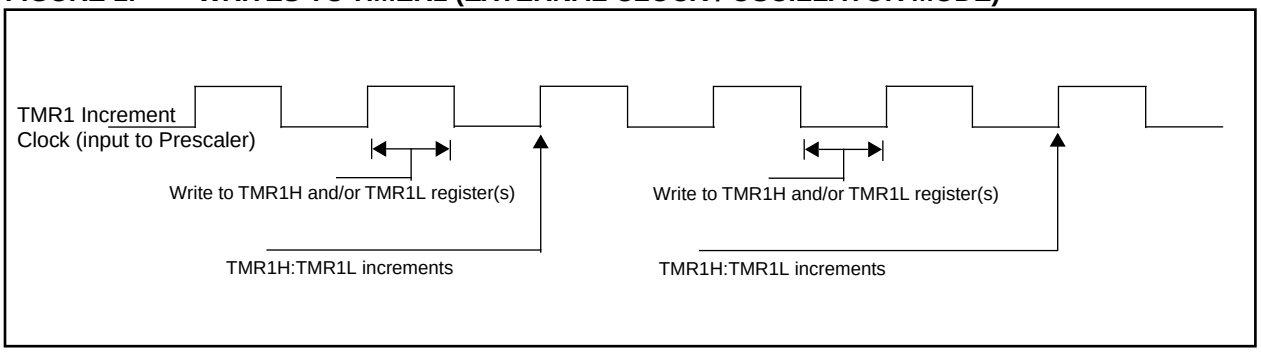
FIGURE 1: WRITES TO TIMER1 (EXTERNAL CLOCK / OSCILLATOR MODE)

a) The operation of Timer1 needs some clarification when the timer registers are written when the TMR1ON bit is set.

The internal clock signal that is the input to the TMR1 presaler affects the incrementing of Timer1 (TMR1H:TMR1L registers and the Timer1 prescaler). When the Timer1 registers are NOT written, the Timer1 will increment on the rising edge of the TMR1 increment clock.

When the TMR1H and/or TMR1L registers are written while this clock is high, TMR1 will increment on the next rising edge of this clock.

When the TMR1H and/or TMR1L registers are written while this clock is low, TMR1 will not increment on the next rising edge of this clock, but must first have a falling clock and the the rising clock for TMR1 to increment.

Figure 1 shows the two cases of writes to the TMR1H and/or TMR1L registers. Due to the VIH and VIL thresholds on the oscillator/clock pins, external Timer1 oscillator components, and external clock frequency, the Timer1 increment clock may not be of a 50% duty cycle.

The TMR1 increment clock is out of phase of the T1OSO/T1CKI pin by a small propagation delay.
