PIC16C924 Rev. A Silicon Errata Sheet

The PIC16C924 (Rev. A) parts you have received conform functionally to the Device Data Sheet (DS30444D), except for the anomalies described below.

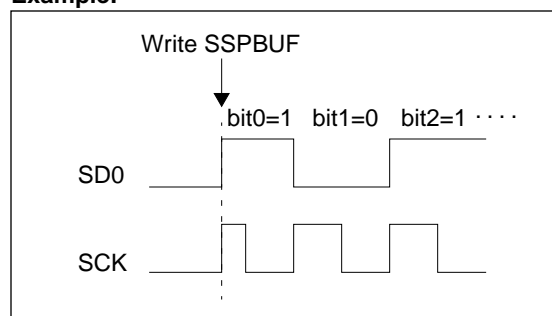
Example:

6. Module: SSP (SPI Mode)

When the SPI is using Timer2/2 as the clock source, a shorter-than-expected SCK pulse may occur on the first bit of the transmitted/received data.

Work Around

To avoid producing the short pulse, turn off Timer2 and clear the TMR2 register, load the SSPBUF with the data to transmit, and then turn Timer2 back on.

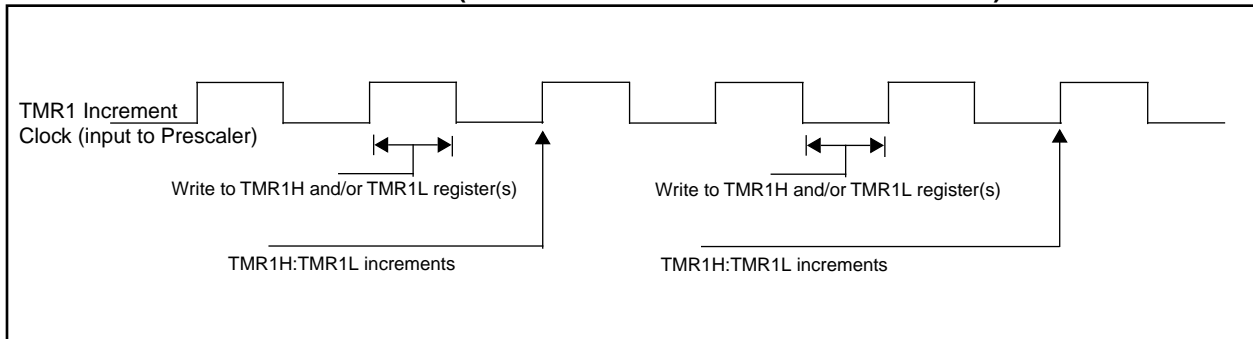
FIGURE 1: WRITES TO TIMER1 (EXTERNAL CLOCK / OSCILLATOR MODE)

The internal clock signal that is the input to the TMR1 prescaler affects the incrementing of Timer1 (TMR1H:TMR1L registers and the Timer1 prescaler). When the Timer1 registers are NOT written, the Timer1 will increment on the rising edge of the TMR1 increment clock.

When the TMR1H and/or TMR1L registers are written while this clock is high, TMR1 will increment on the next rising edge of this clock.

When the TMR1H and/or TMR1L registers are written while this clock is low, TMR1 will not increment on the next rising edge of this clock, but must first have a falling clock and the rising clock for TMR1 to increment.

Figure 1 shows the two cases of writes to the TMR1H and/or TMR1L registers. Due to the V_{IH} and V_{IL} thresholds on the oscillator/clock pins, external Timer1 oscillator components, and external clock frequency, the Timer1 increment clock may not be of a 50% duty cycle.

The TMR1 increment clock is out of phase of the T1OSO/T1CKI pin by a small propagation delay.
